Habitat Update

Hudson River CAG May 28, 2020

Habitat Background

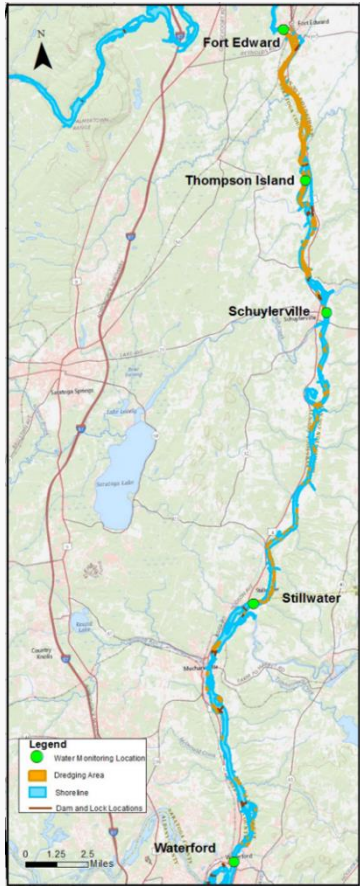
River Section 1
RM 194.5 - 188.5
Reach 8

308 Acres Dredged
6.0 River Miles

10.5 acres RFW established
61.9 acres SAV established

River Section 2
RM 188.5 – 182.4
Reaches 7 and 6

88 Acres Dredged
6.1 River Miles

12.9 acres RFW established
17.7 acres SAV established

River Section 3
RM 182.4 – 154
Reaches 5 through
1

96 Acres Dredged
29.2 River Miles

6.4 acres RFW established
15.4 acres SAV established

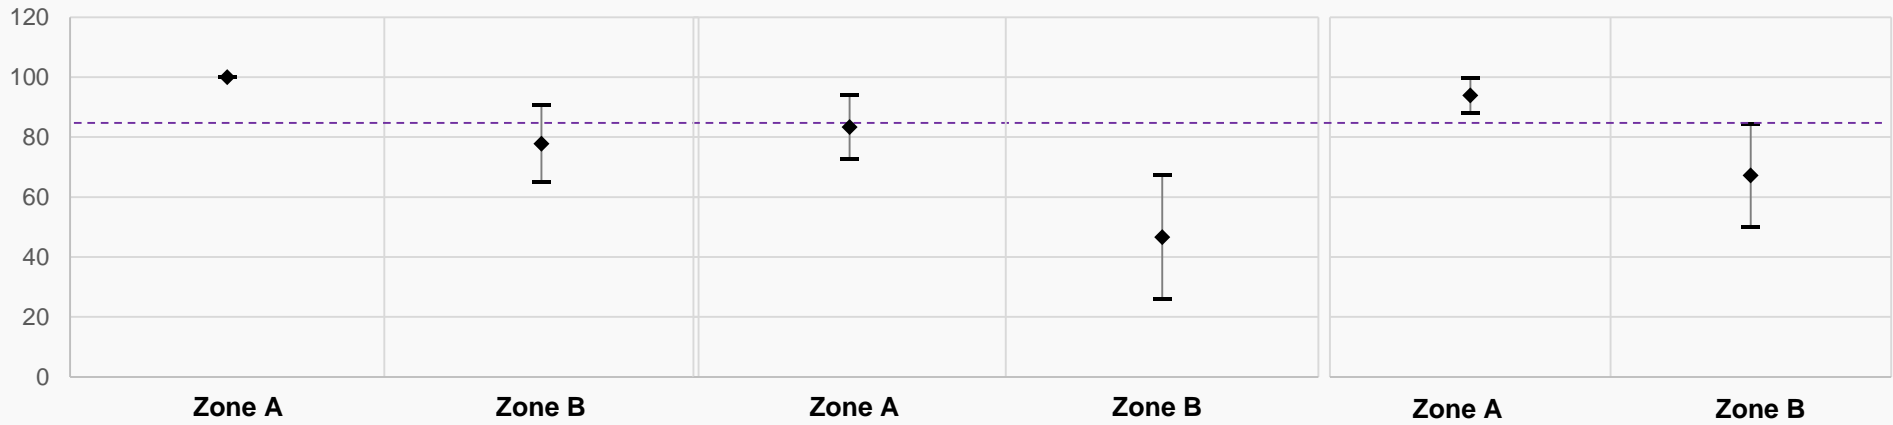
CU60 Percent Cover by Zone

CU60 RFW 2017 by Zone

CU60 RFW 2018 by Zone

CU60 RFW 2019 by Zone

- - - - - 85% (Absolute) Cover

Average percent cover + 2x Standard Error of the Mean
 Average percent cover observed in plots
 Average percent cover - 2 x Standard Error of the Mean

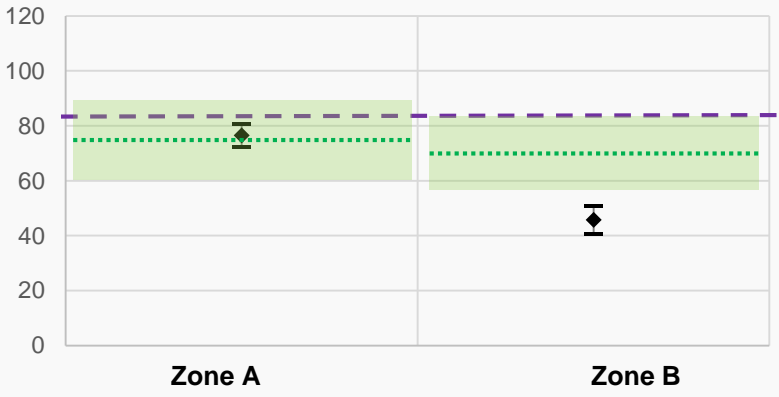
2018 RFW Reconstruction Areas
Percent Cover by Zone

Average percent cover + 2x Standard Error of the Mean

Average percent cover observed in plots

Average percent cover - 2 x Standard Error of the Mean

85% (Absolute) Cover

Reference Area Mean +/- 2*SEM for Each Zone and Year

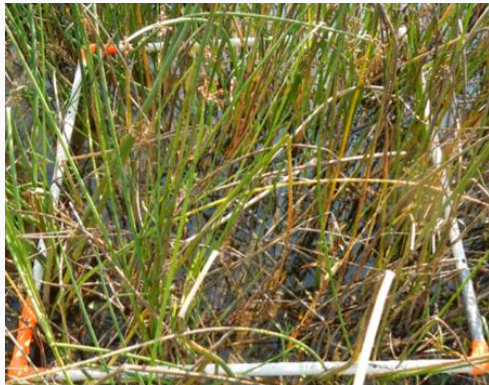
RFW Zone A Areas:

- Generally exceeding benchmarks
- Typically high diversity with good mix of installed and recruited species
- Percent cover in some locations needs to improve
- Represents approx. 35% of RFW reconstruction areas

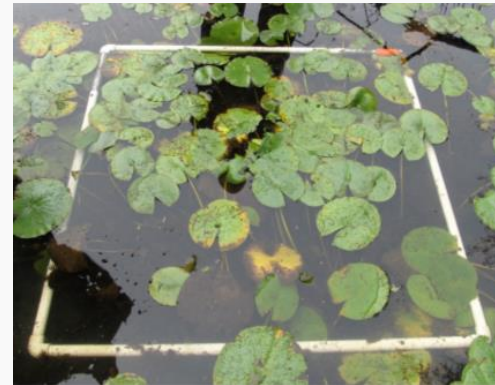
RFW Zone B Areas:

- Generally lagging benchmarks
- Overall percent cover and species diversity needs to improve
- Some areas dominated by SAV species rather than RFW emergent species
- Represents approx. 65% of RFW reconstruction areas

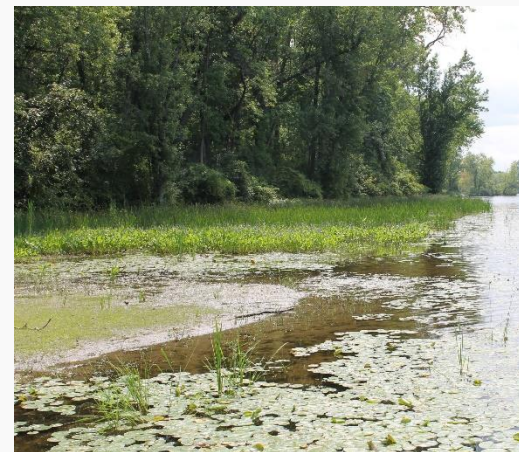
- GIS analysis to categorize RFW areas
 - physical conditions
 - percent cover
 - Code areas based on type of action
 - red=consider viability of the area
 - yellow=adaptive response
 - green=continue monitoring and/or expand
- Field reconnaissance to ground-truth the above categories, especially the areas identified for adaptive response (yellow)
 - Develop action proposal for a pilot test to be implemented in 2020
- Scale the work based on the results of the pilots
- Pilot areas monitoring
 - End of the 2020 growing season
 - June 2021 (identify viable approaches)
- Additional response actions in 2021 as needed

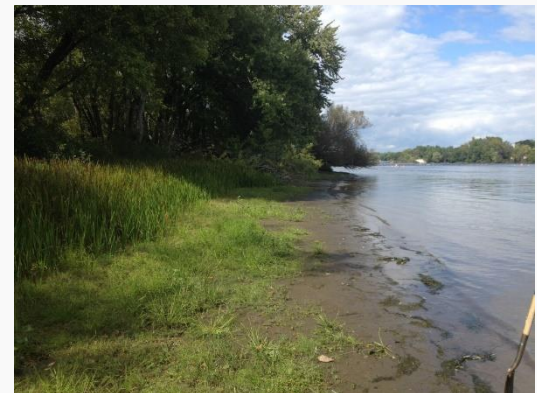
- More extensive visual surveys planned (entire RFW areas)
 - Document percent cover and presence of invasive species
- Develop criteria for bringing expanded RFW areas adjacent to existing wetlands or new RFW areas into the program
- Site observations in 2020 to identify areas for inclusion
 - Confirm criteria
 - Add metrics (if needed)
 - Select expanded or new areas
- Continue to use Habitat Ledger to track RFW areas
 - Added/dropped/re-delineated starting in 2020

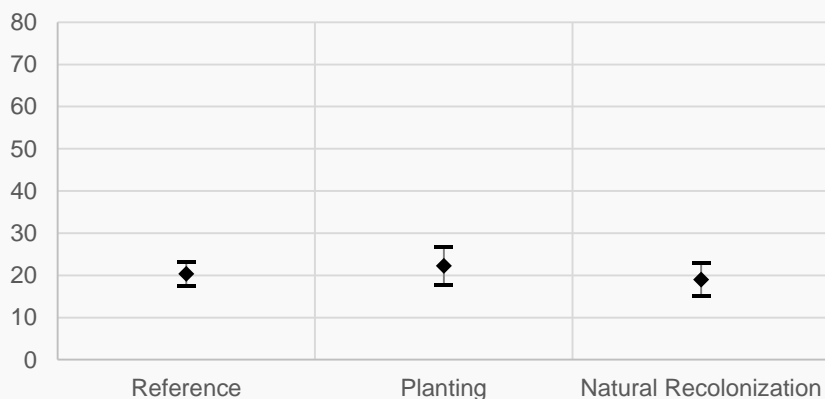
2019 SAV %Cover by Plot Type

Average percent cover + 2x Standard Error of the Mean
 Average percent cover observed in plots
 Average percent cover - 2 x Standard Error of the Mean

- Some areas approach or overlap reference areas but some are not exceeding benchmarks
- Many areas have been exhibiting decreased percent cover since 2017

- Generally low overall percent cover
- Most areas are not meeting or exceeding benchmarks
- However certain areas are showing increased cover since 2017

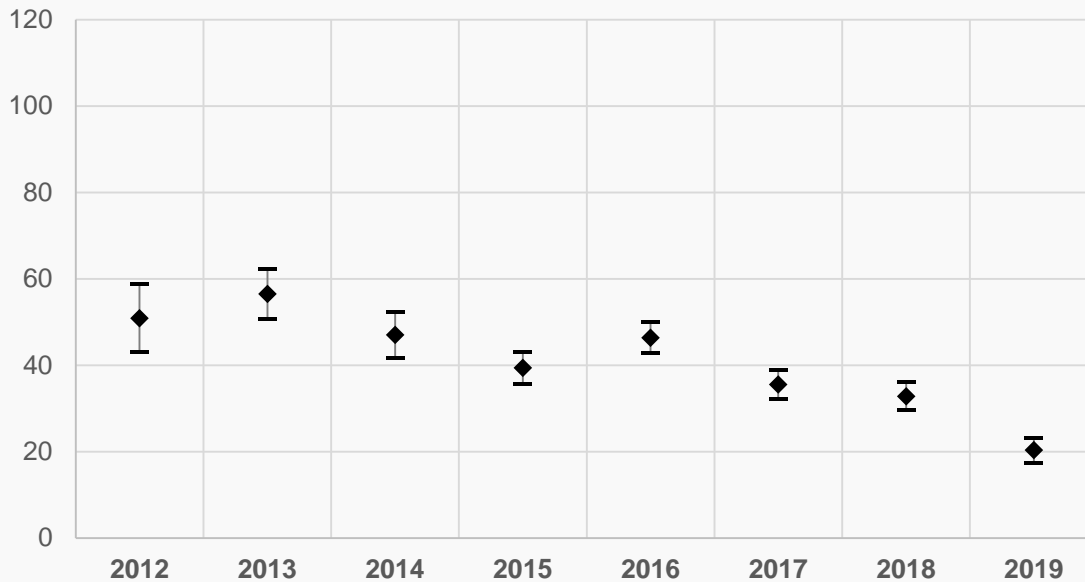
Percent Cover in SAV Reference Plots 2012-2019

Average percent cover + 2x Standard Error of the Mean
Average percent cover observed in plots
Average percent cover - 2 x Standard Error of the Mean

- Through 2016, cover was not dense but was holding steady
- There are multiple potential reasons for this apparent decline
- We know that SAV beds shift and also change (thin out or get more dense) over time
- It is also possible that what has traditionally been a reference bed has declined while other areas have gained vegetation
- EPA is evaluating this trend with GE in coordination with NYSDEC

SAV reference areas are exhibiting decreased percent cover since 2017. These trends have become apparent in recent years.

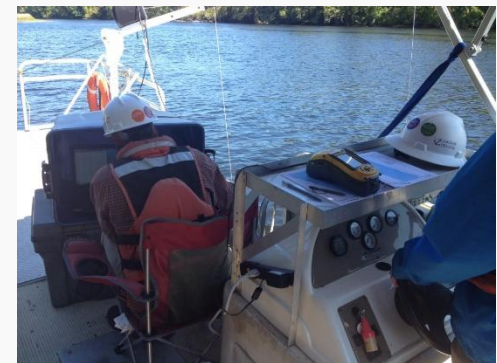
SAV Planting Areas:

SAV Natural Recolonization:

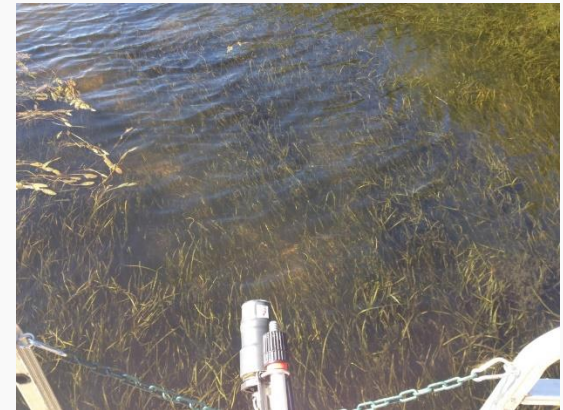
- Continued use of GIS analysis
 - Evaluate possible reasons for apparent recent decrease in percent cover
- Continued coordination with SAV experts
- Conduct field monitoring of 2019 buoy seeding
 - Based on results
 - Evaluate increasing density of seeding
 - Changing the method of seed deployment
 - Other modifications
- Plot existing percent cover data in relation to river bottom conditions
- 2019 underwater video to be reviewed in greater detail
 - Determine presence of SAV and prioritize areas suitable for BioSonics surveys in 2020.
 - Prioritize planting and seeding efforts in 2020 and 2021
- Confirm presence of plant founder colonies

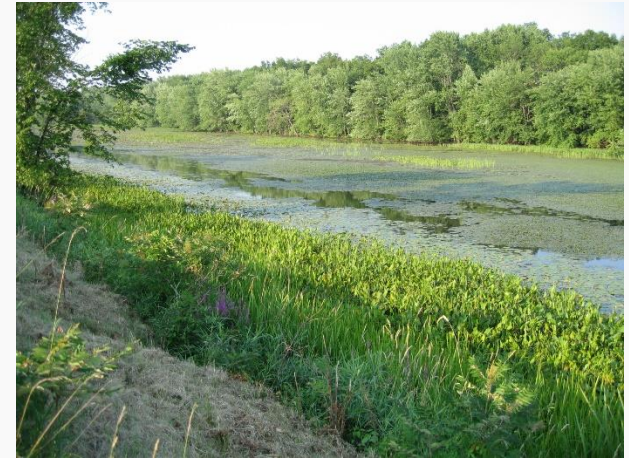
West Griffin Island Area

- Planting and wild rice seeding
- Areas seeded in 2020 will be reseeded in 2021
- Field evaluation of alternative species installed in 2019
 - If results are positive, develop proposal for additional plantings in 2020
 - Considerations
 - Planting in tighter clusters
 - Planting alternative species
 - Use of larger plant units
 - Installing wave breaks
- Larger-scale plantings in 2021
- Follow line of evidence to assess area and adjust approach

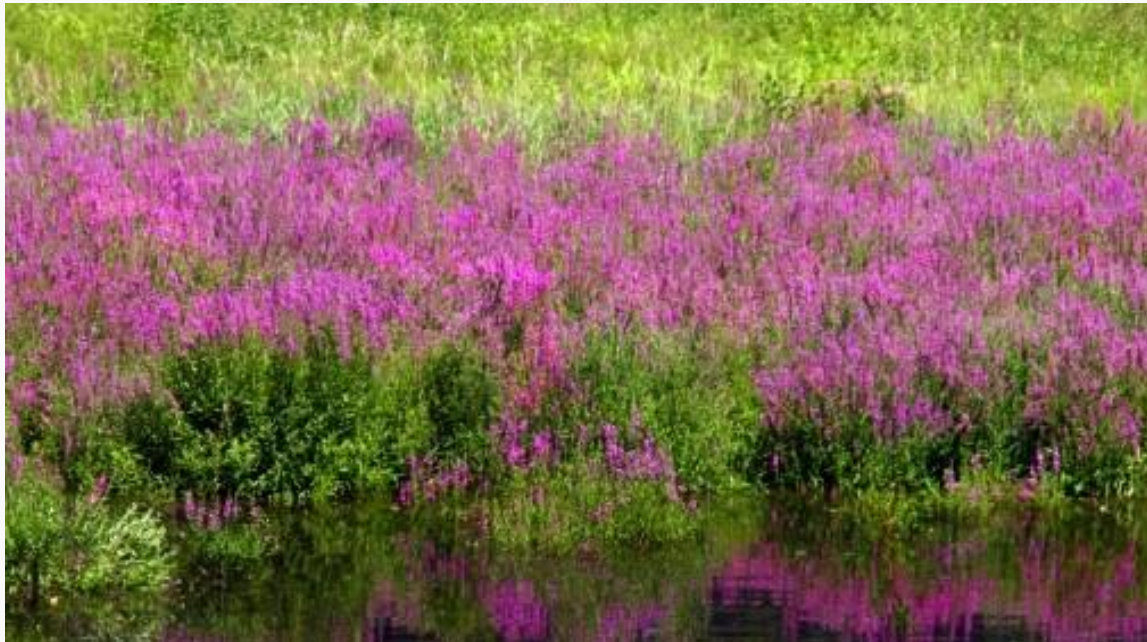
- In addition to quadrats - identify percent invasive species by overall visual inspection
- Continue removal of invasive species

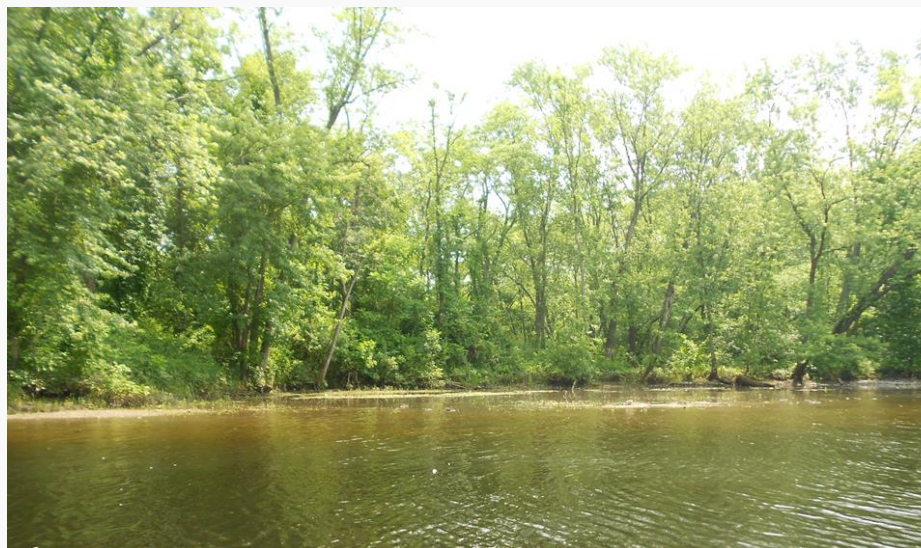
CU02 “Bond Creek” RFW Area

Conditions at approximately 4,800/5,000 cfs river flow

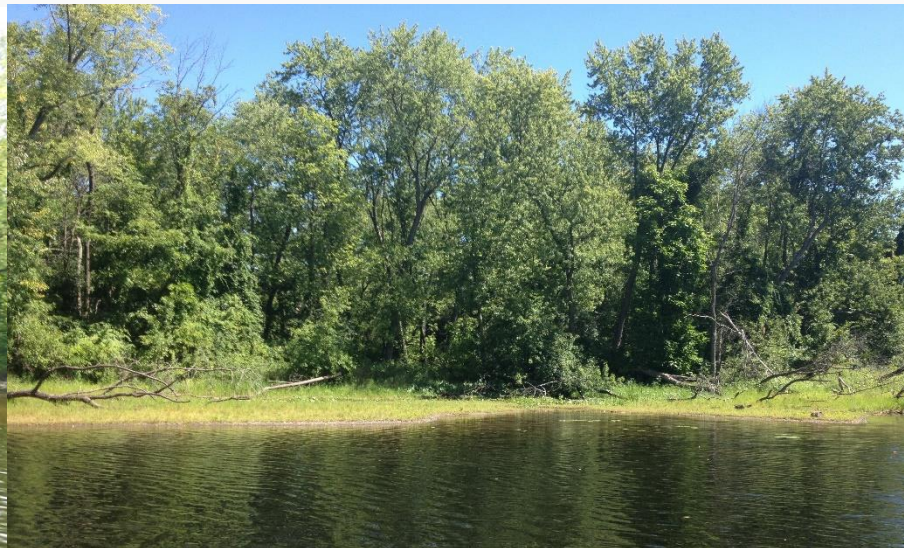
Conditions at approximately 2,500 cfs river flow

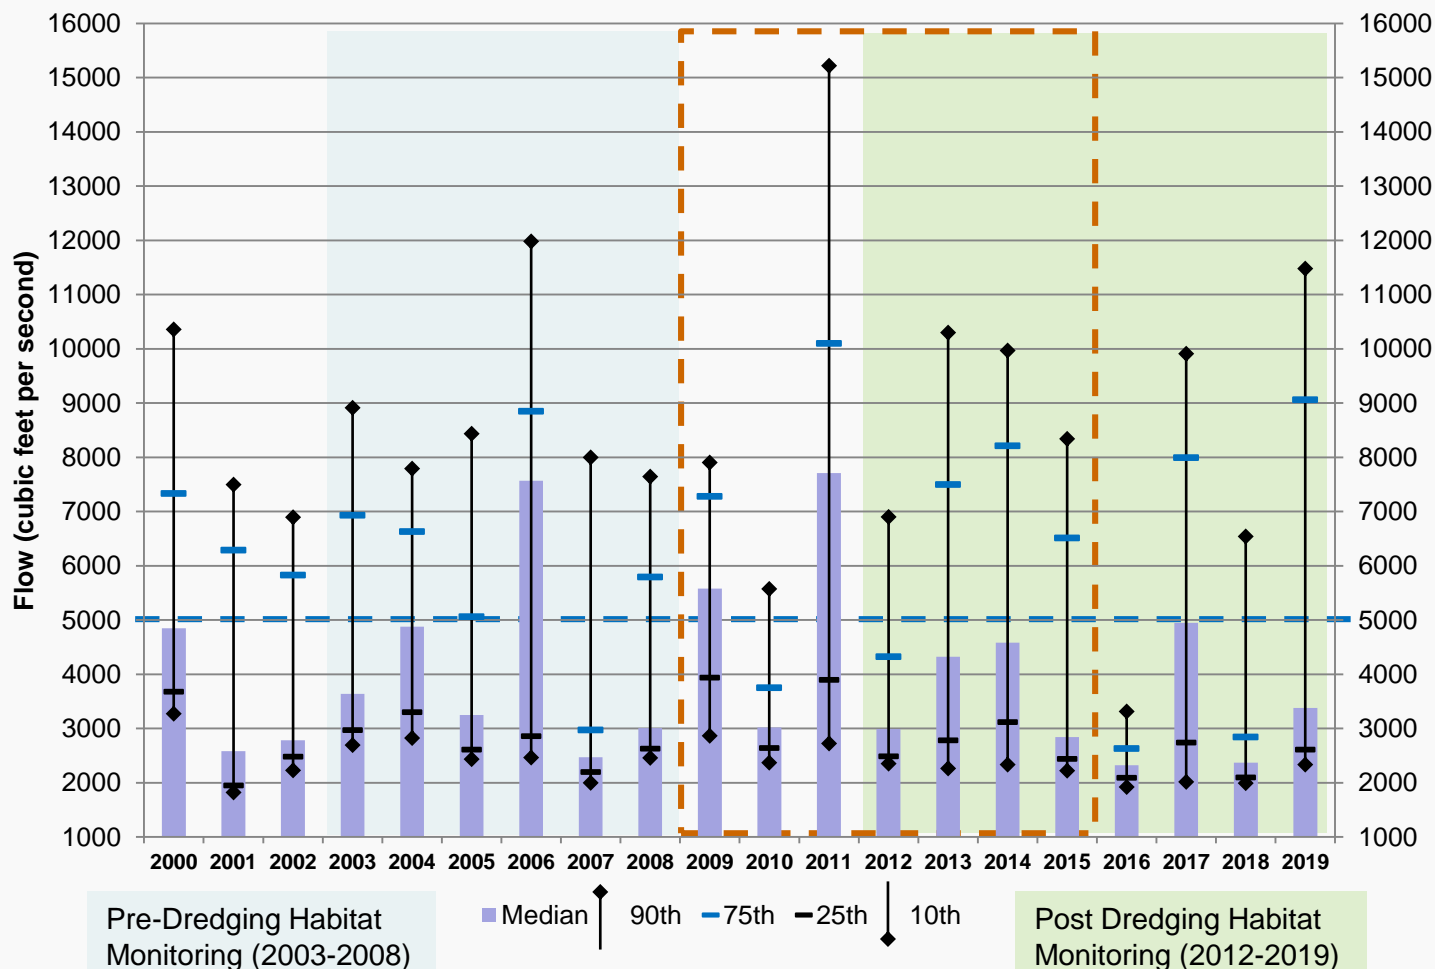
HR PCB Site TIP Mean Daily Flows in Growing Season May 1 - Sept 30
(Data from USGS Fort Edward Gauge)

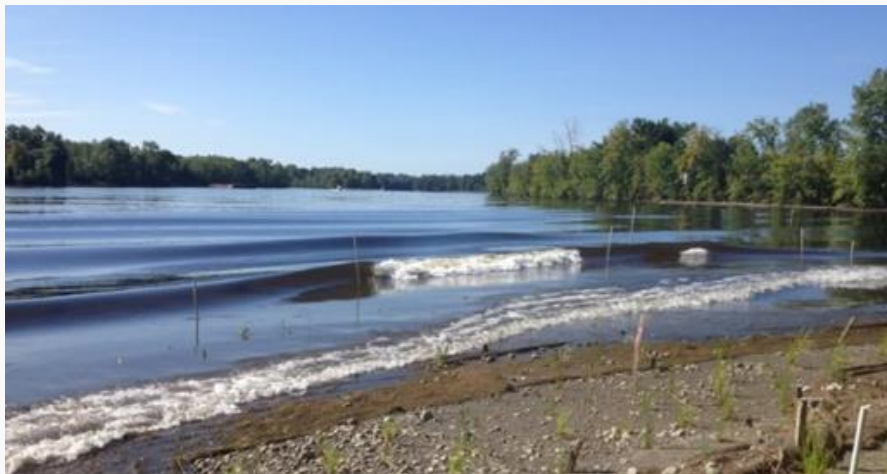
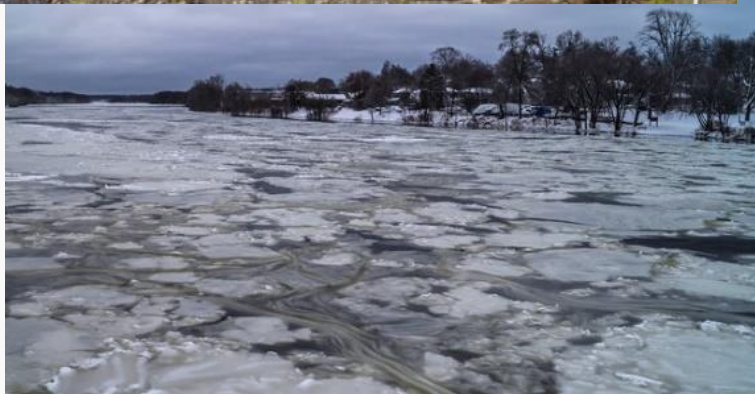
Other “Variable Flow” Stressors:

- Wave and wind action (from recreational vessels and wind)
- Ice erosion

Potential Adaptive Responses:

- Wave break berms
- Stabilization measures
- Shoreline stabilization

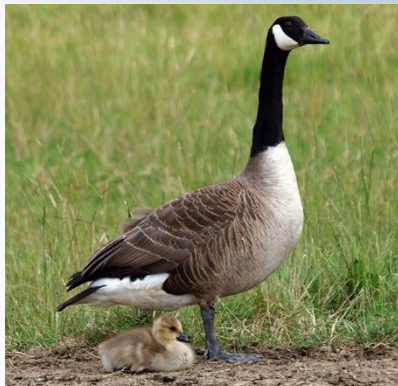
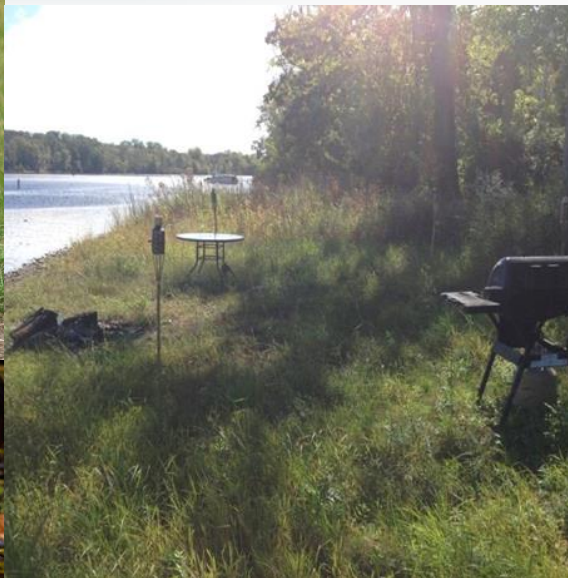
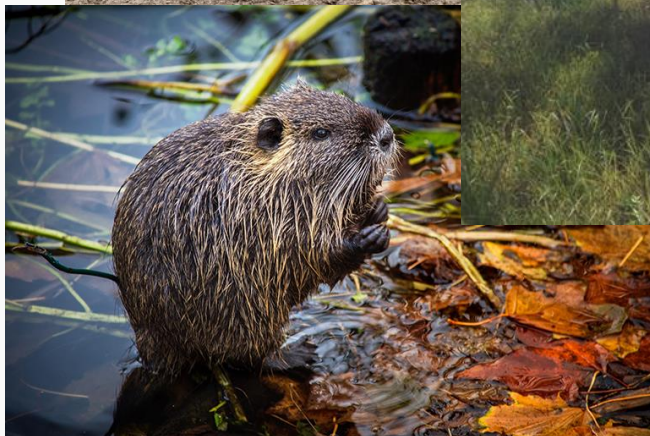
Stressors:

- Herbivory
- Invasive species
- Various recreational activities
