Dredging Project Update – December 2014

Dredging Project Update – 2014 Summary

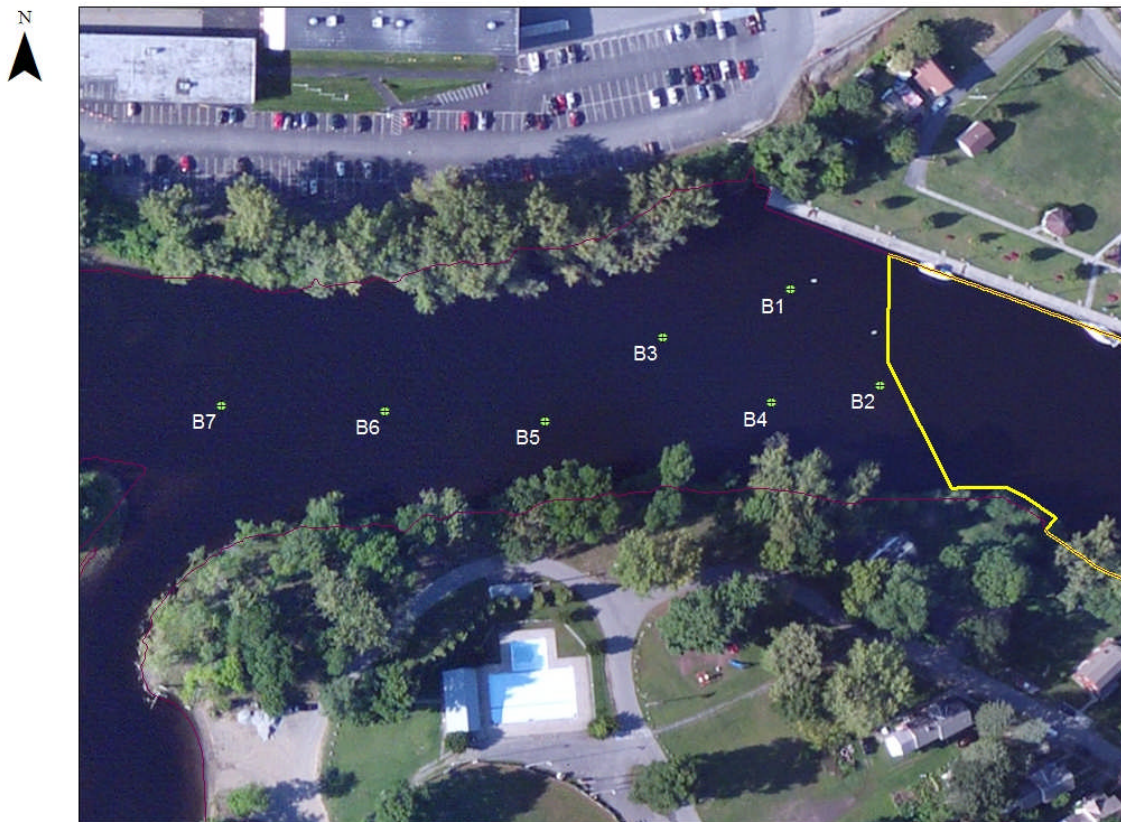
CU 0

- GE data show that 2 out of 6 samples were above the MPA criteria (3 g/m^2), but because they were individual areas, dredging was not required.
- NYSCC data show that 5 out of 7 samples were above the MPA criteria using a different sampling method
