Community Advisory Group Meeting
Fort Edward Fire House
June 30, 2011

Phase 2 Year 1
Dredging/Project Update

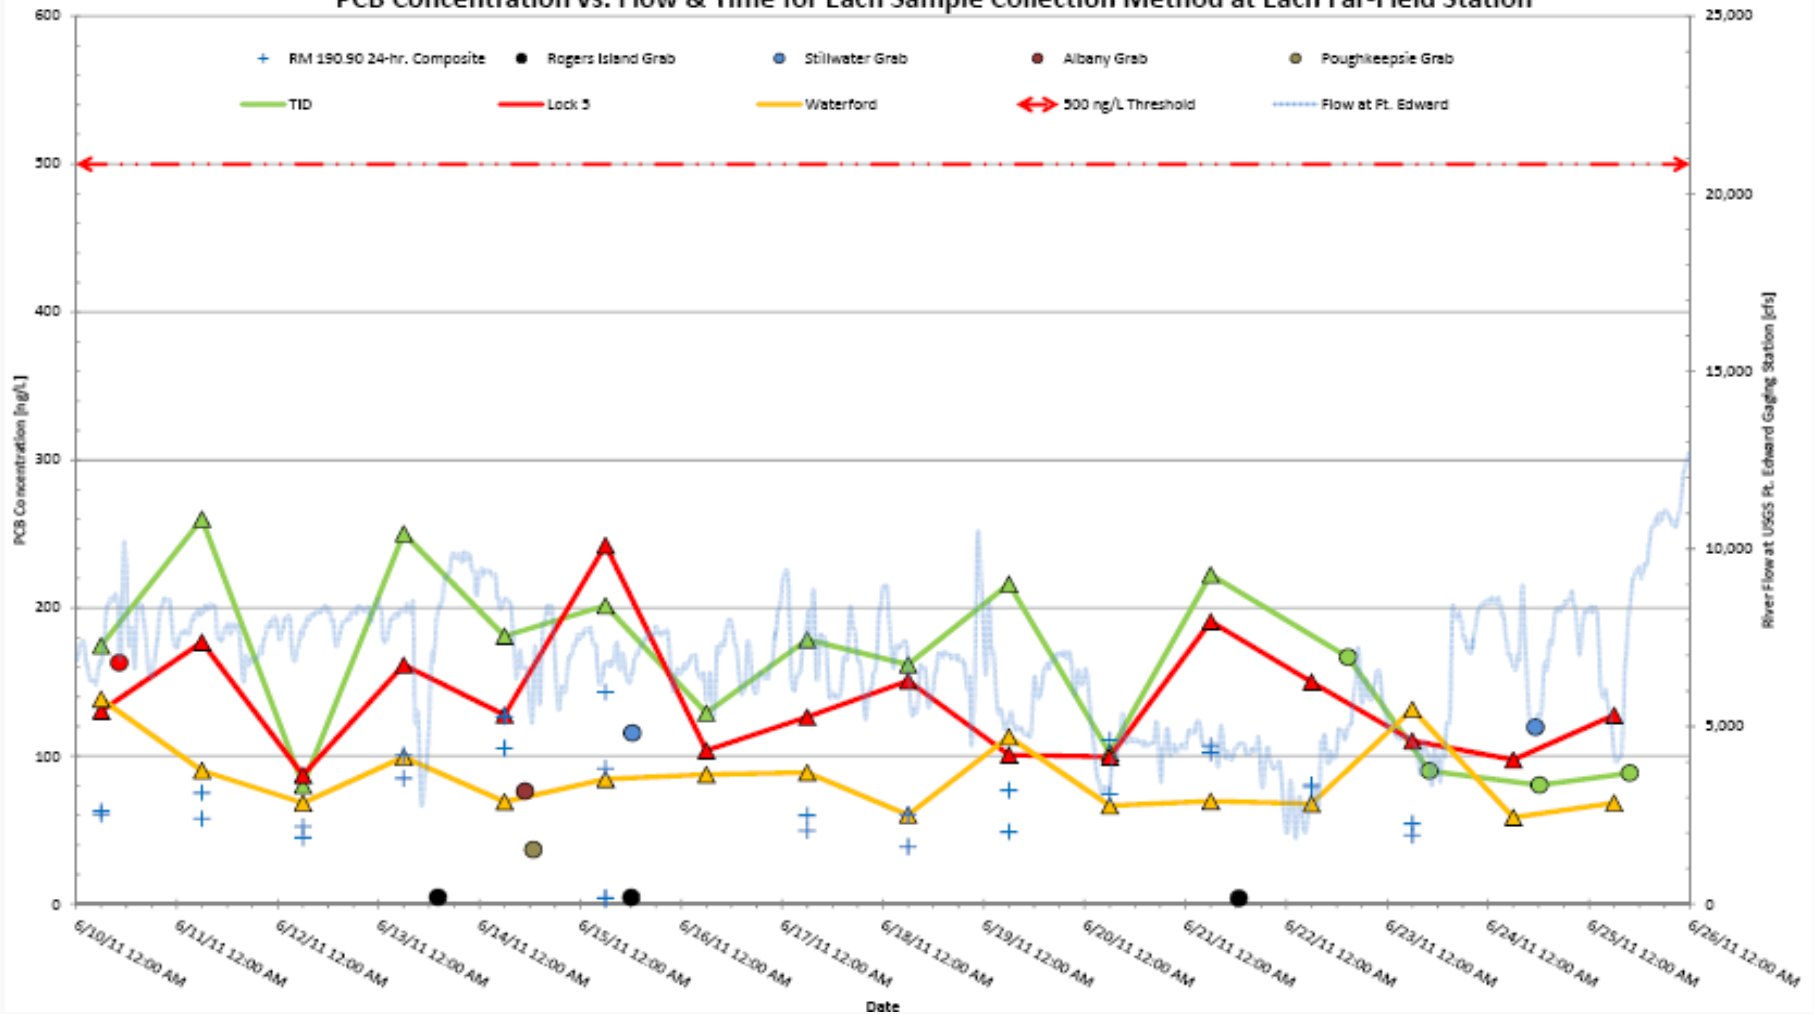
PCB Concentration vs. Flow & Time for Each Sample Collection Method at Each Far-Field Station
