Habitat Monitoring Update

Hudson River CAG November 16, 2017

Habitat Reconstruction Overview: Habitats

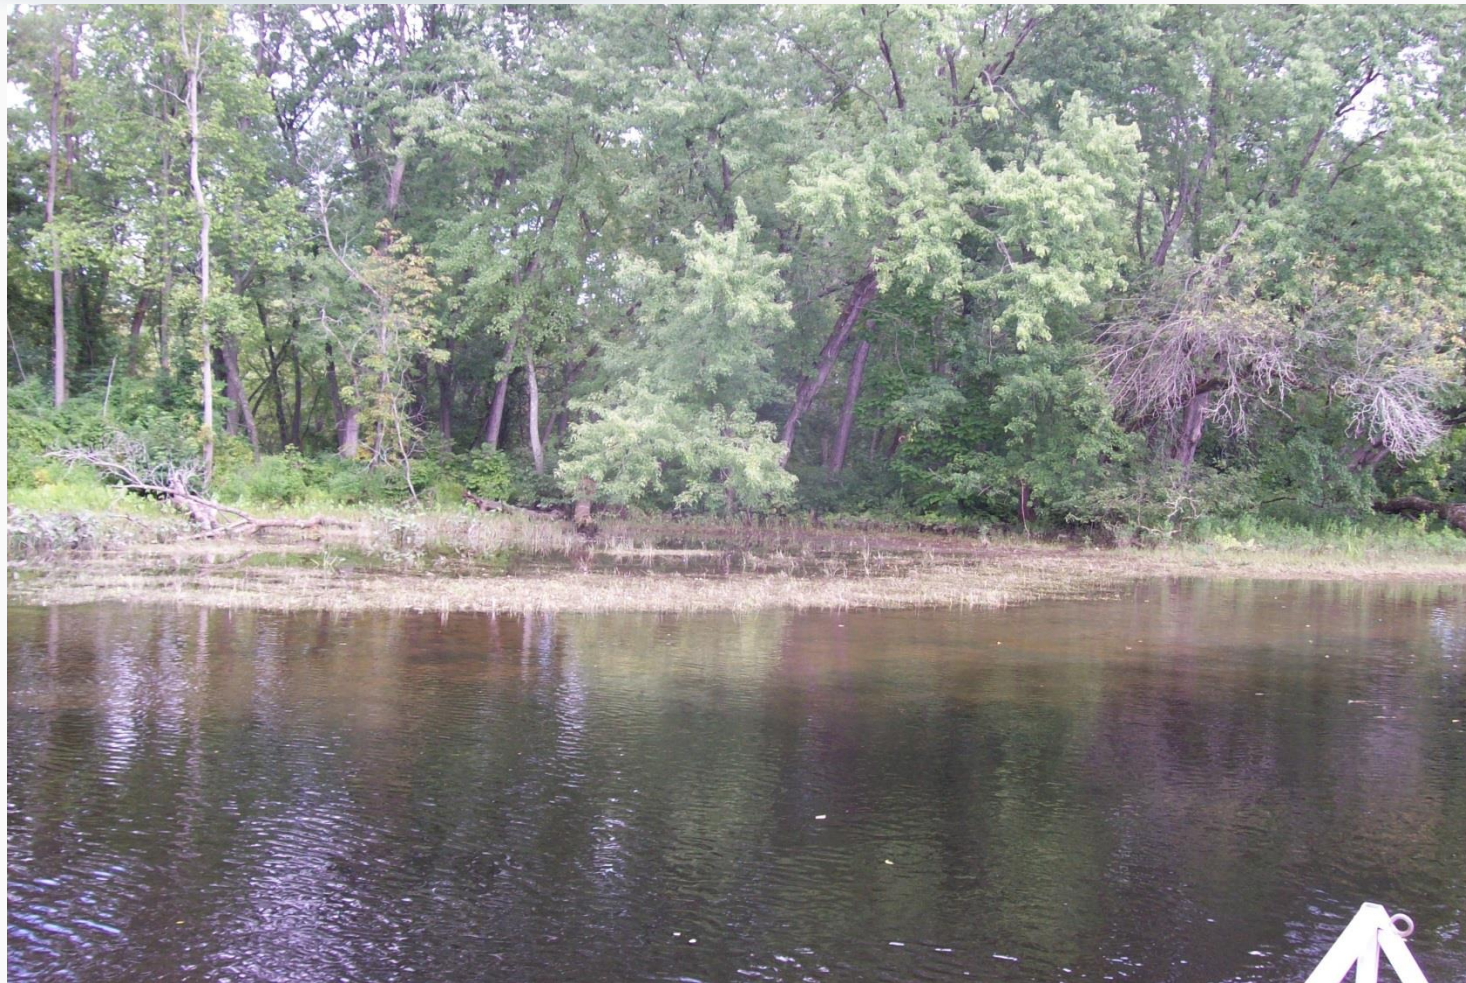
August 2008, Approx 6,000 cfs

Rice cut grass/spike rush community, 95% Coverage 2007-2008

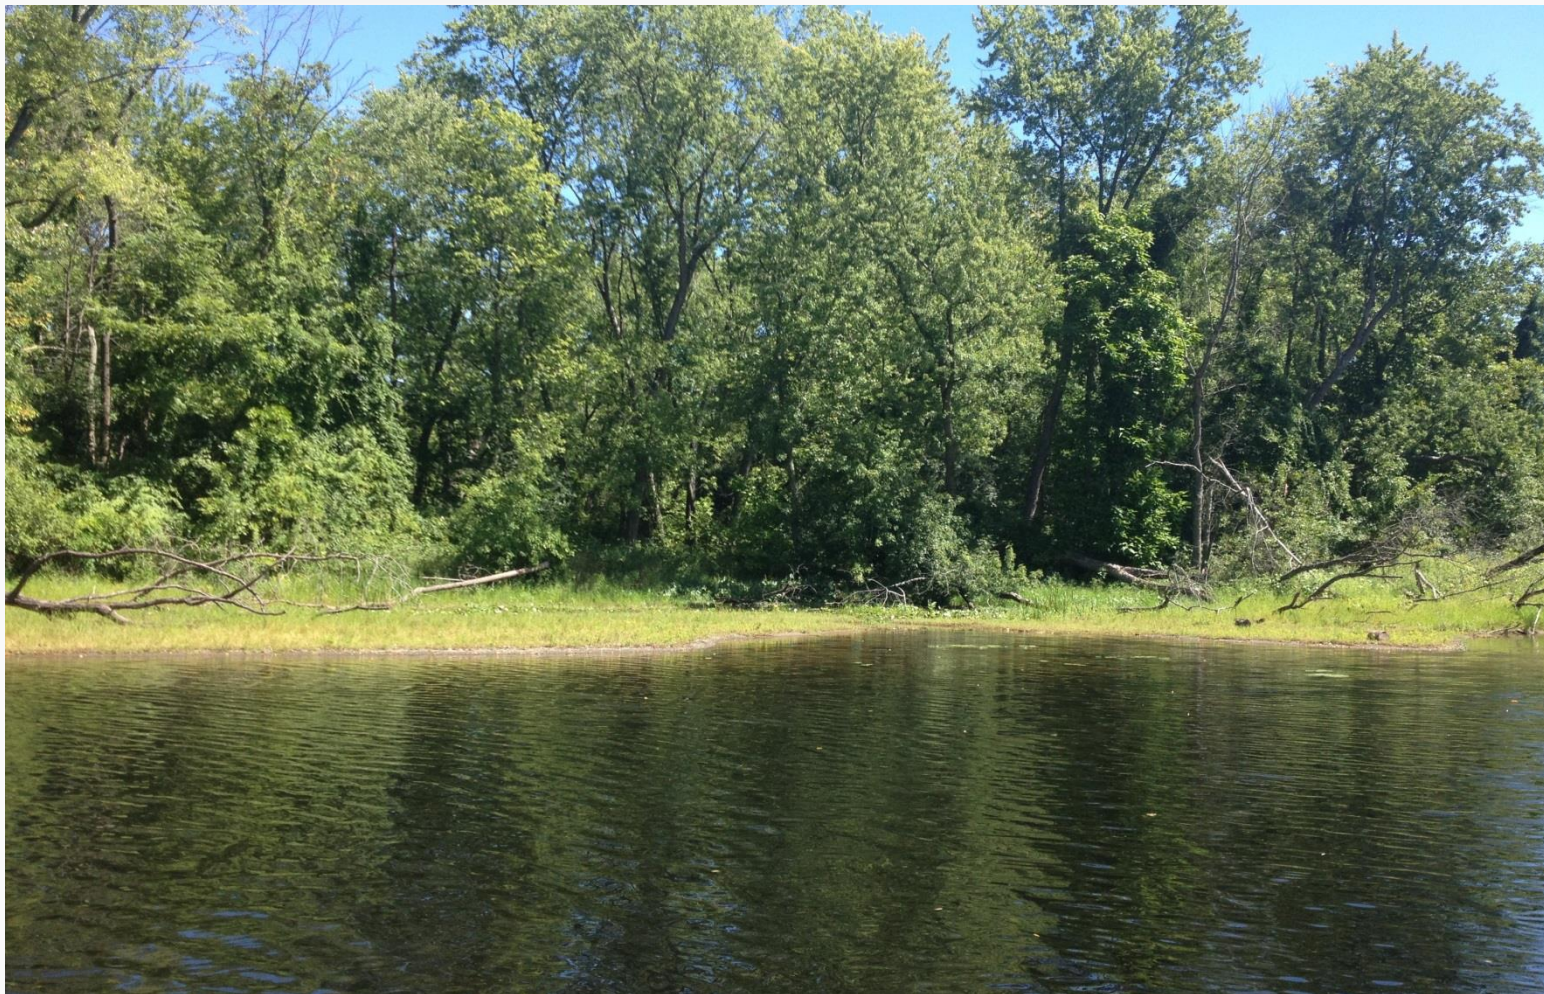
CU-2 “Bond Creek Wetland” Post-construction

August 2016, Approx 3,000 cfs
