Hudson River Floodplain Update

Community Advisory Group Meeting

Thursday, March 29, 2018

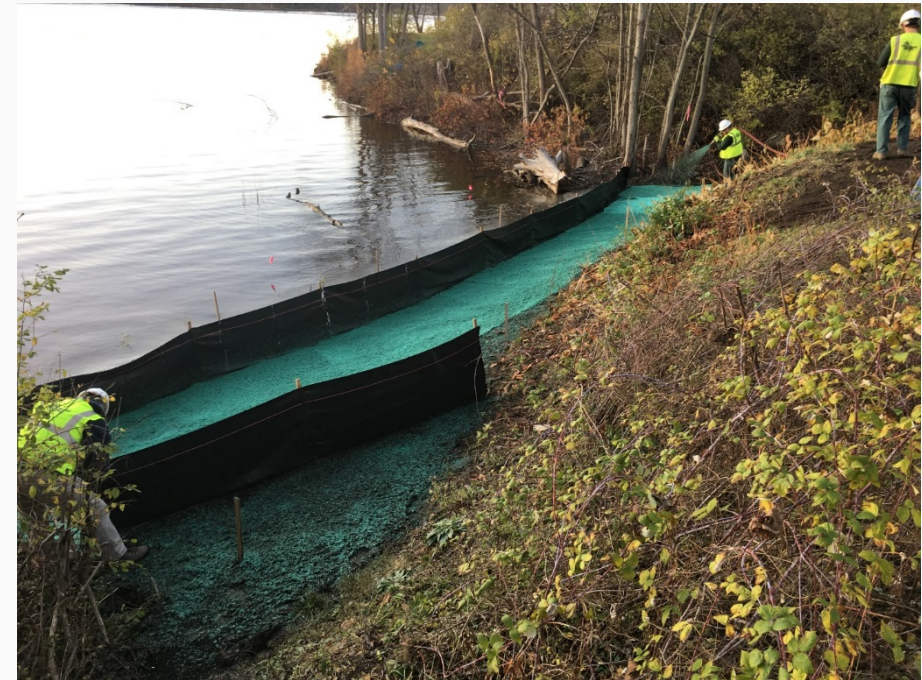
Short-Term Response Actions

- Protective measures are immediately taken when soil concentrations of PCBs are found to generally exceed 10 ppm
 - 66 implemented to date
 - Typically consist of a protective soil cover (48)
 - May be signage if limited human use (18)
- Inspected and repaired annually
- 2017 - GE installed one additional soil cover at a residential property
- As data is collected others may be implemented
- These actions are considered temporary

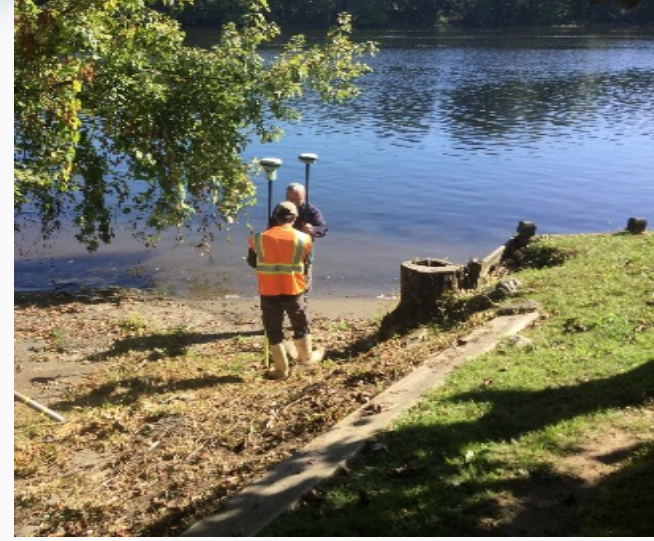
2017 Floodplain Work

- 2017 work began with outreach to property owners for access
 - Alternate sample locations sometimes needed
- Sampling occurred October – December 2017
- 390 samples were collected from ~ 170 properties

- Samples were collected to fill data gaps based on statistical analysis and spatial coverage
- PCB results consistent with previous sampling (higher upstream and closer to river)

- 133 of the 170 properties (78%) showed either no PCBs or PCB levels below 1 part per million
 - On 30 properties (18%), PCB levels ranged between 1 ppm and 10 ppm

- The remaining 7 properties (4%) were above the 10 ppm threshold, and will be further reviewed by EPA and GE. Those properties are not currently used as residential or recreational areas

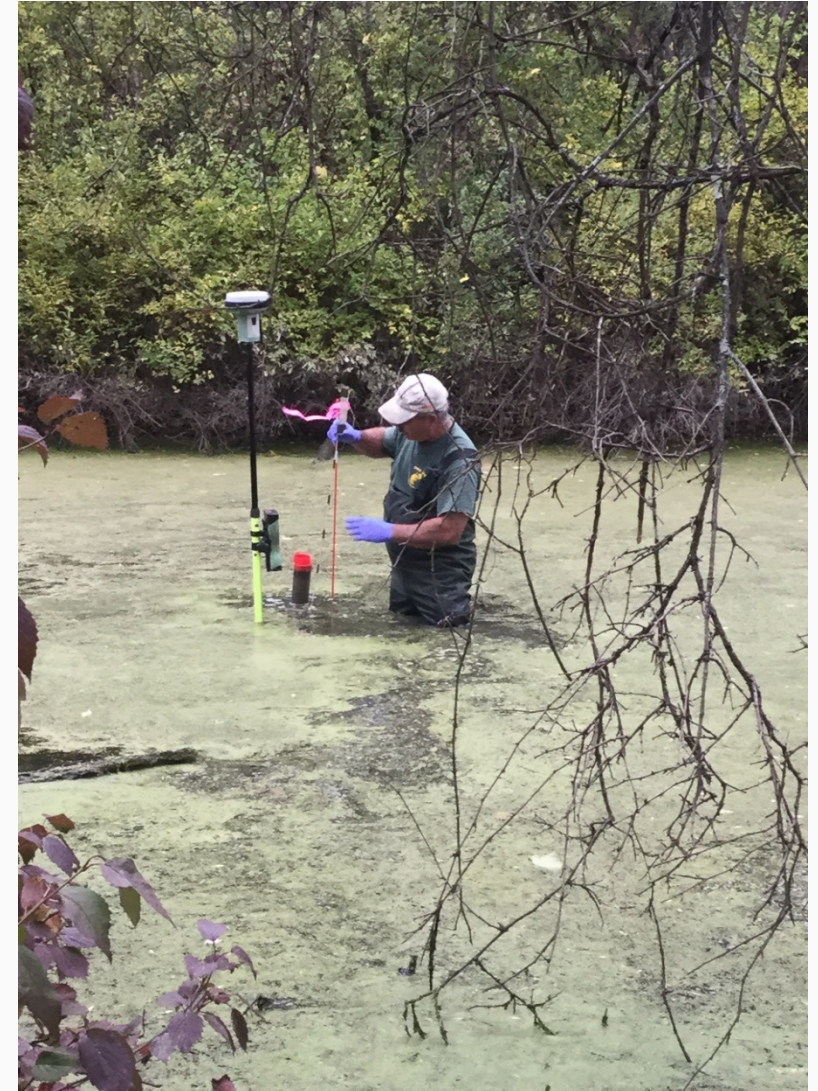
2017 Standing Water Areas Sampling

- Exclude tributaries and typically have water year-round
 - Includes areas such as wetlands and ponds
 - The Old Champlain Canal is a standing water area
 - Some areas are connected directly to the River via culverts and others are isolated
 - Some standing water areas also have some water flow
- 240 sediment and 85 surface water samples collected
- Important data in terms of potential ecological impacts
- Water samples ranged between not detected and 9 ppt (one sample)
- Sediment samples ranged between not detected to 9 ppm

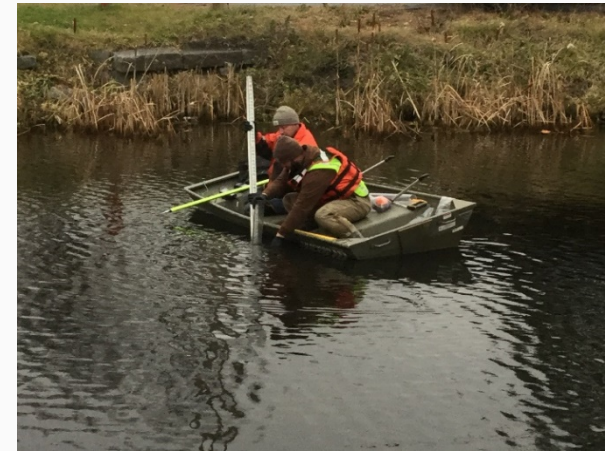
Schuylerville – Old Champlain Canal and Park

- Follow up regarding July 2017 flooding from old canal into Fort Hardy Park
- Ongoing close coordination between EPA, NYSDEC, NYSDOH, Village, Town and GE
- Old Canal - sediment samples (13 new) collected from old canal by GE and NYSDEC (16 to date)
 - Low levels of PCBs found in some sediment
 - One area of elevated PCBs detected by NYSDEC
 - PCB results inconclusive (co-located samples have different results)
 - EPA and DEC agree re-sampling the area is the appropriate next step
 - Further close coordination with Village and Town regarding sampling planned
 - » Future use, community use plans and other sediment test parameters
- Park - soil samples (5 new) in areas where canal water flooded to park (43 to date)
 - Very low or no PCBs detected
 - Additional sampling planned (0 to 2 inches) as needed
- Park is safe for use – area near river was addressed with soil cover

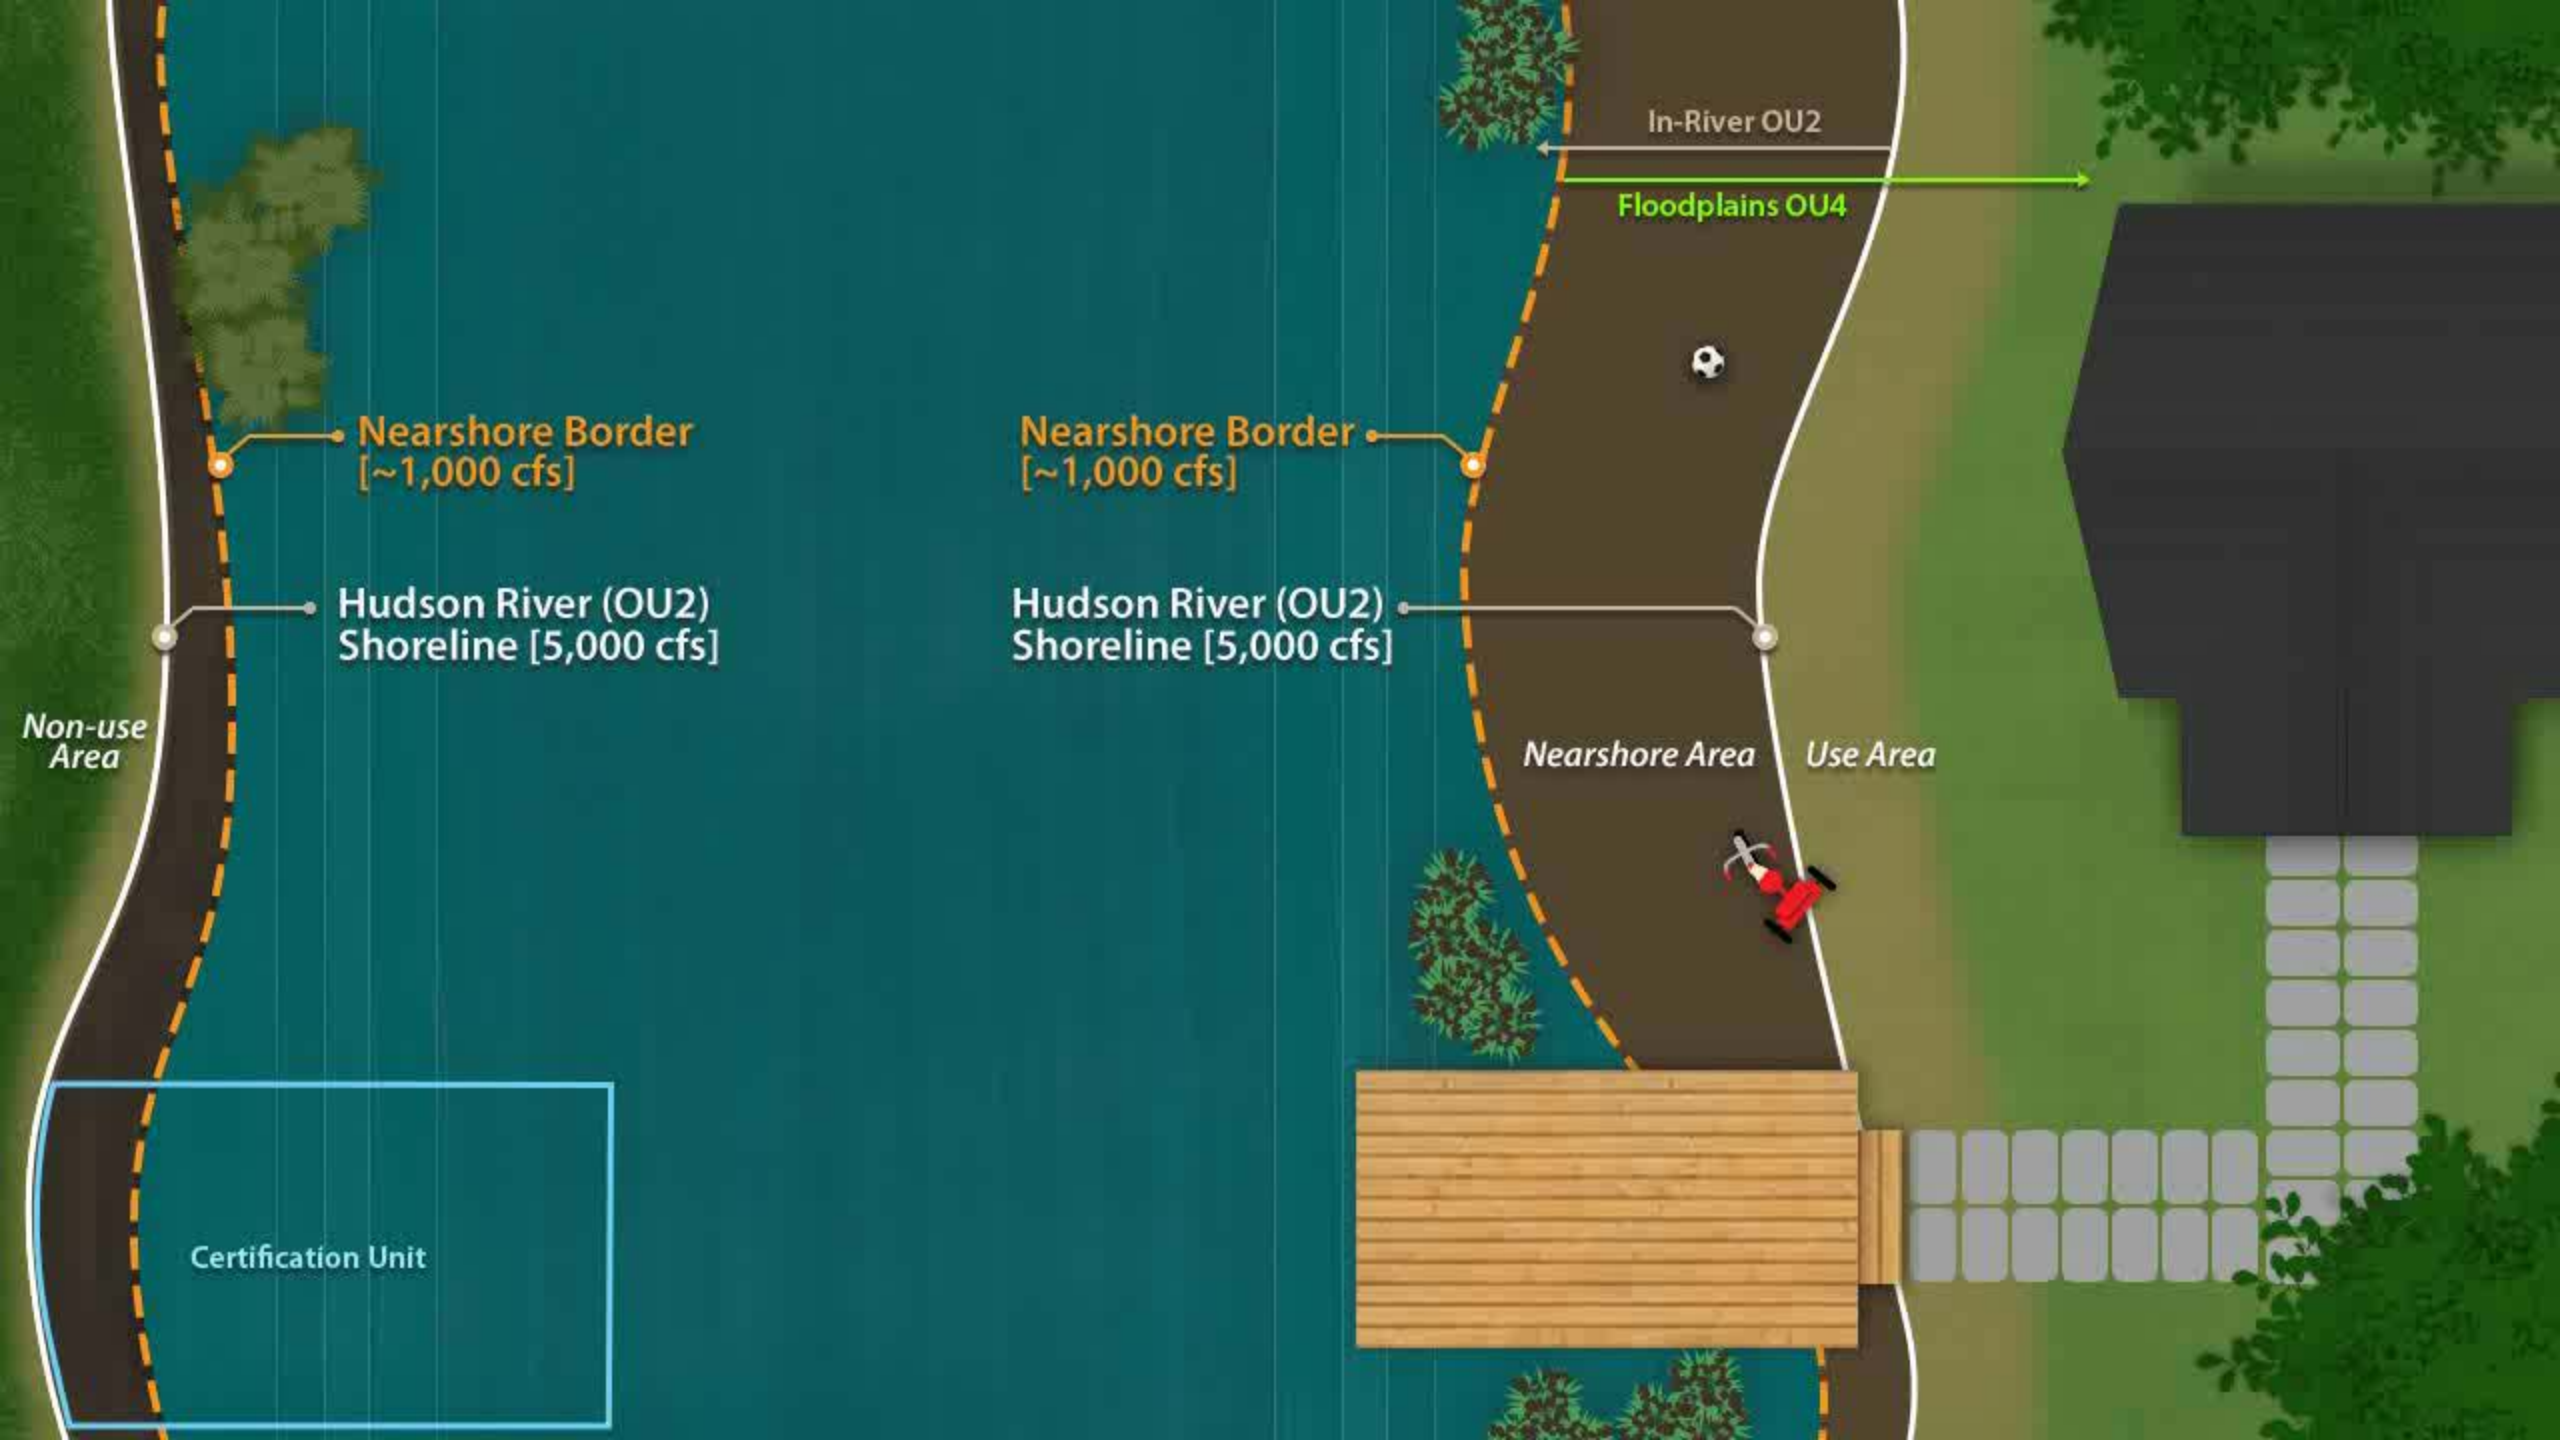
Near-Shore Sediments

- Situations where people could encounter PCBs (see next slide graphic)
 - Swimming and/or wading in river – public recreational use
 - Evaluated as part of river risk assessment
 - River bottom sediment PCB data shows continued decline
 - See NYSDOH – Advice About Swimming:
https://www.health.ny.gov/environmental/outdoors/udson_river/swimming_during_udson_river_dredging.htm
 - Water level drops and river bottom exposed – people can access and use the area
 - Shorelines – areas people use
 - Floodplain soil and/or sediment
 - See EPA – Minimizing Exposure to PCBs in Floodplain Soil (Spring 2017 Community Update):
<https://www3.epa.gov/udson/2017%20Spring%20Sampling%20Fact%20Sheet%20051017%20Final.pdf>
 - Standing water - not expected to contain significant PCBs - sampling ongoing

In-River OU2

Floodplains OU4

Nearshore Border
[~1,000 cfs]

Hudson River (OU2)
Shoreline [5,000 cfs]

Non-use
Area

Nearshore Area Use Area

Certification Unit
