Habitat Reconstruction & Replacement Overview

Habitat Reconstruction Update

CAG Meeting October 30, 2014

Hudson River
PCBs SUPERFUND SITE

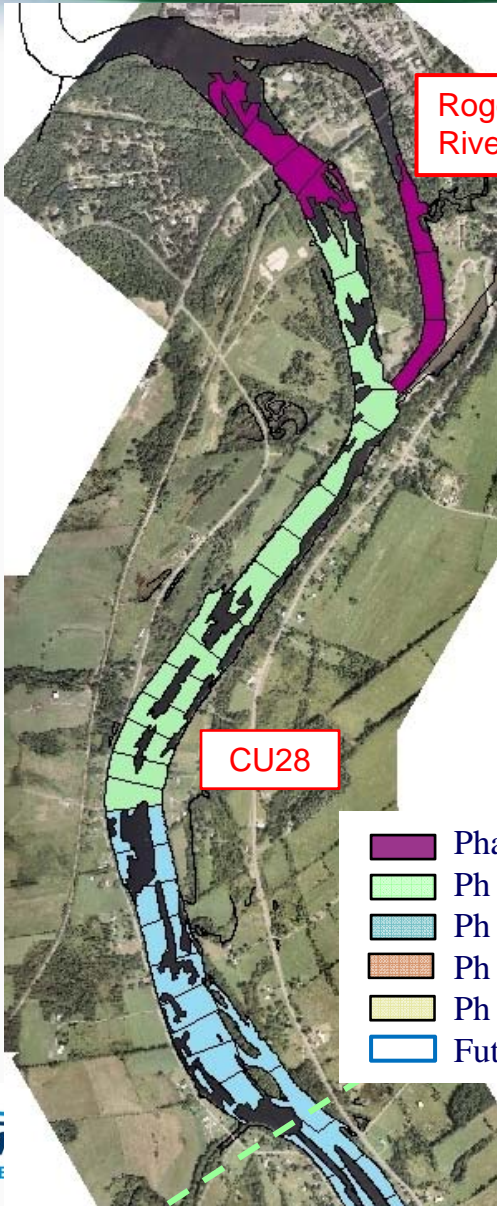
River Section 1 (Thompson Island Pool)

CU's 2-8
Planted
2010-2011

CU's 9,
10, 19
Planted
2012

CU's
20-27
Planted
2013

CU's
28-49
Planted
2014

CU's 28-79
Proposed to be
Seeded and
Planted in 2014

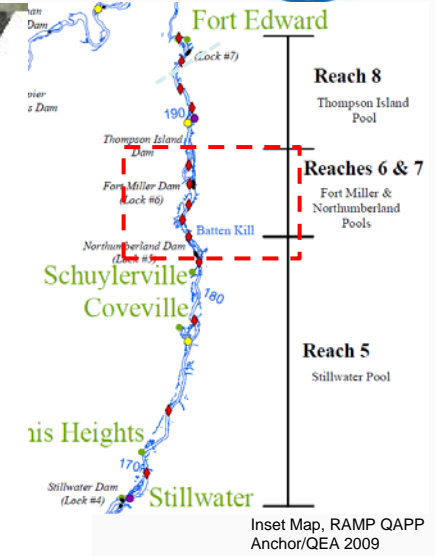
River Section 2 (Northumberland Pool)

CU's 61-66 (Reach 7) Dredging In 2014 and 2015. Planting TDB

CU's 67-71 Planted 2014

CU's 72-79 and CU 84 Planted 2014

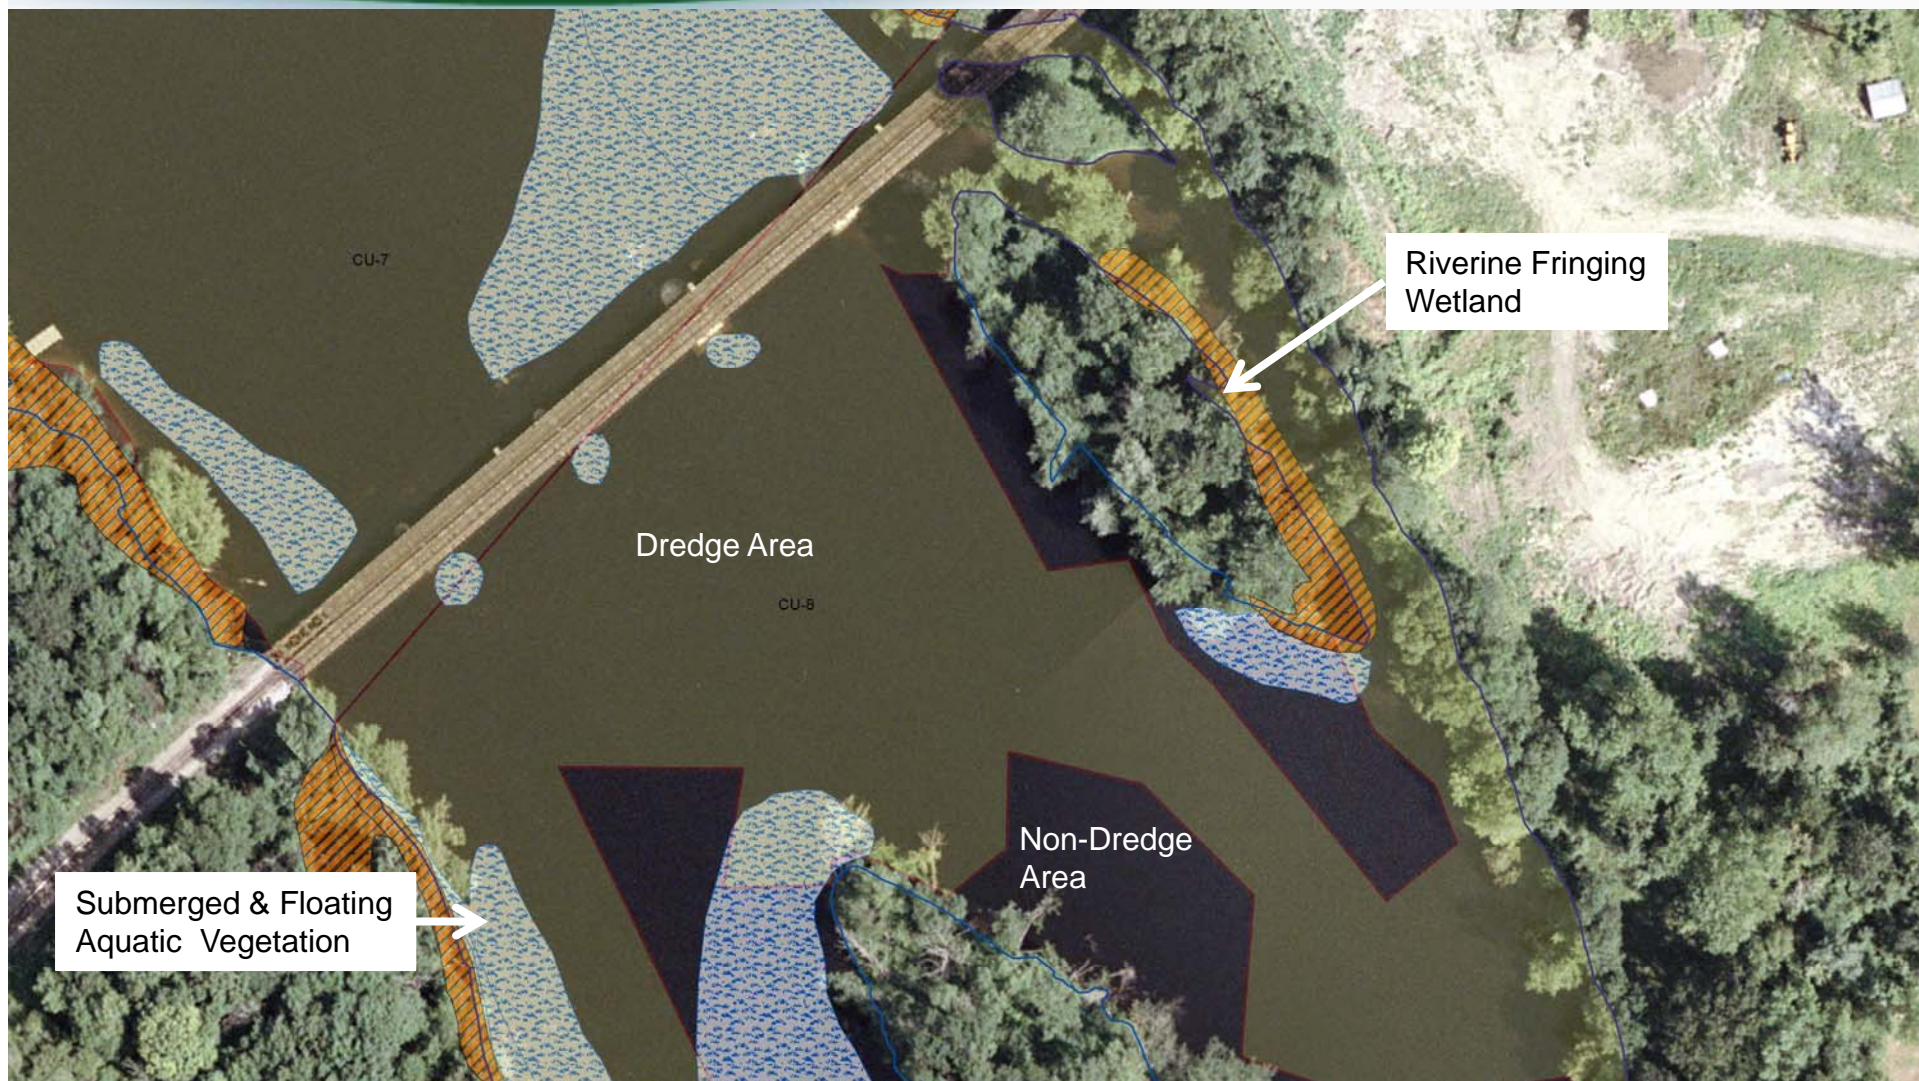
Pre-Dredge Habitats & Dredge Areas

Riverine Fringing Wetland

Submerged & Floating Aquatic Vegetation

Dredge Area

Non-Dredge Area

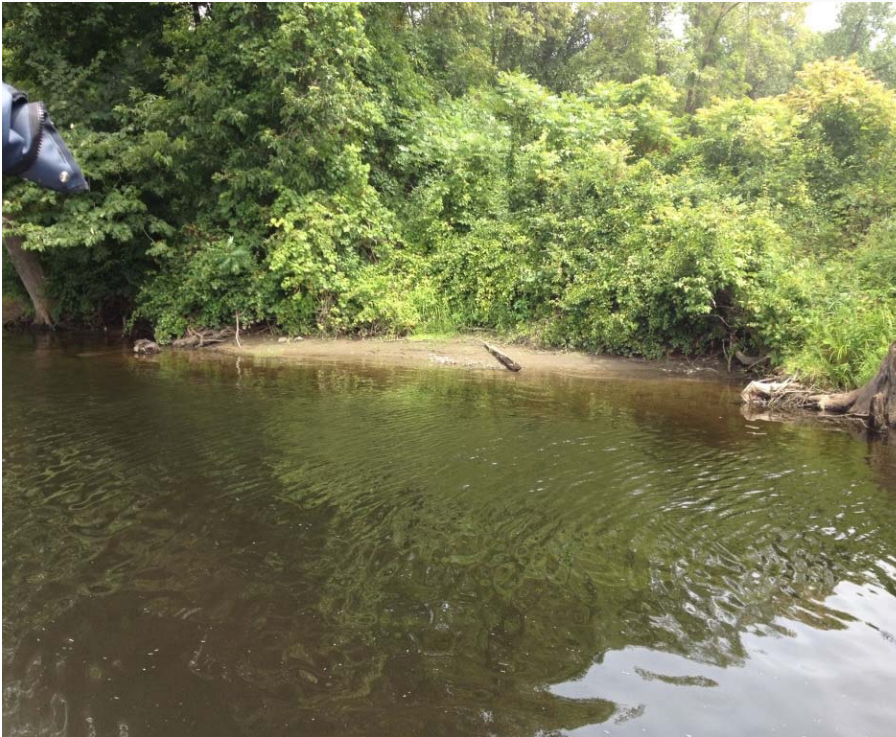
Non-dredge shoreline near CU08

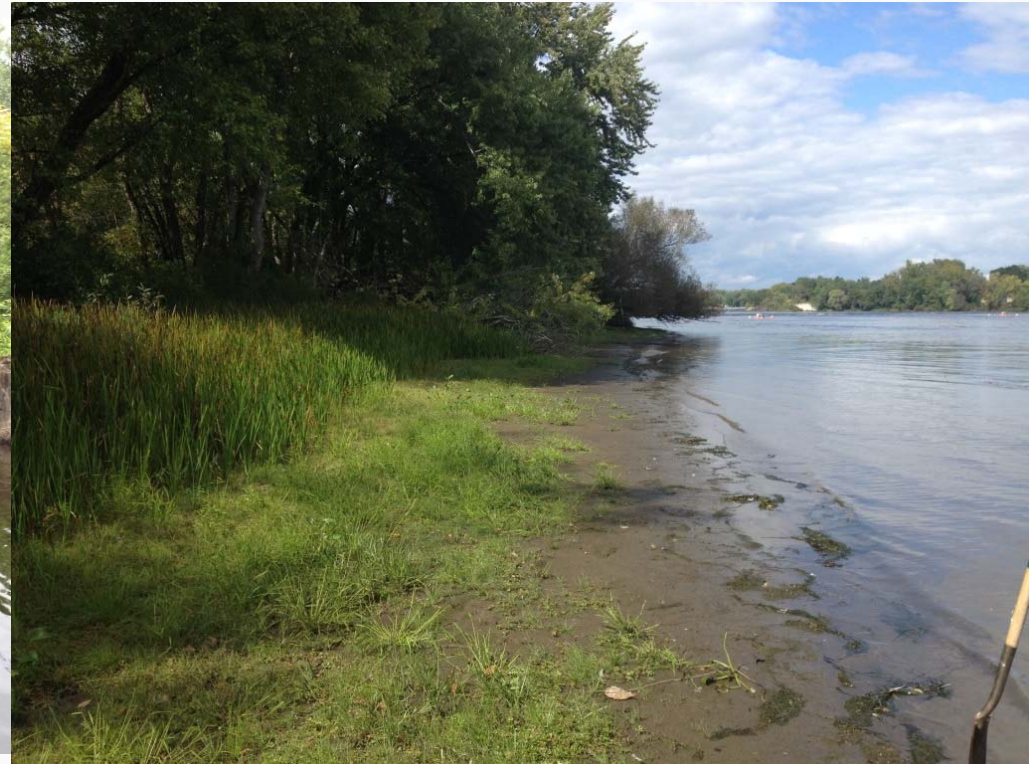
Typical RFW Zone A, Reference WET-03R

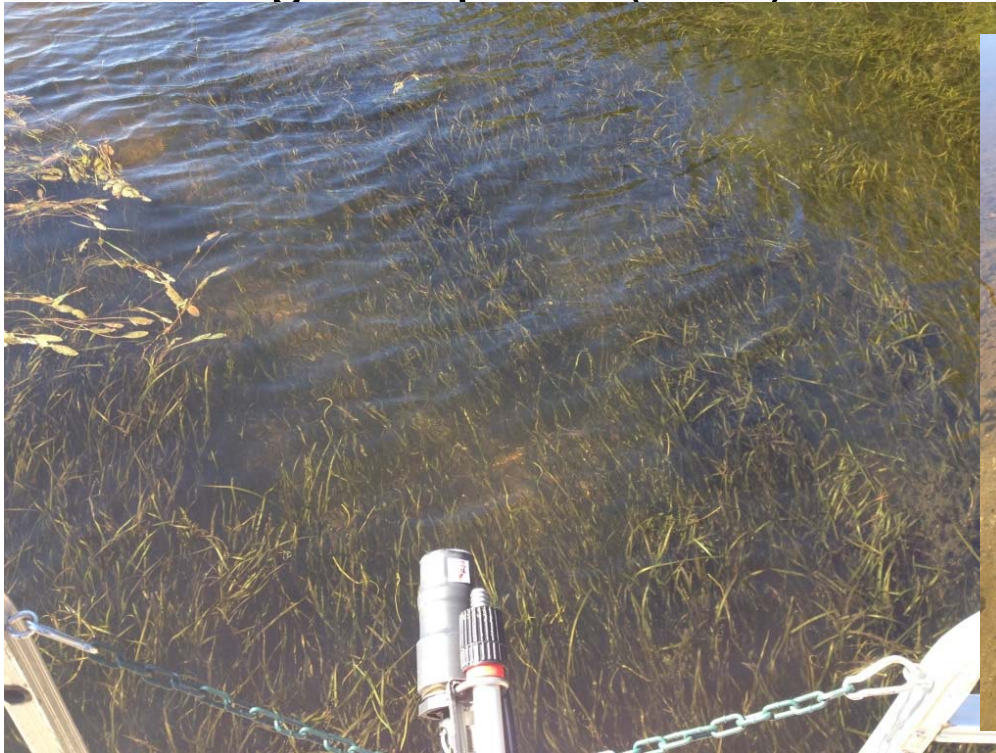
Reference SAV area near CU80

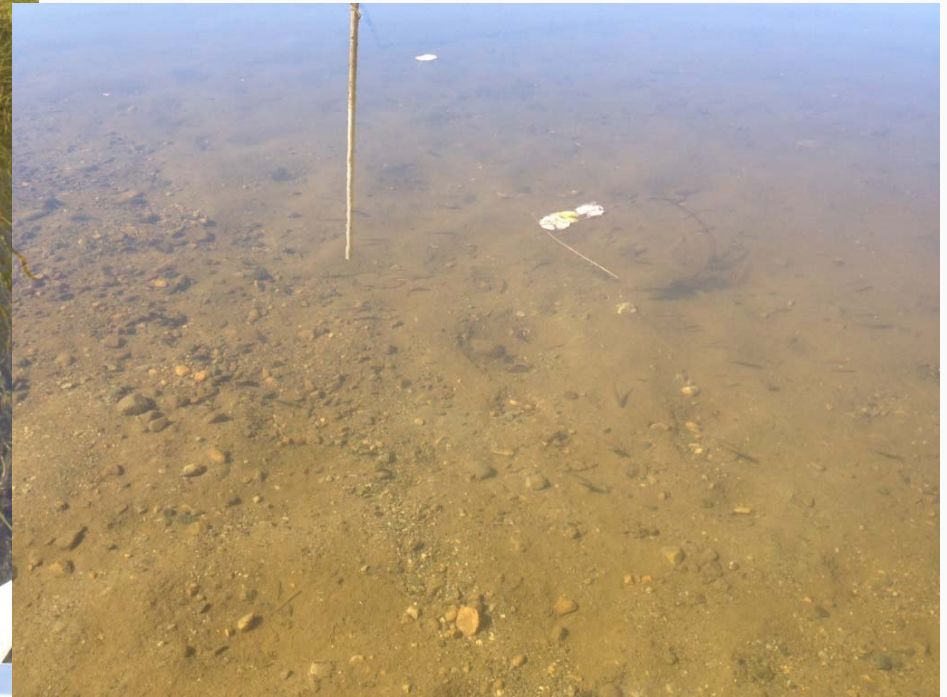
Sediments near CU56

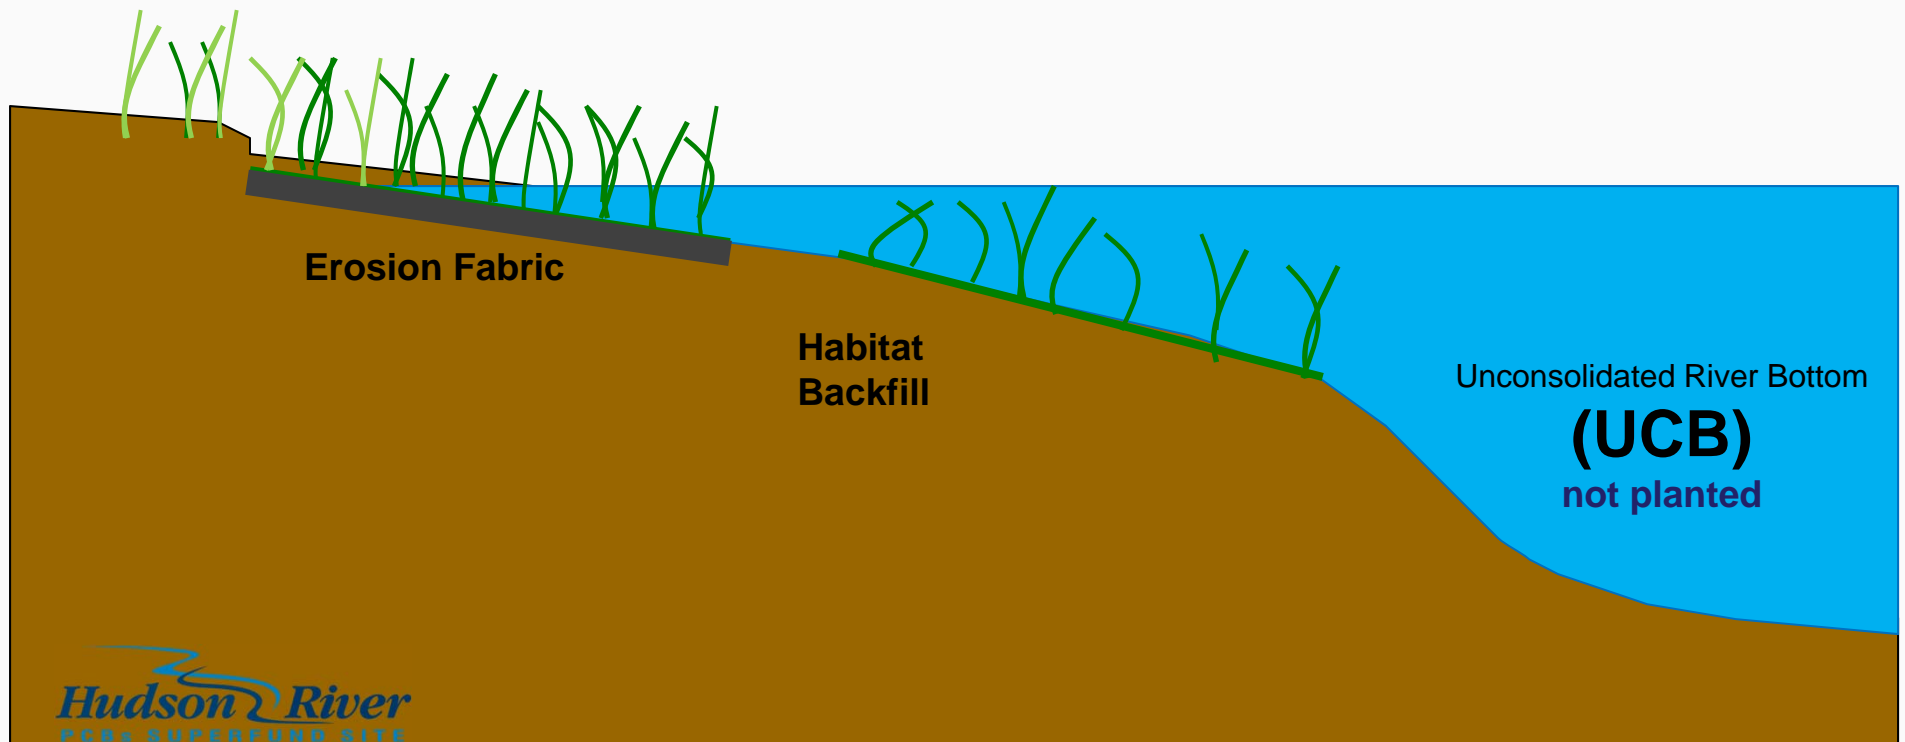
Planting with Natural Recolonization

Upland
(undisturbed)

Riverine Fringing Wetland
(RFW)

Sub Aquatic Vegetation
Floating Aquatic Vegetation
(SAV and FAV)

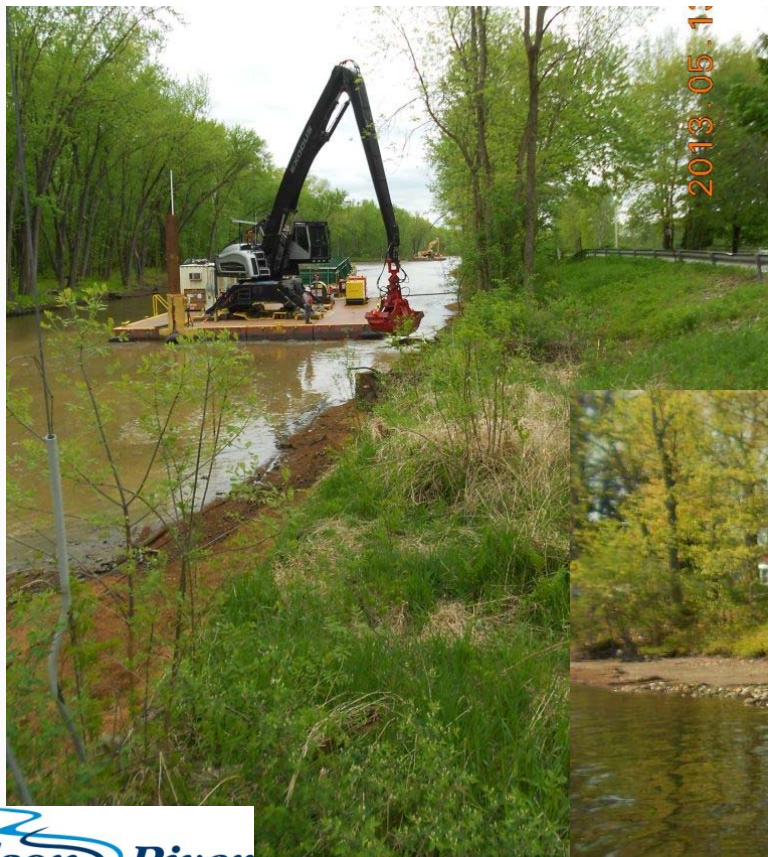
Dredging/Backfilling

Erosion control fabric/berms
Initial RFW Zone A seeding

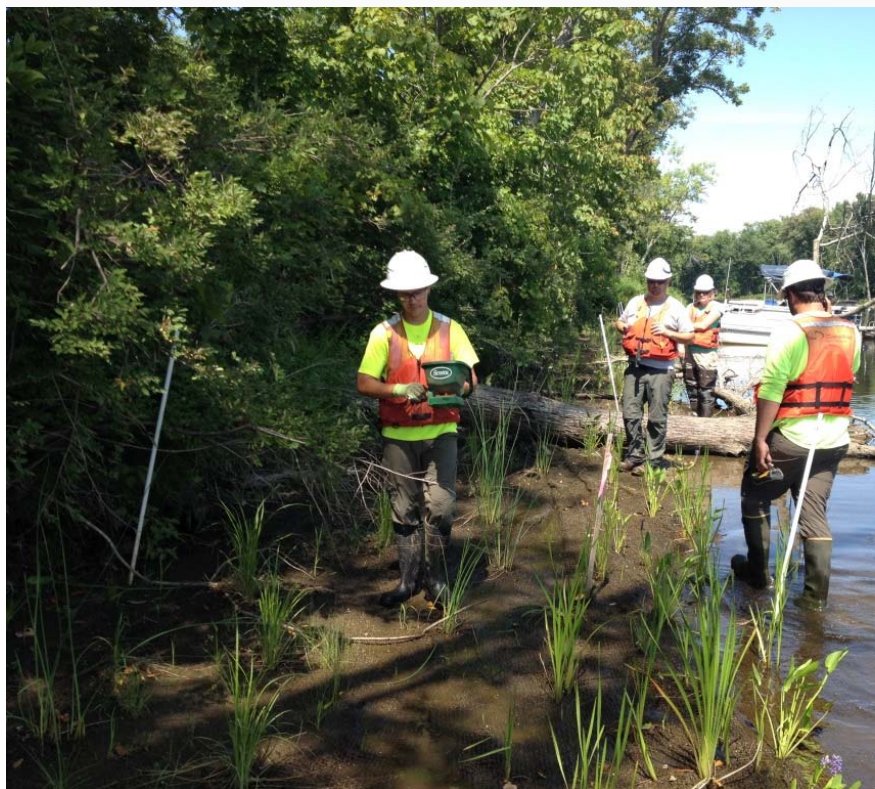
RFW Zone A Seeding CU52

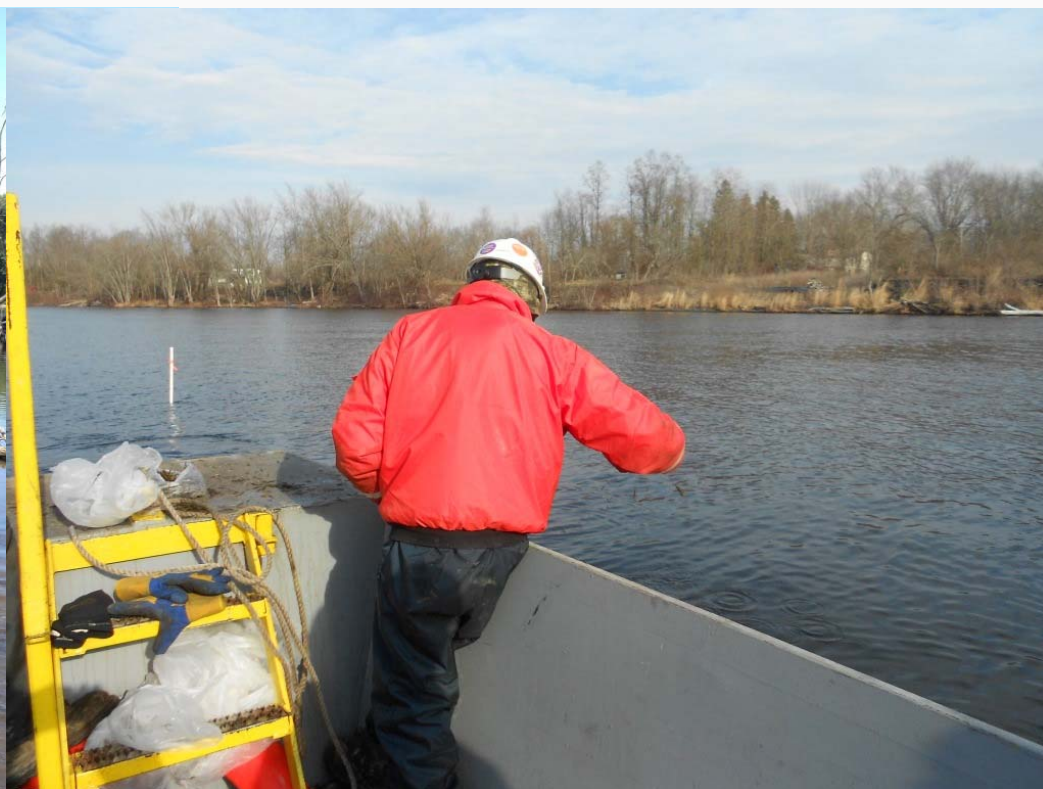
RFW Zone B Seeding CU69

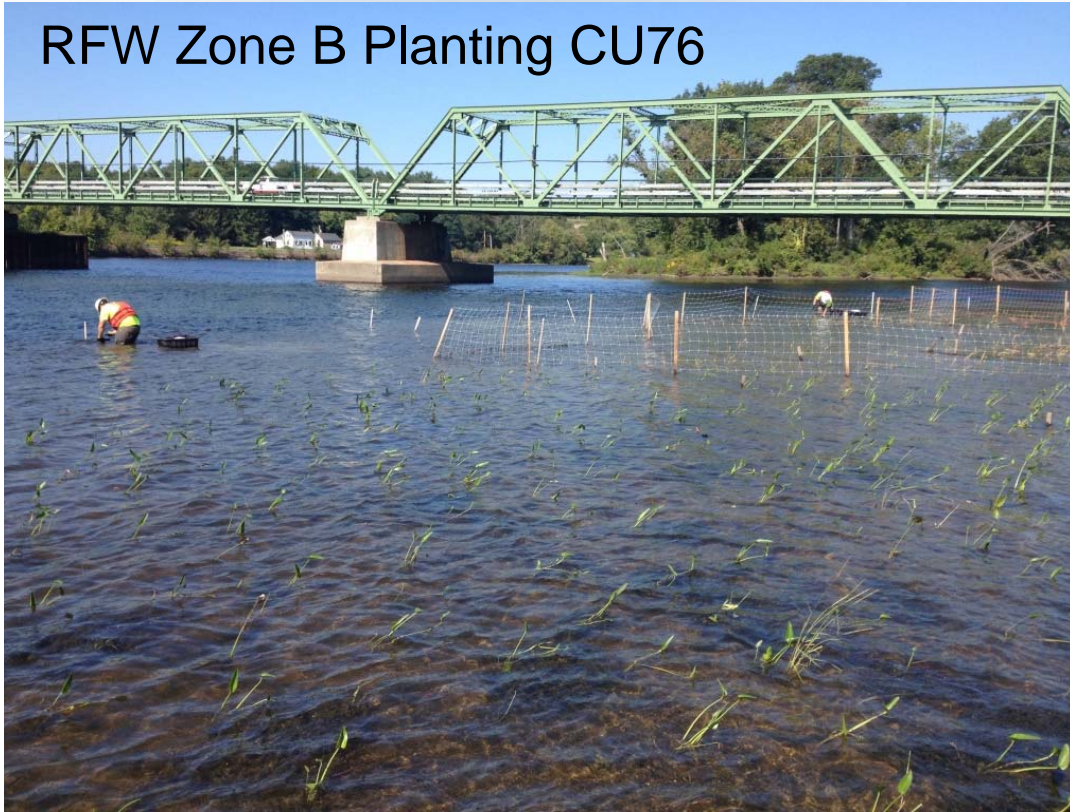
RFW Zone B Planting CU76

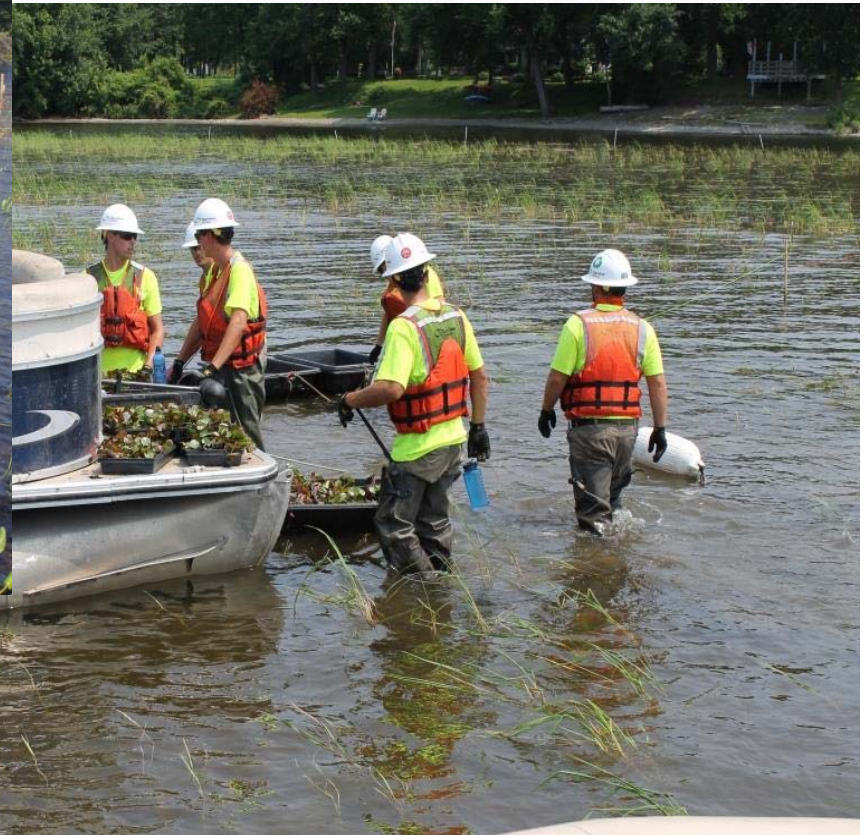
RFW Zone B Planting CU70

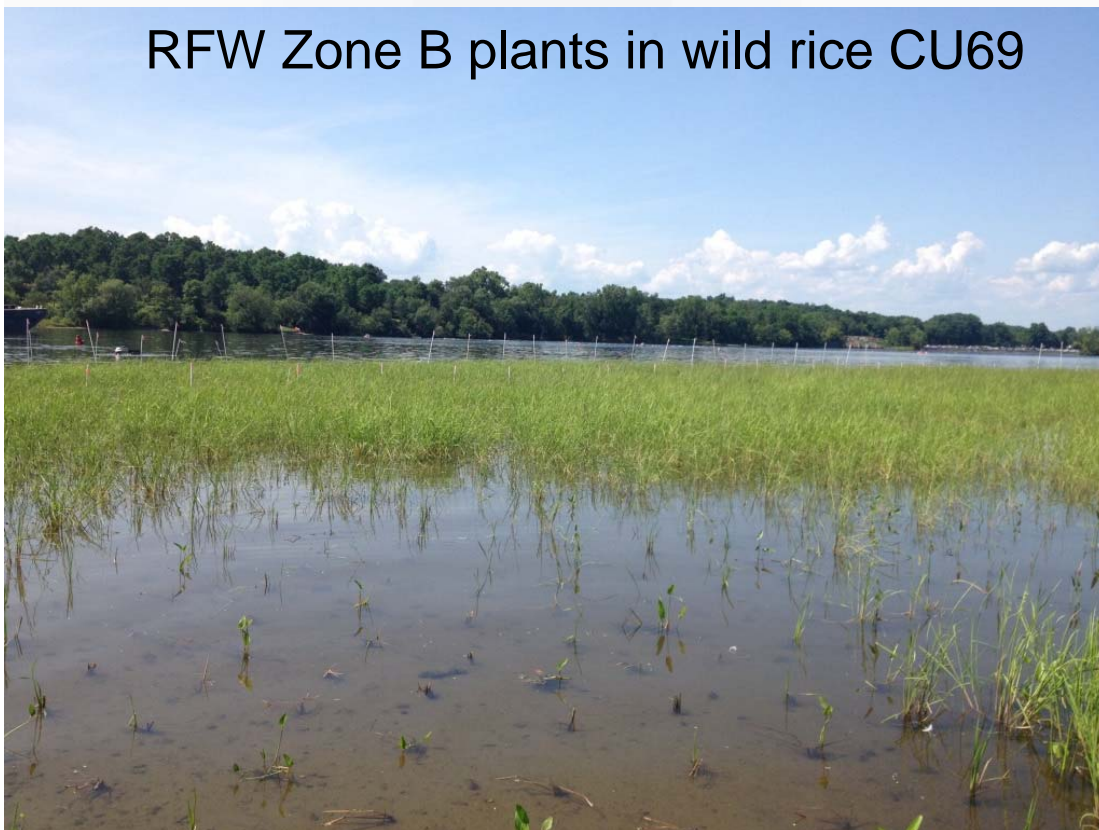
RFW Zone B plants in wild rice CU69

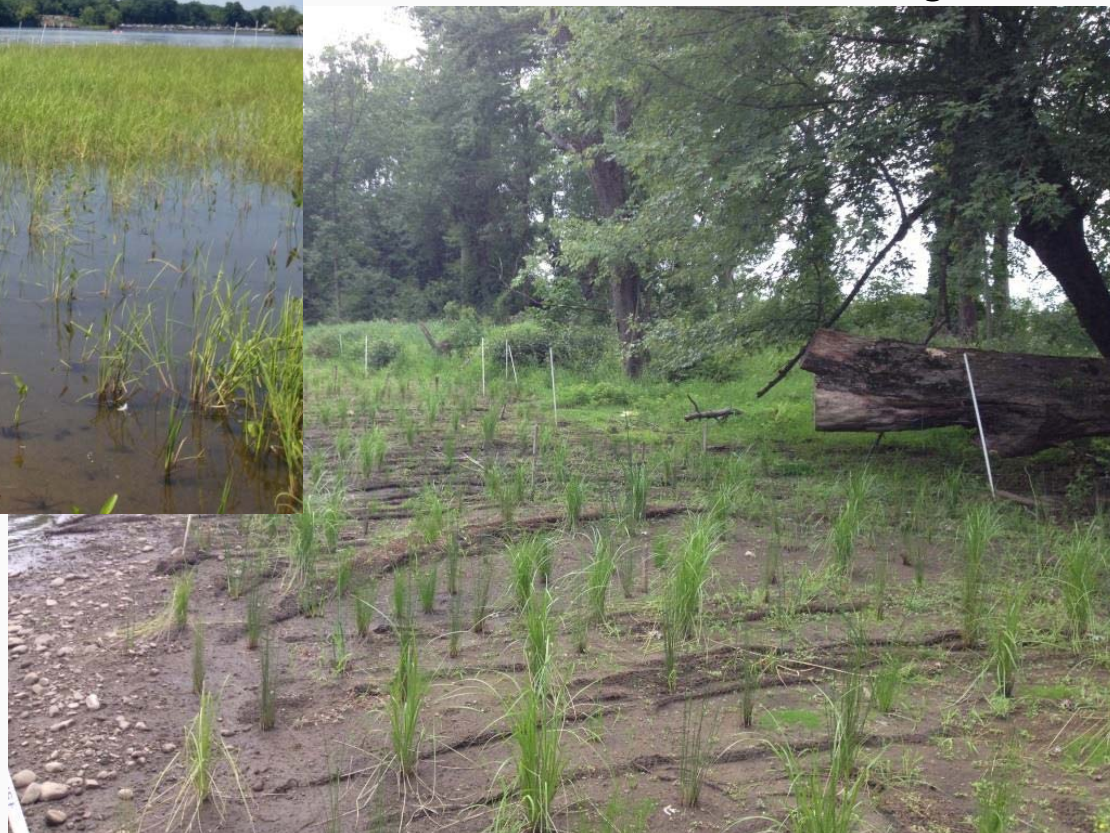
RFW Zone A Planting CU35

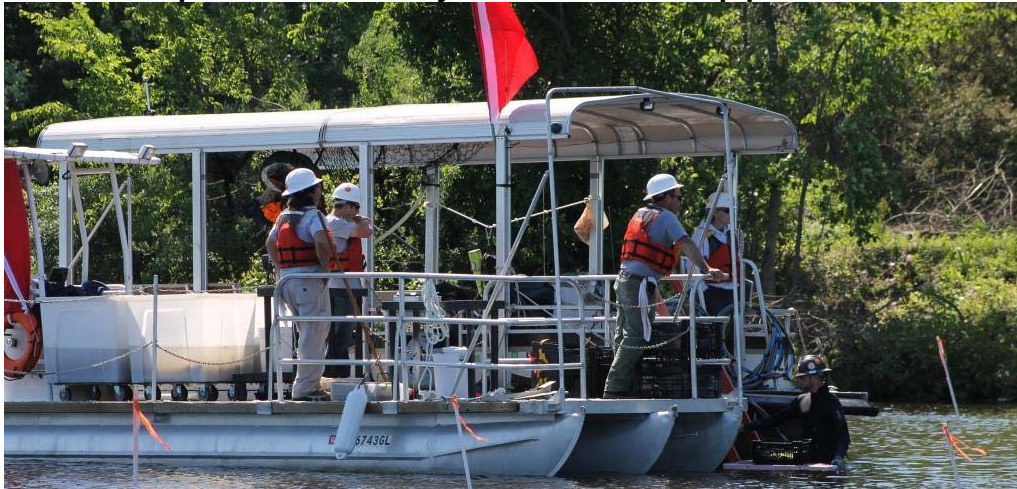
SAV plant delivery and dive support vessels

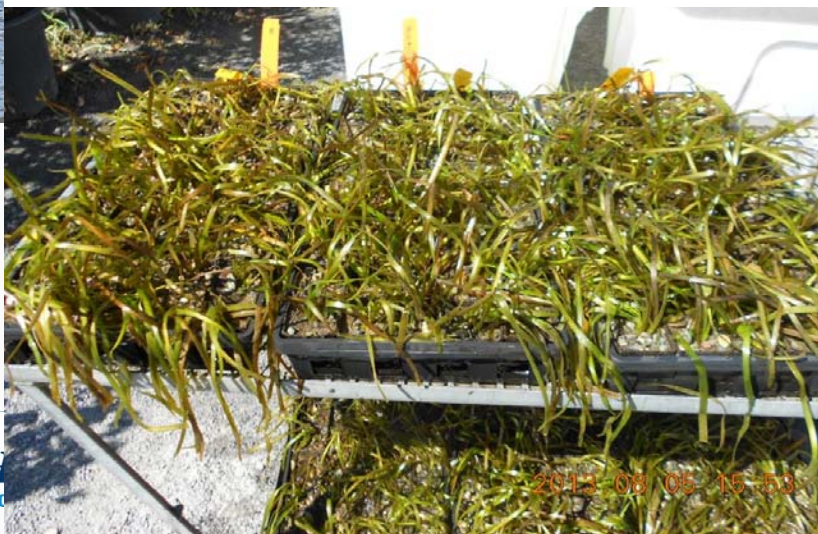
American wild celery plants in flats

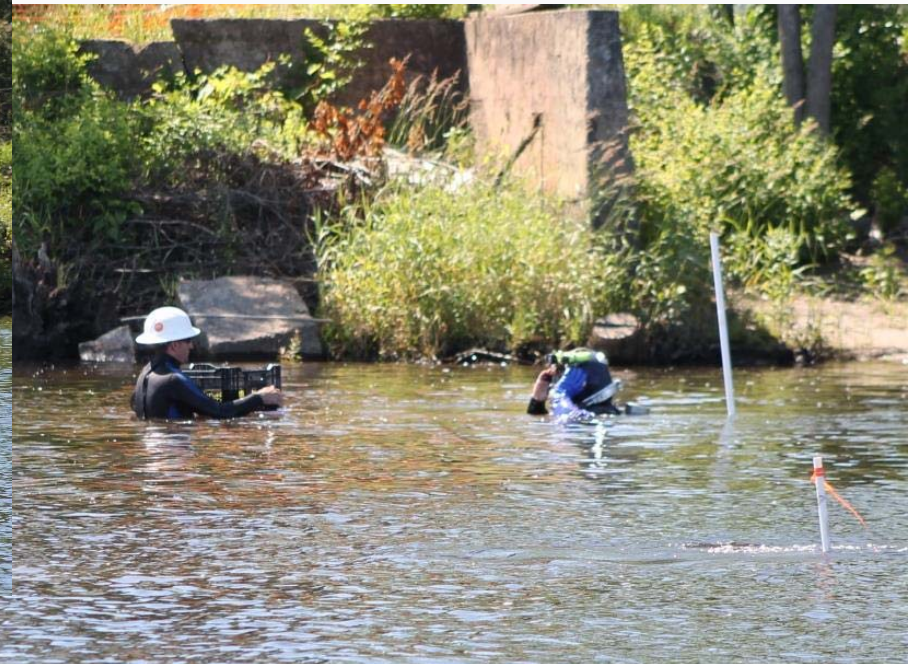
Diver & diver tender installing plants

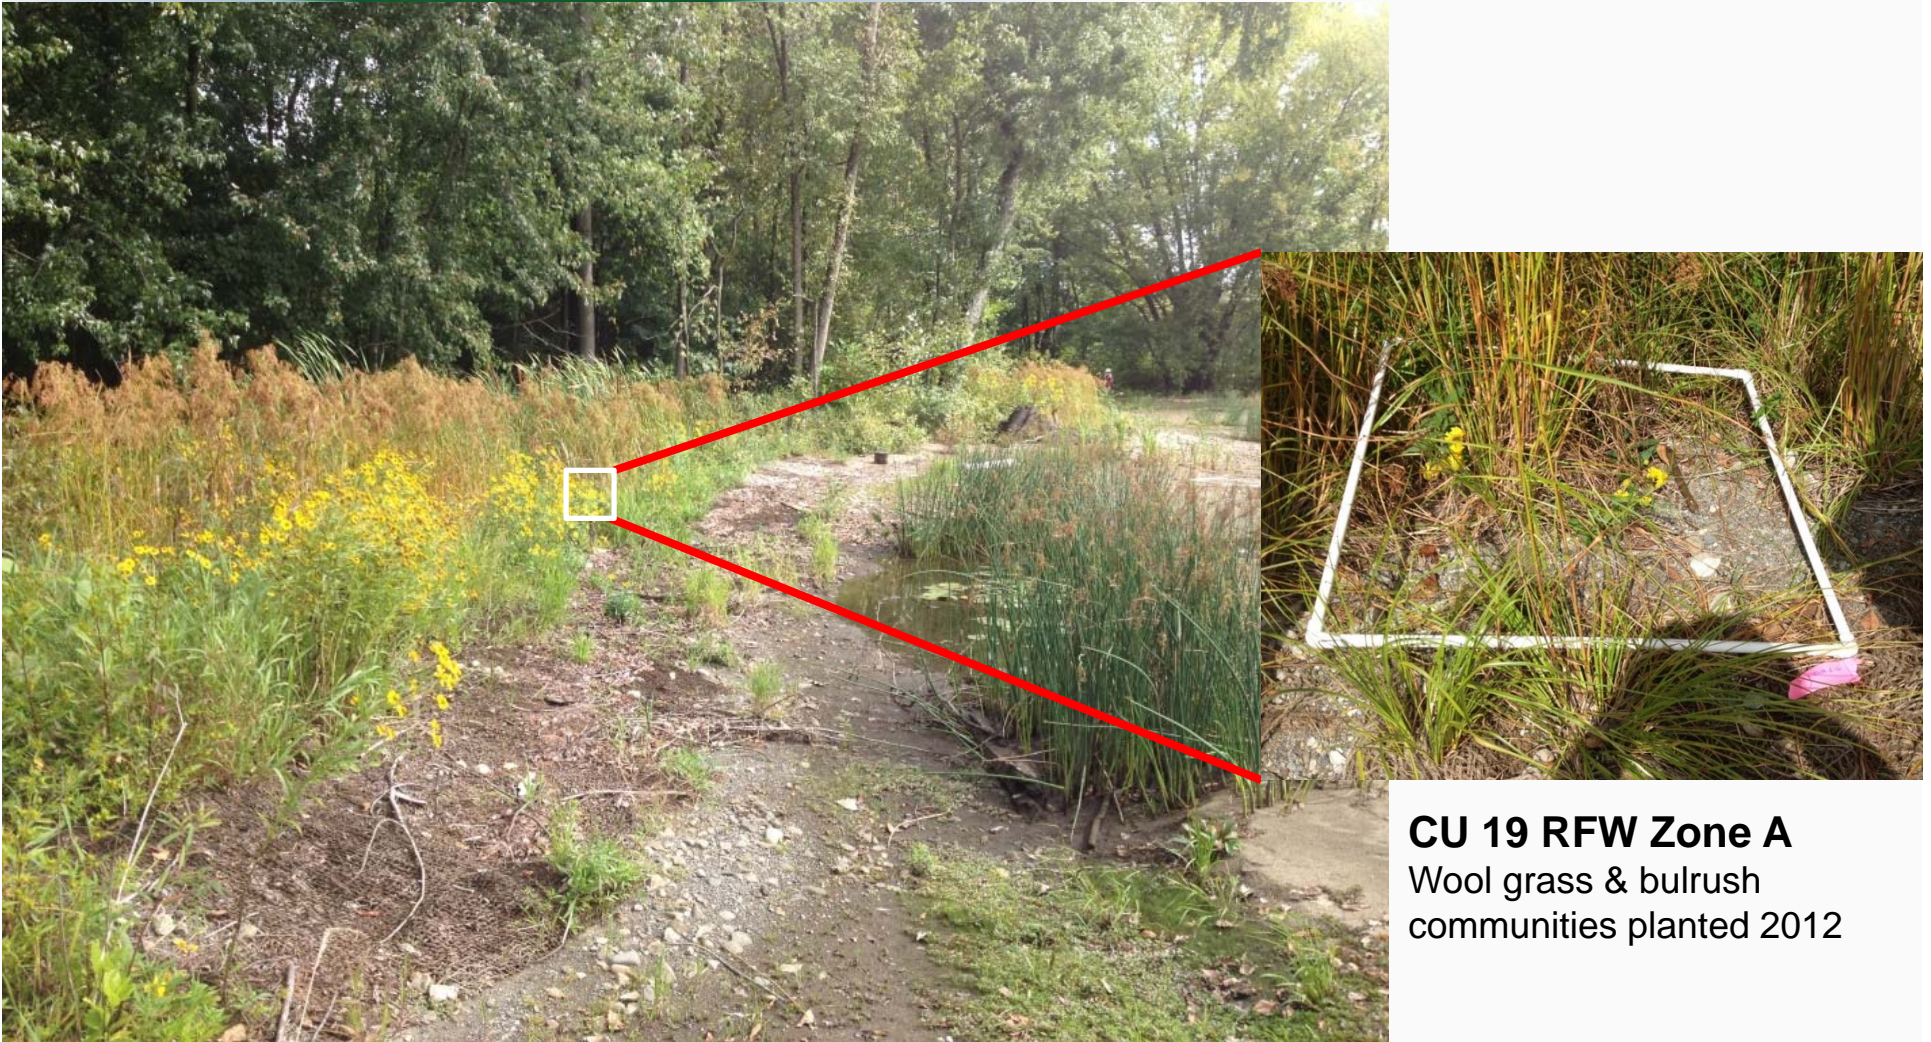
CU 19 RFW Zone A
Wool grass & bulrush
communities planted 2012

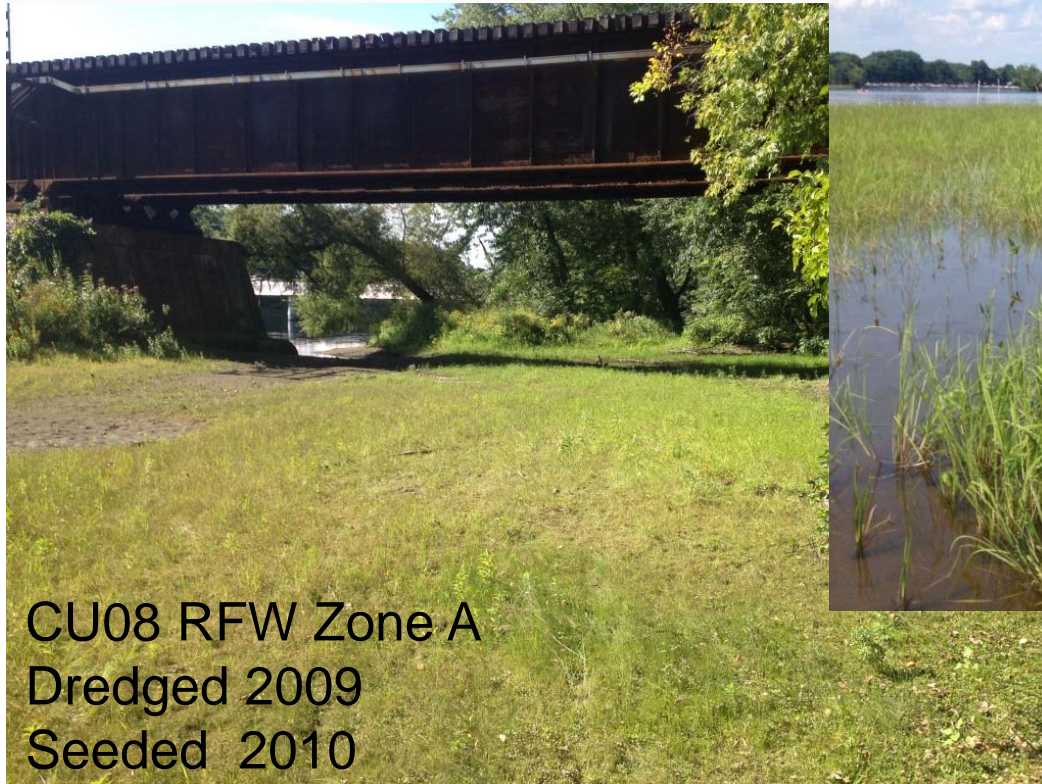
CU08 RFW Zone A
Dredged 2009
Seeded 2010

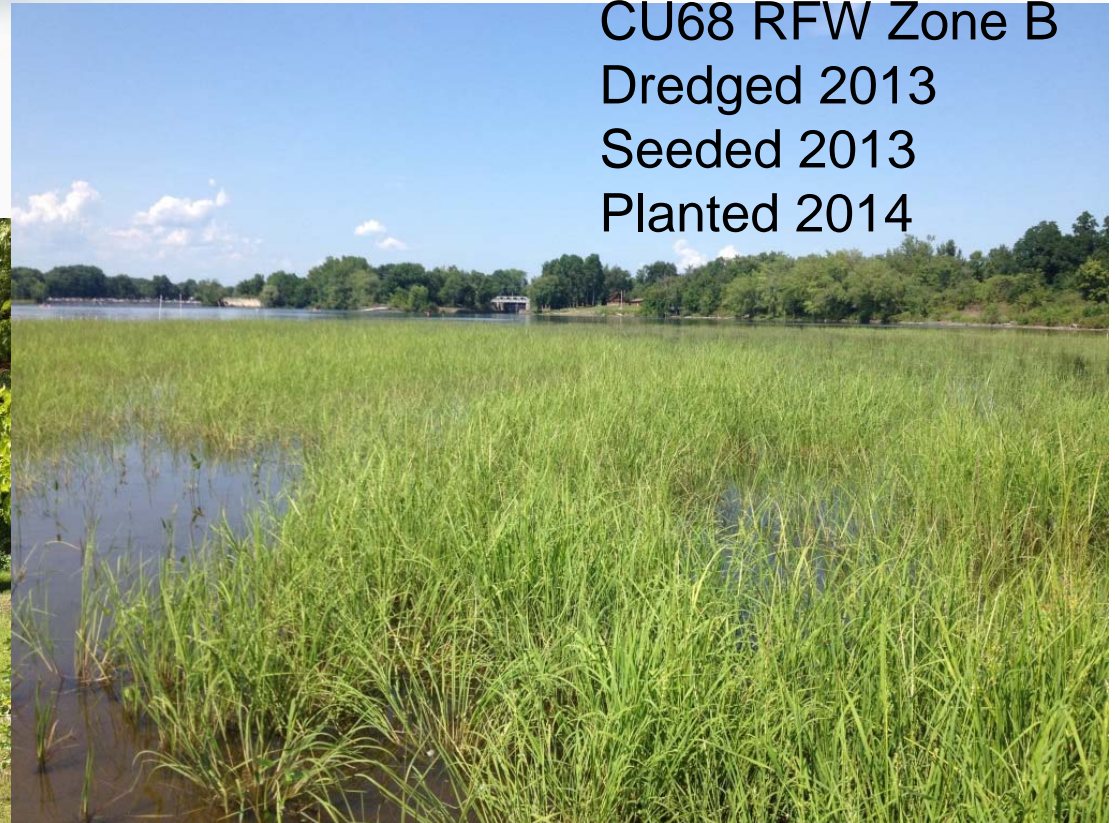
CU68 RFW Zone B
Dredged 2013
Seeded 2013
Planted 2014

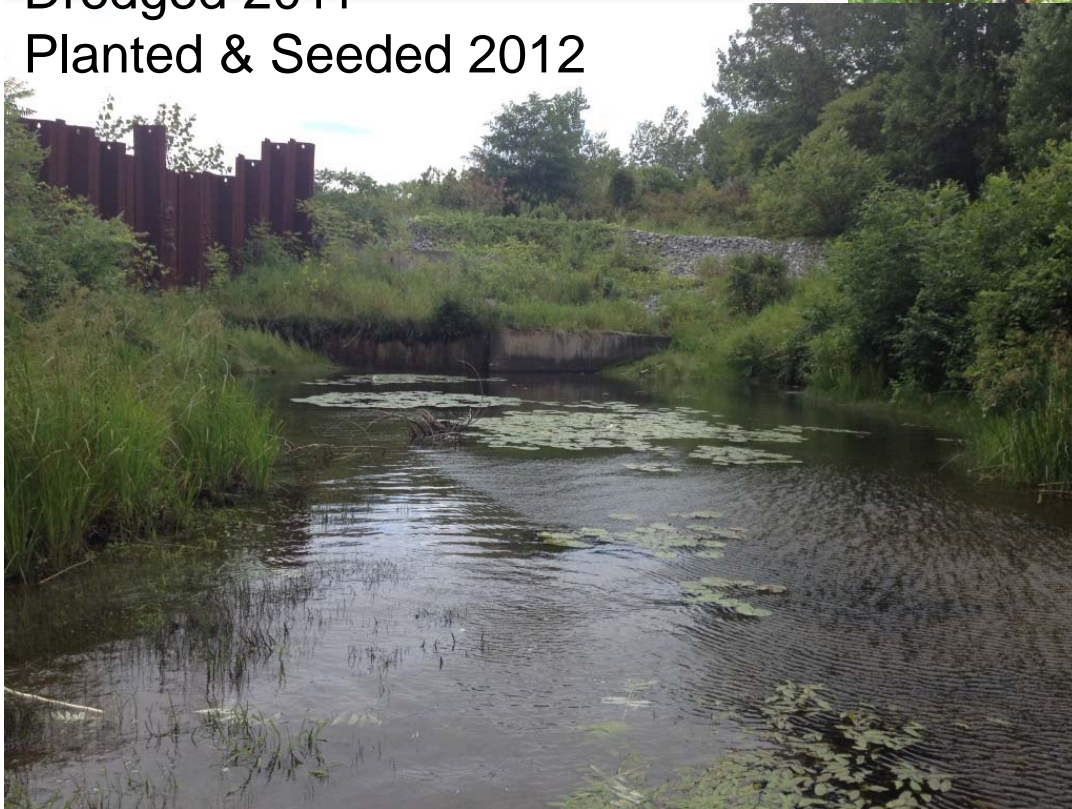
CU09 RFW Zone B
Dredged 2011
Planted & Seeded 2012

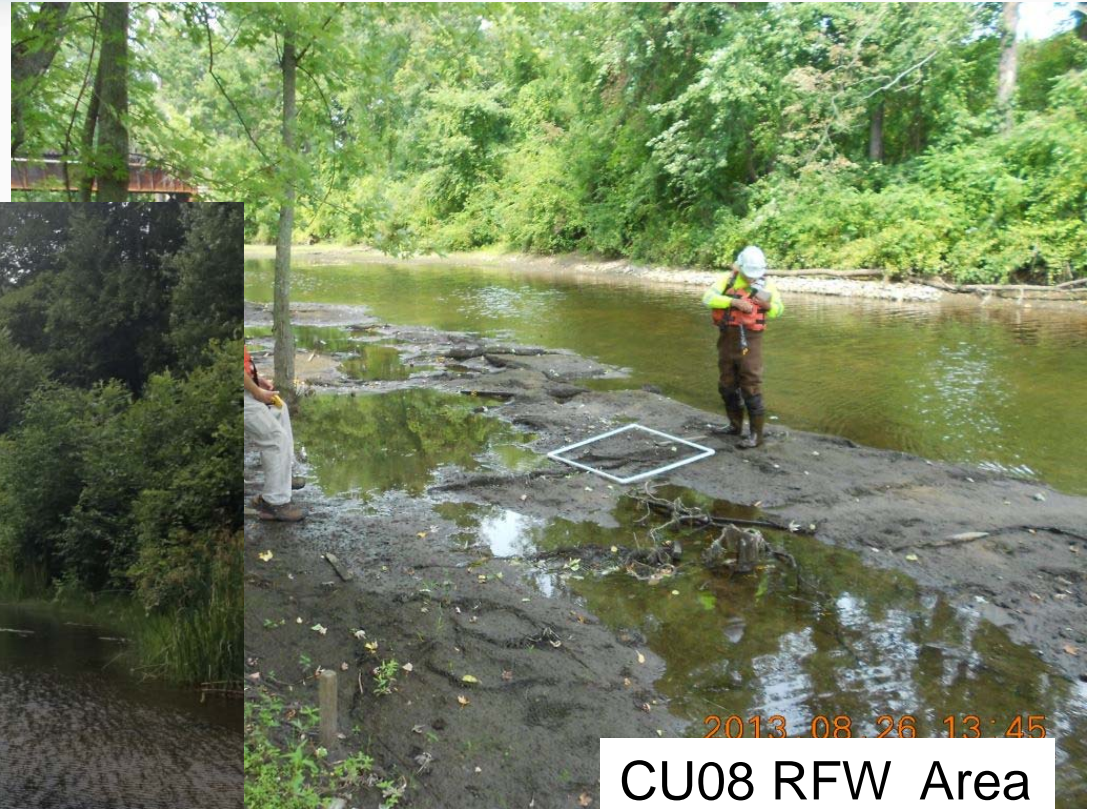
CU08 RFW Area
Dredged 2009
Planted 2010
Replanted 2014

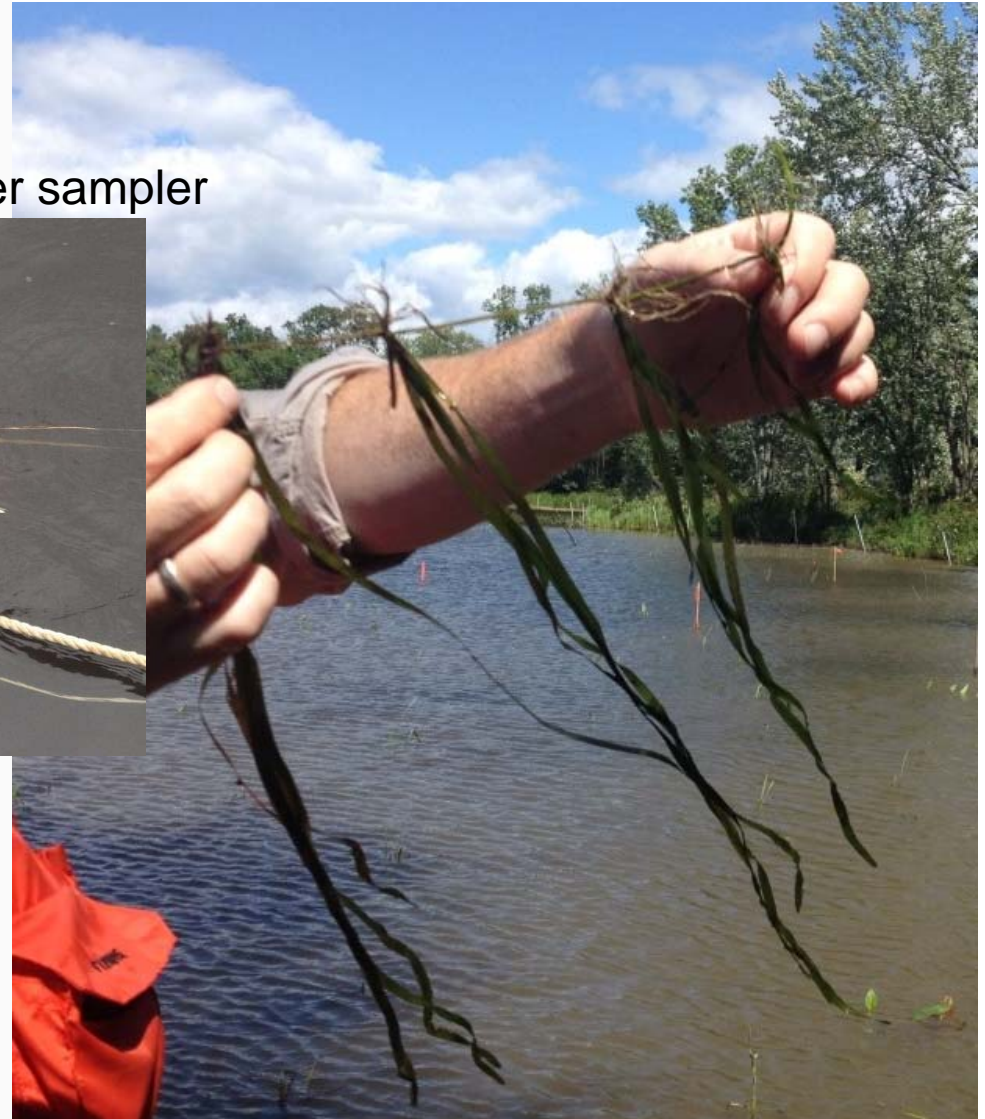
Underwater video camera mounted on water sampler
