Former GE Hudson Falls Facility

Powerhouse Deconstruction - Overview

Allen Mill Deconstruction Status

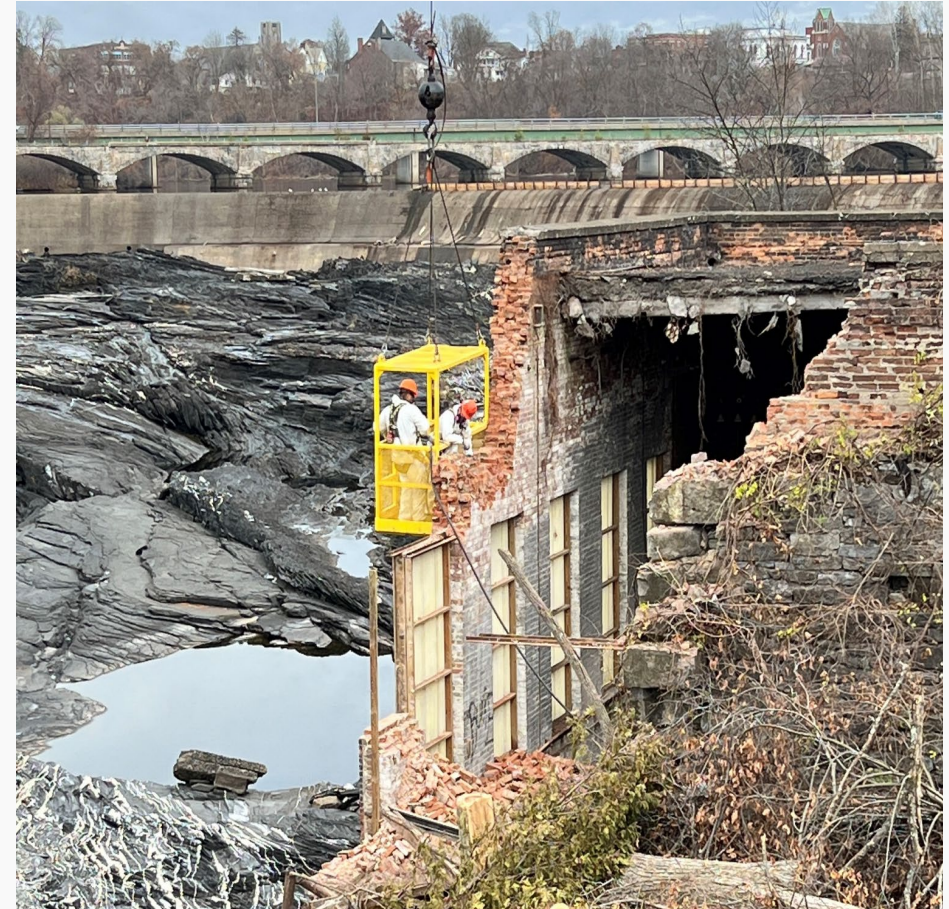
This photo shows the Powerhouse building being carefully dismantled using hand tools to limit disturbances to bedrock and minimize fallen debris into the river

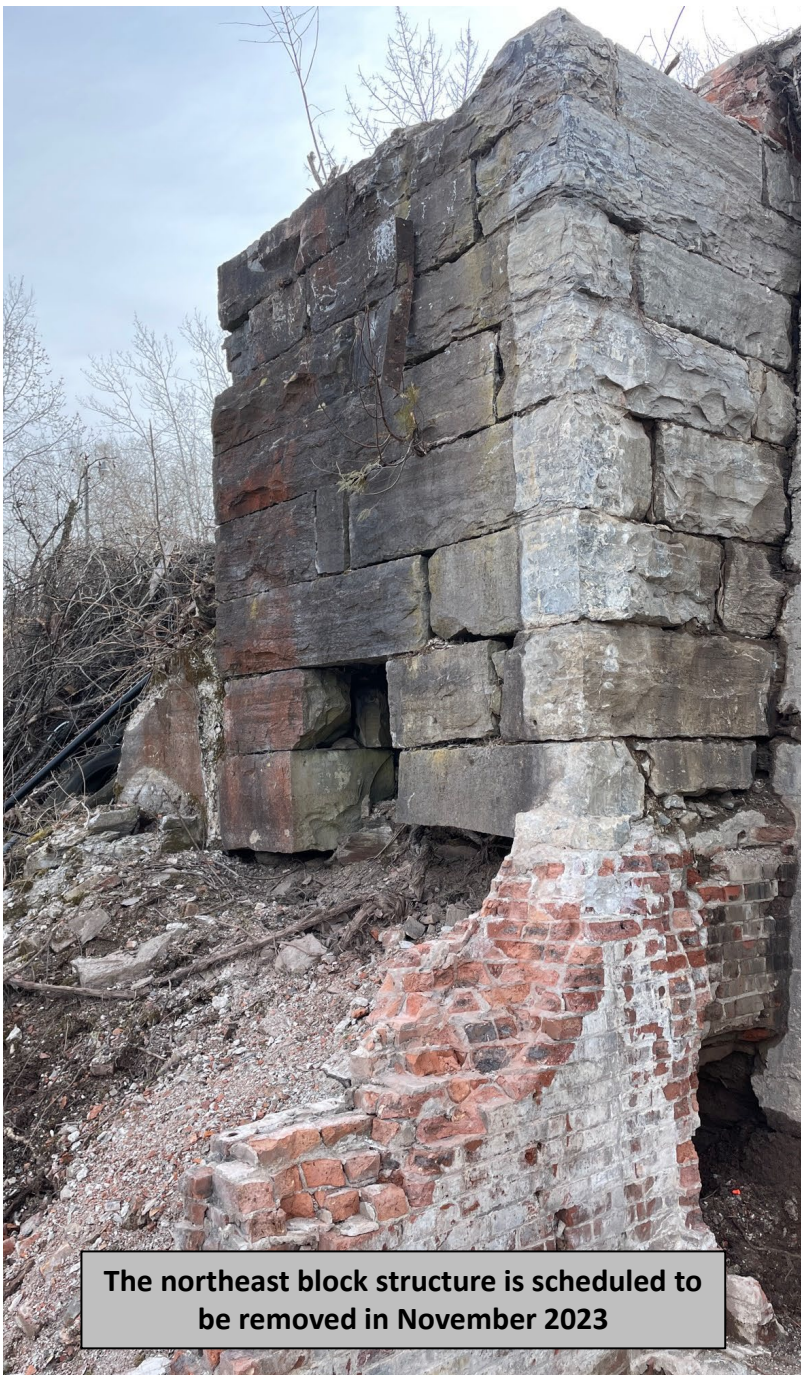
The northeast block structure is scheduled to be removed in November 2023

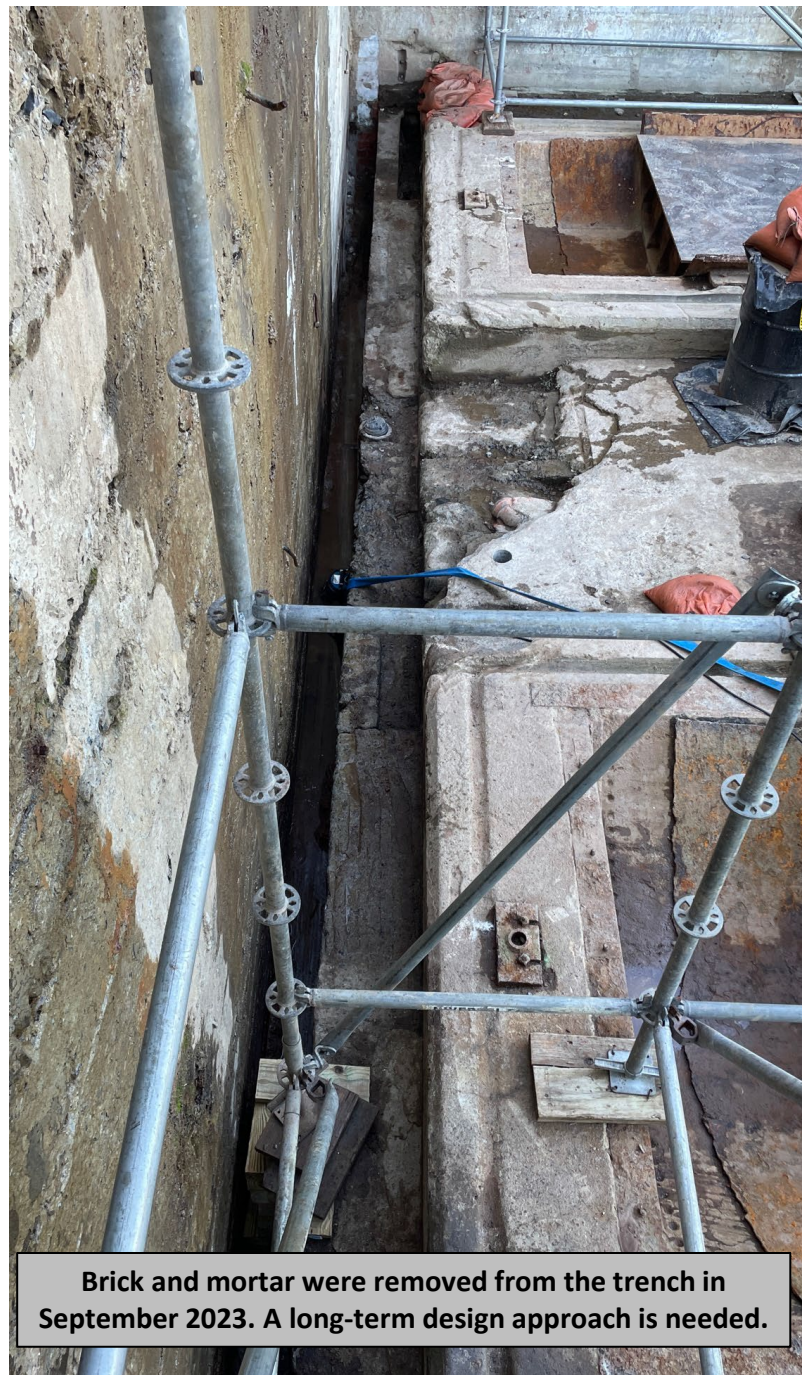
Brick and mortar were removed from the trench in September 2023. A long-term design approach is needed.

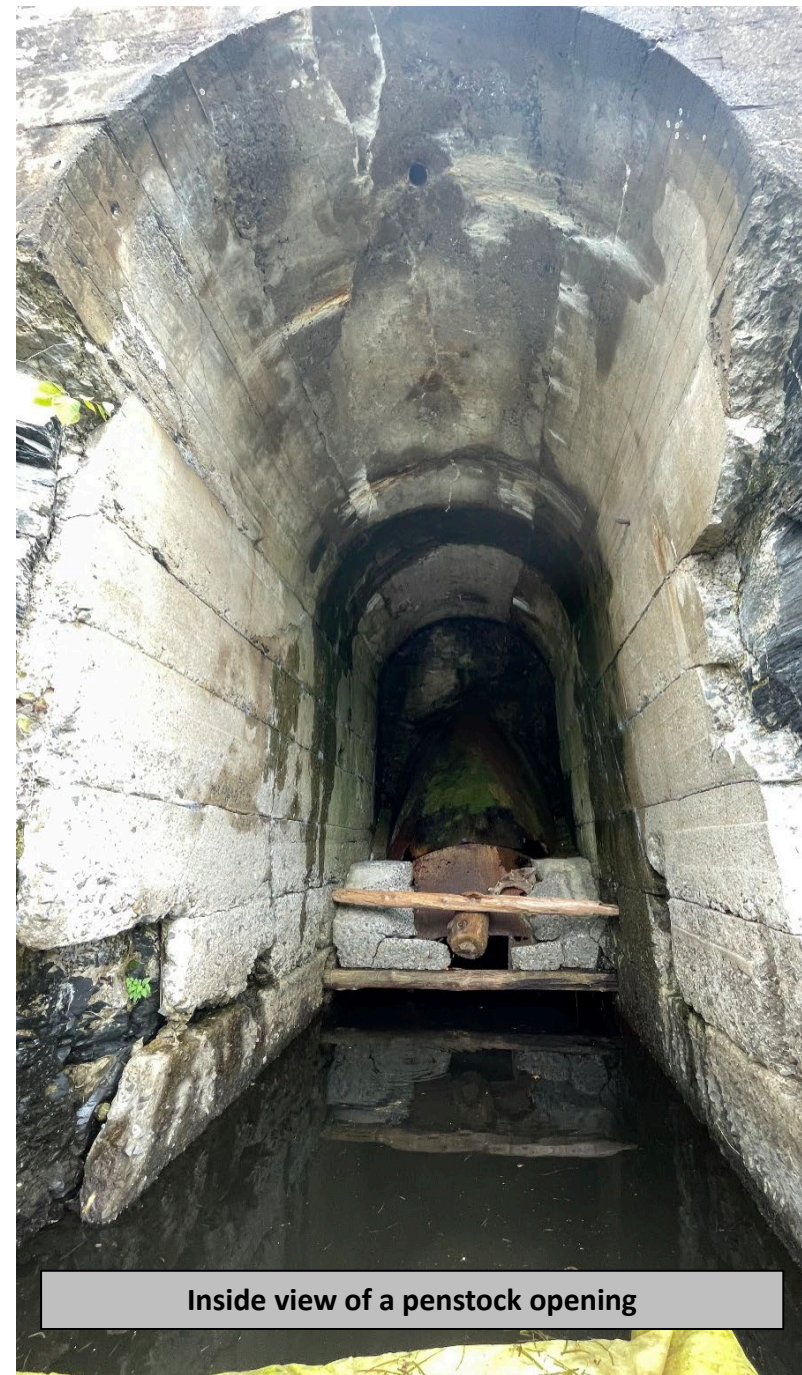
Inside view of a penstock opening

Penstock Openings
The installation of grout, concrete and steel plates was completed in April 2023
