Powerhouse Deconstruction – Background

Hudson Falls Powerhouse and Allen Mill Site

Powerhouse Deconstruction Site

Index Number: CERCLA-02-2022-2016
Hudson Falls, New York

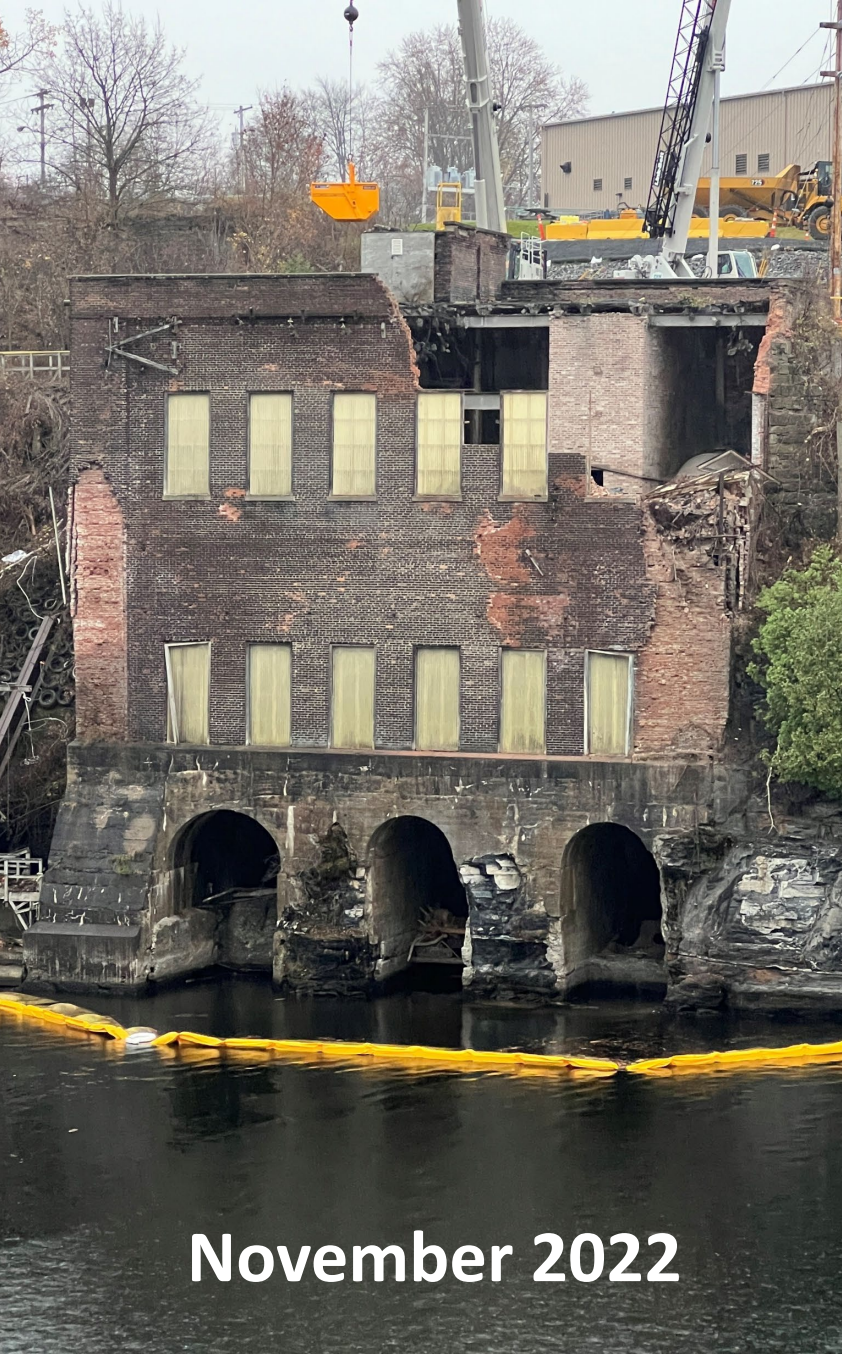
November 2022

THE DECONSTRUCTION OF THE POWERHOUSE BEGAN IN OCTOBER 2022 AND IS ALMOST COMPLETE

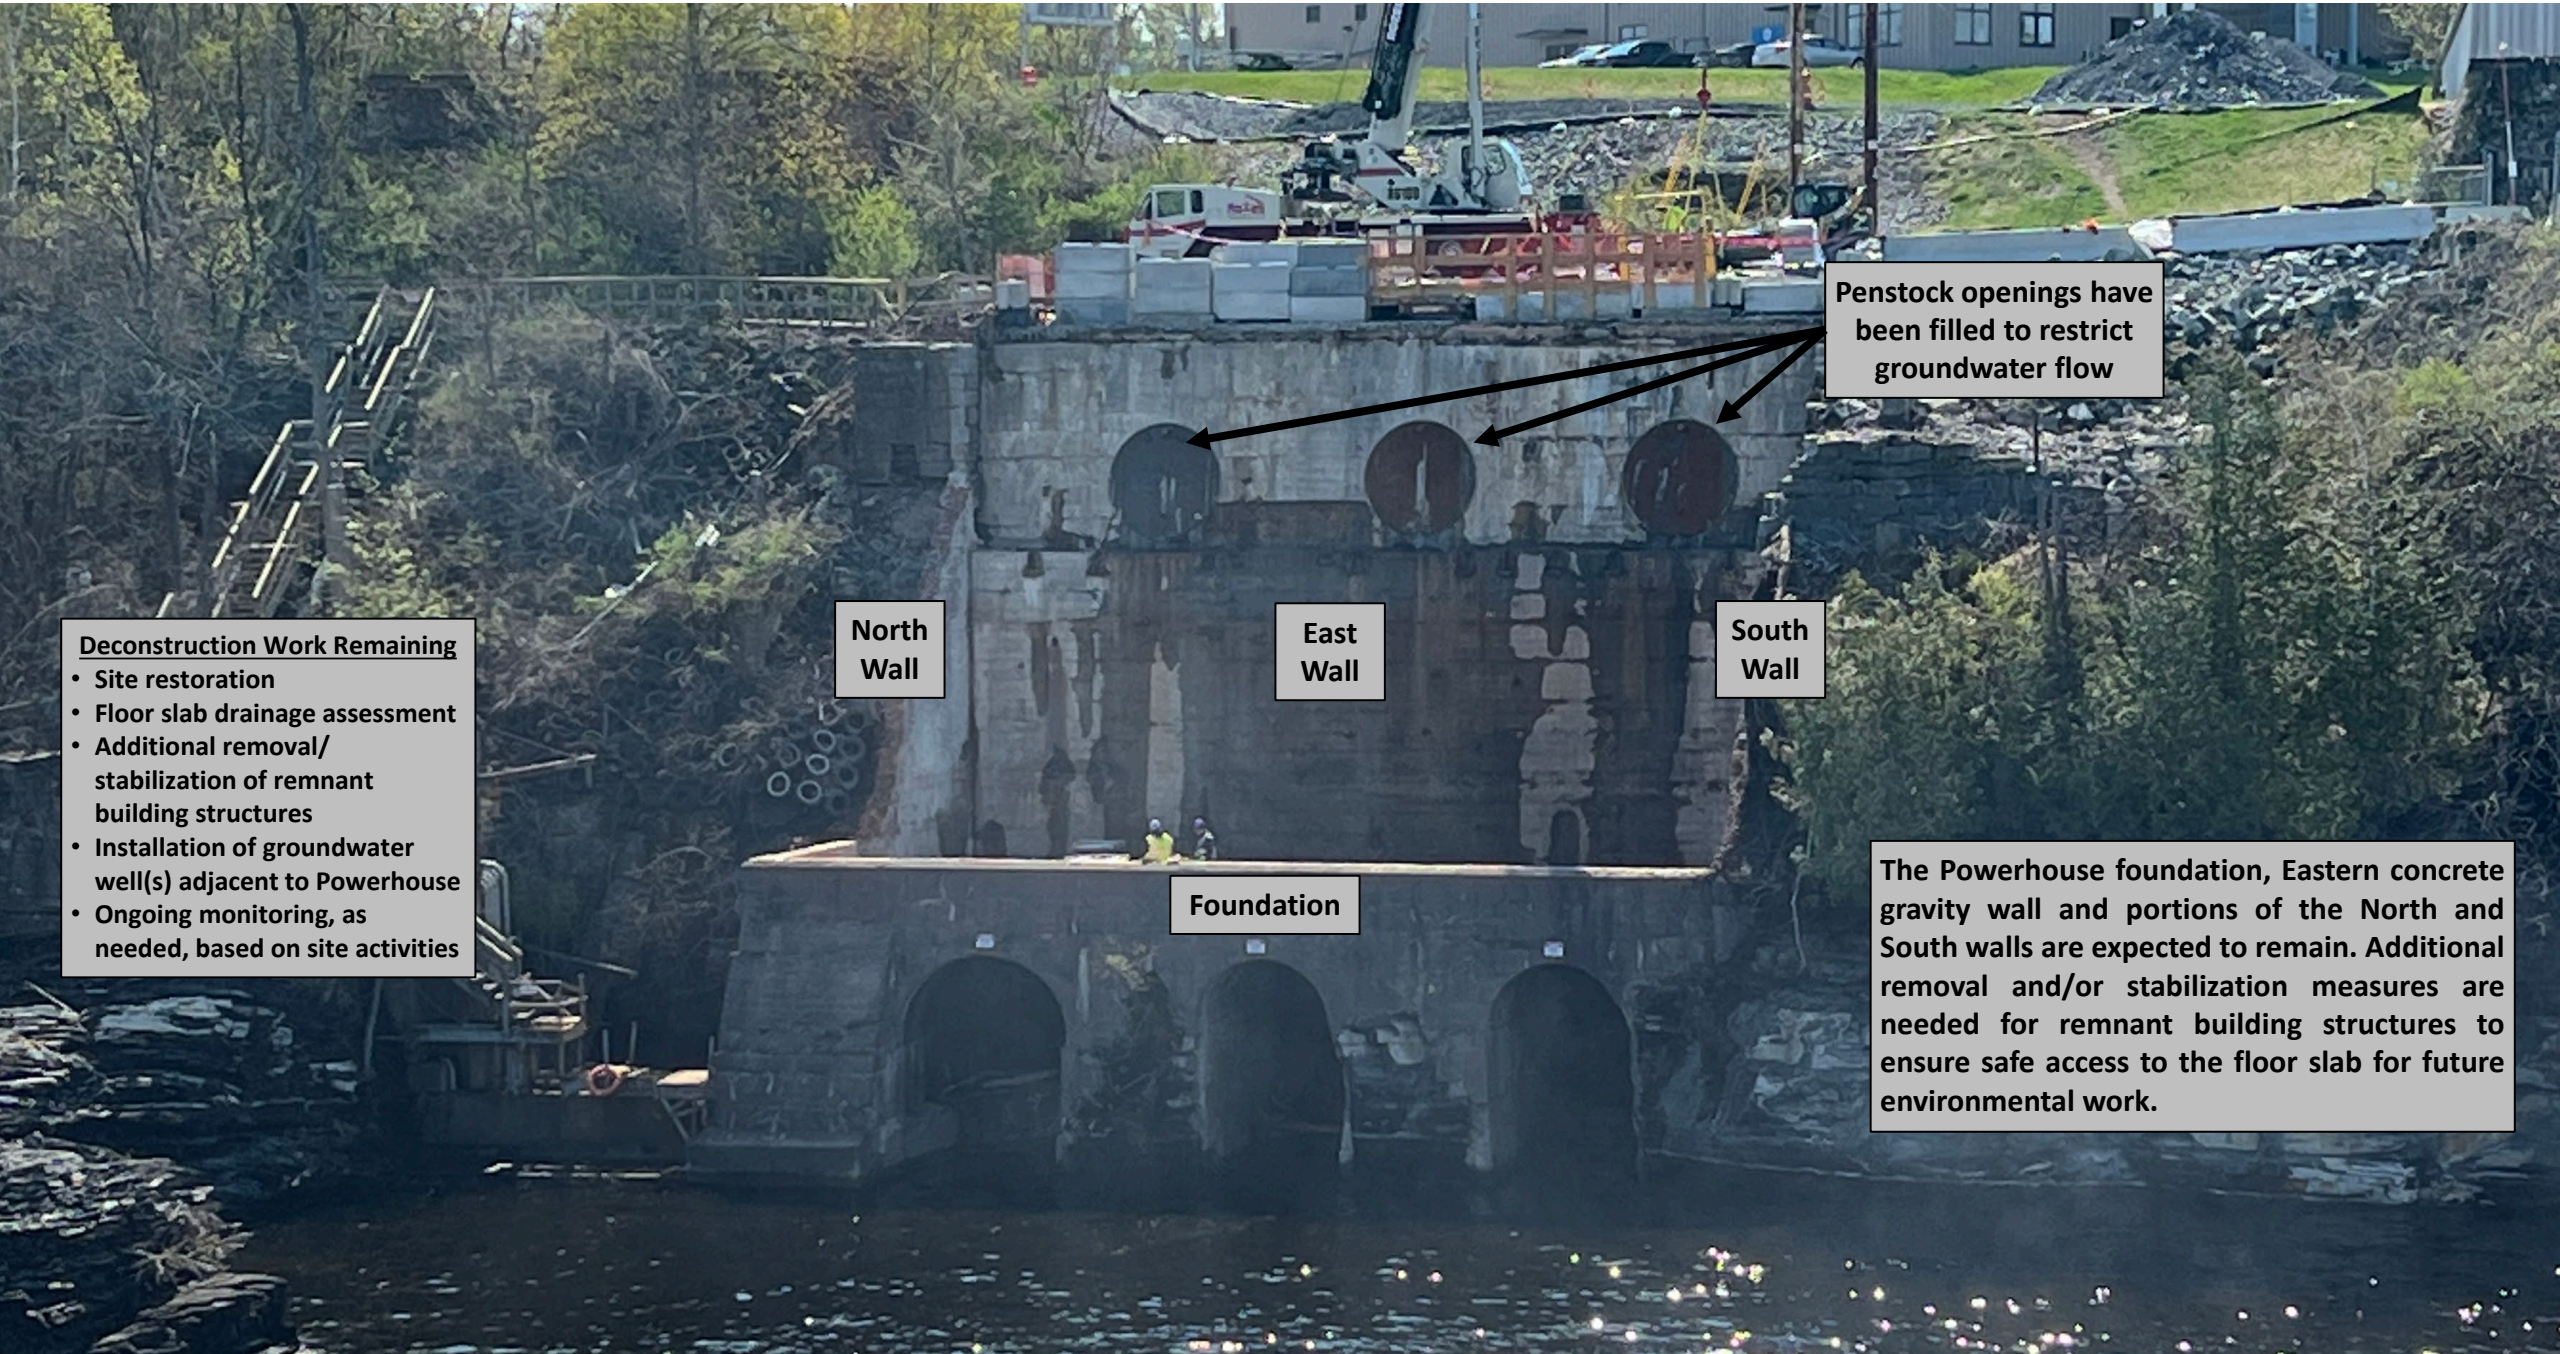
Current Powerhouse Deconstruction Status (April 26, 2023)

North Wall

East Wall

South Wall

Foundation

Penstock openings have been filled to restrict groundwater flow

The Powerhouse foundation, Eastern concrete gravity wall and portions of the North and South walls are expected to remain. Additional removal and/or stabilization measures are needed for remnant building structures to ensure safe access to the floor slab for future environmental work.

- Deconstruction Work Remaining**
- Site restoration
 - Floor slab drainage assessment
 - Additional removal/ stabilization of remnant building structures
 - Installation of groundwater well(s) adjacent to Powerhouse
 - Ongoing monitoring, as needed, based on site activities
