Upper Hudson River Habitat Reconstruction & Restoration

2023 Habitat Reconstruction Monitoring

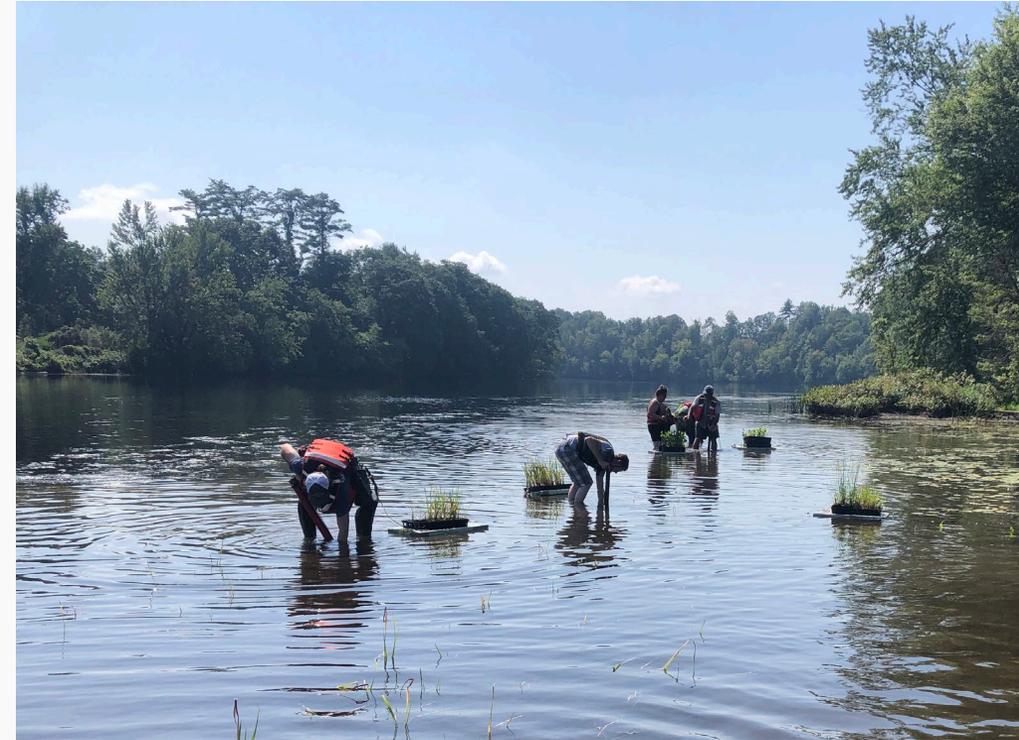
- Response actions implemented annually based on previous years monitoring results and the results of planting pilot and other studies
- 2023 RFW response actions included:
 - Installation of wave-break measures (coir logs),
 - Plantings in select RFW areas, and
 - Invasive species management
- 2023 SAV response actions included using American wild celery (*Vallisneria americana*) seed buoys

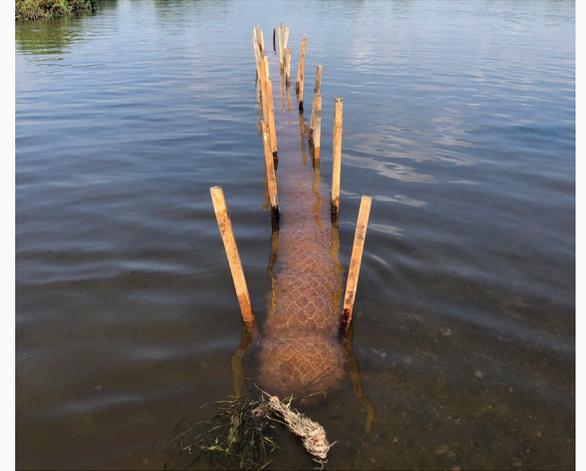
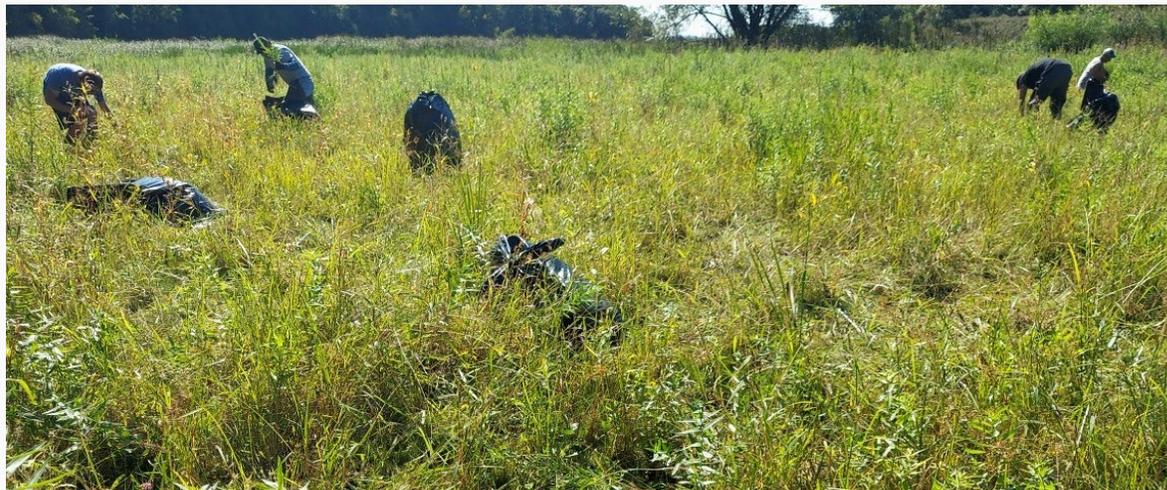
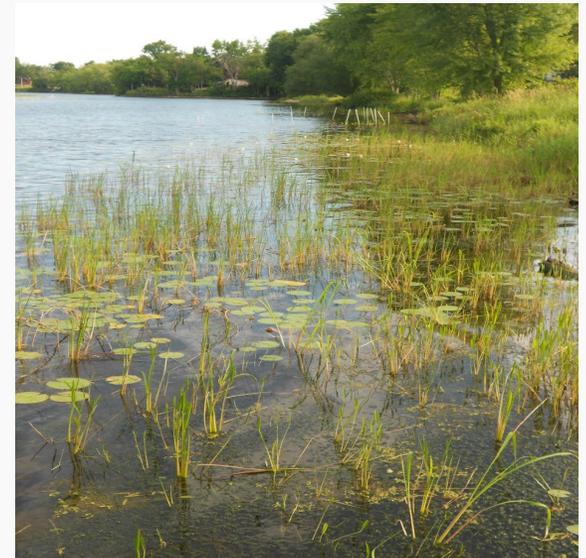
- Certification Unit (CU) 68-70:
 - 4,600 plants (primarily water lily)
 - 12 coir logs installed to absorb wave energy
- CU64:
 - 1,600 plants (pickerelweed, bur-reed, bulrush, water lily)
 - 8 coir logs to slow down flows and prevent sedimentation
- Invasive species management (multiple areas)

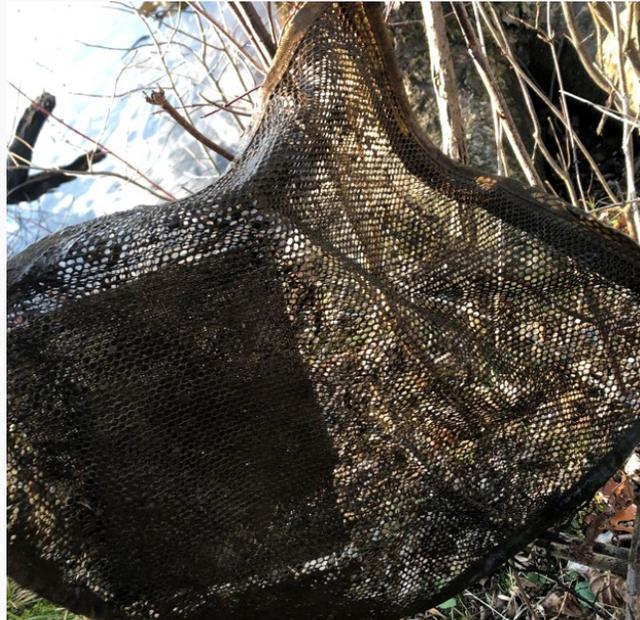
Seed Buoy Mesh Bag

- More about wild celery seed pods
 - Seed pods are harvested from relatively dense SAV beds, placed into mesh bags and attached to buoys to encourage re-vegetation - seeds fall in area around seed buoy
