GE Fort Edward Plant Site
Investigation of Bedrock
Contamination in the Vicinity of
Former 004 Outfall

Presentation for
Hudson River PCBs Superfund Site
Community Advisory Group
July 28, 2005

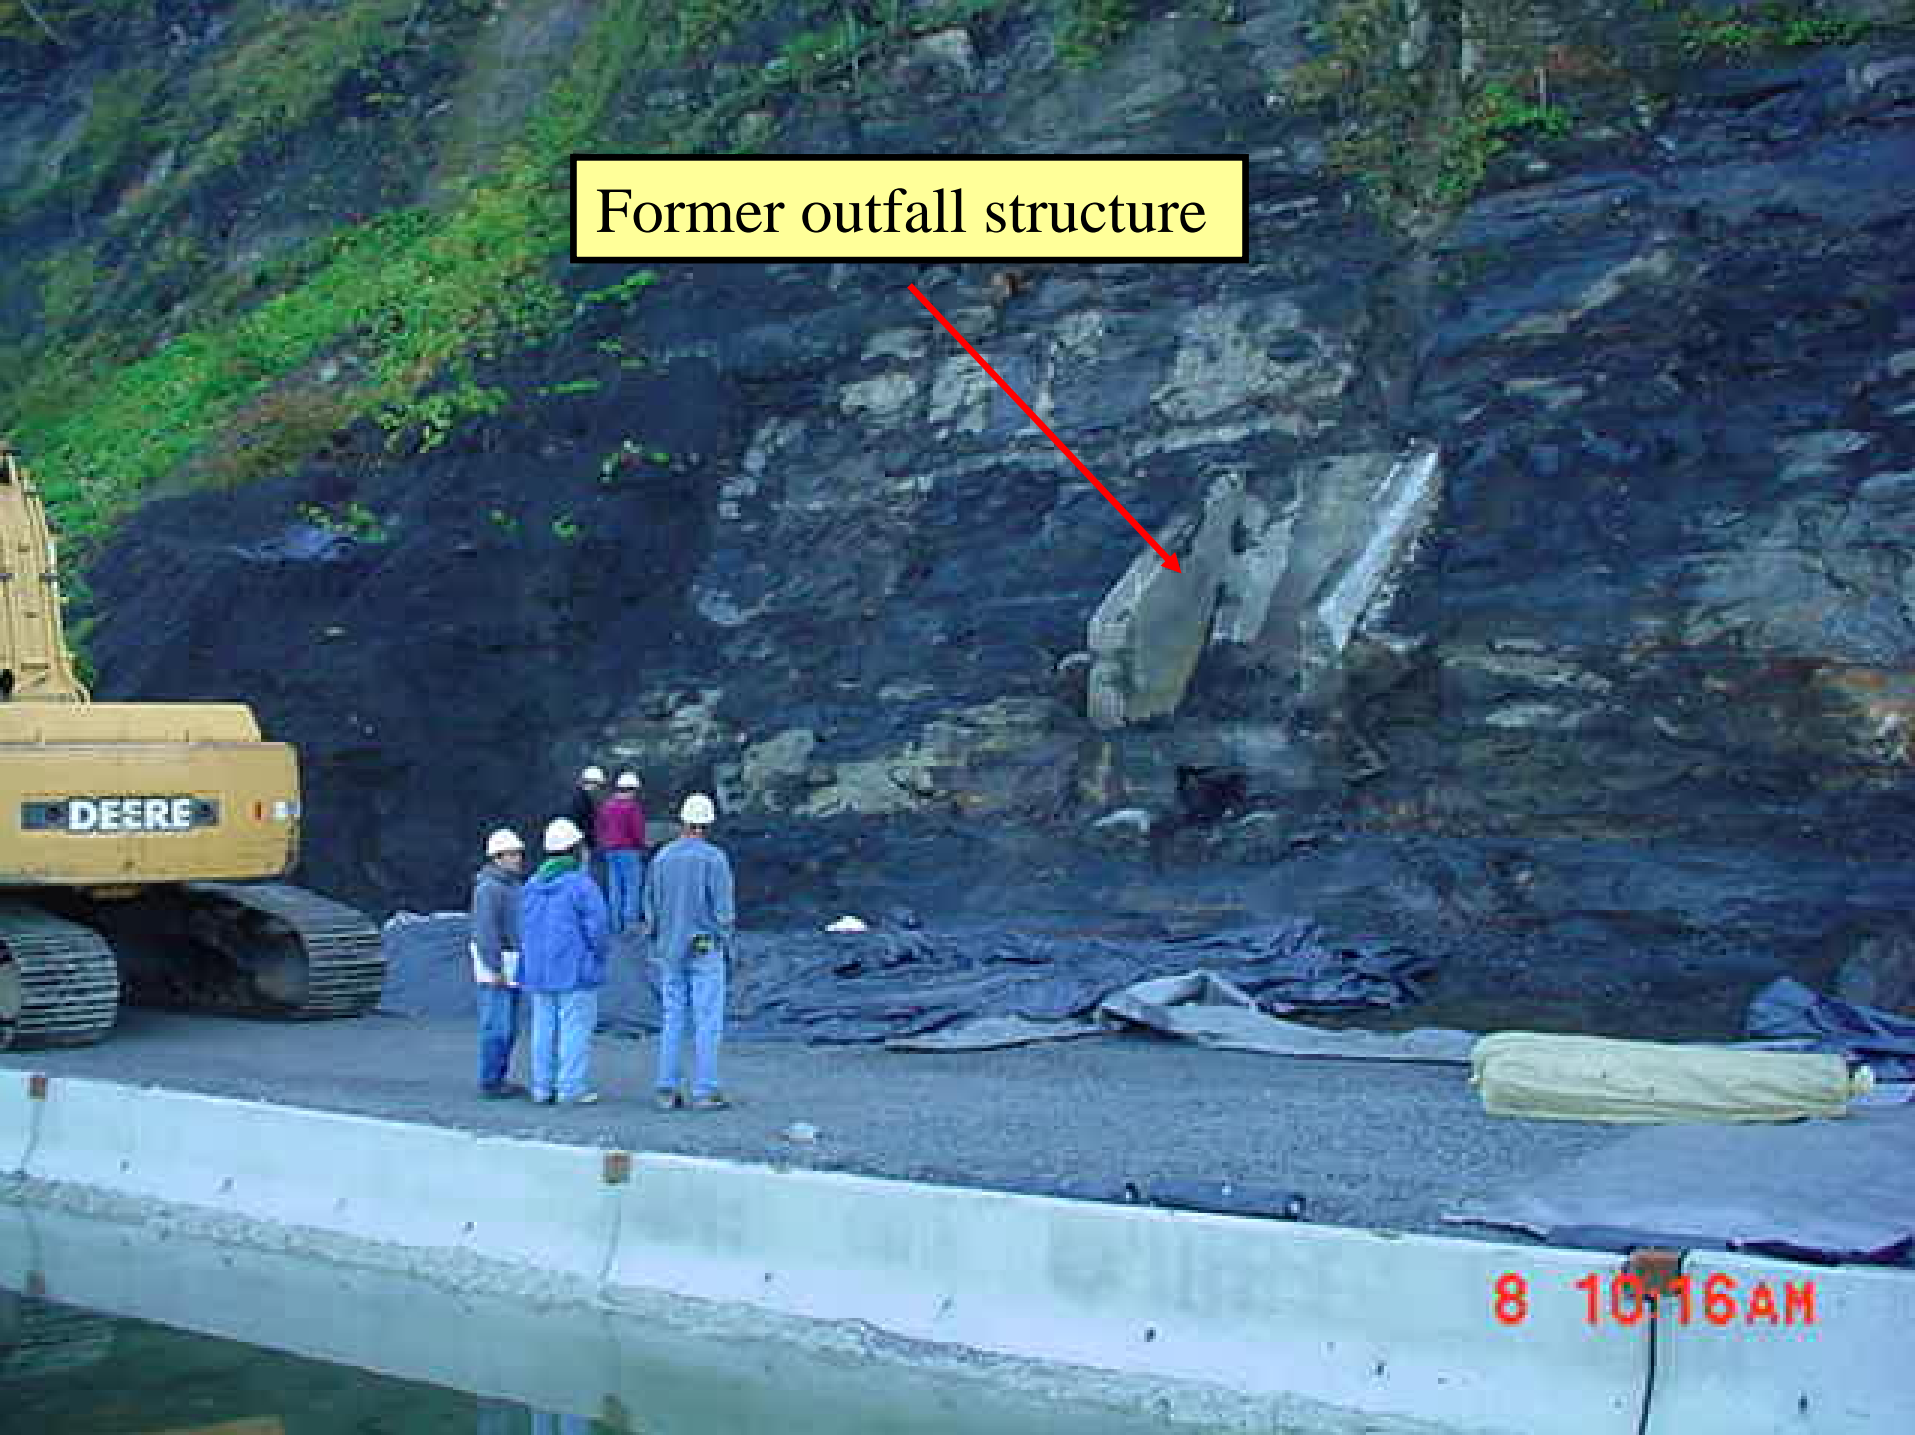
Former outfall structure

Former alignment
of pipe from plant

Former outfall
location

Shallow bedrock
monitoring well

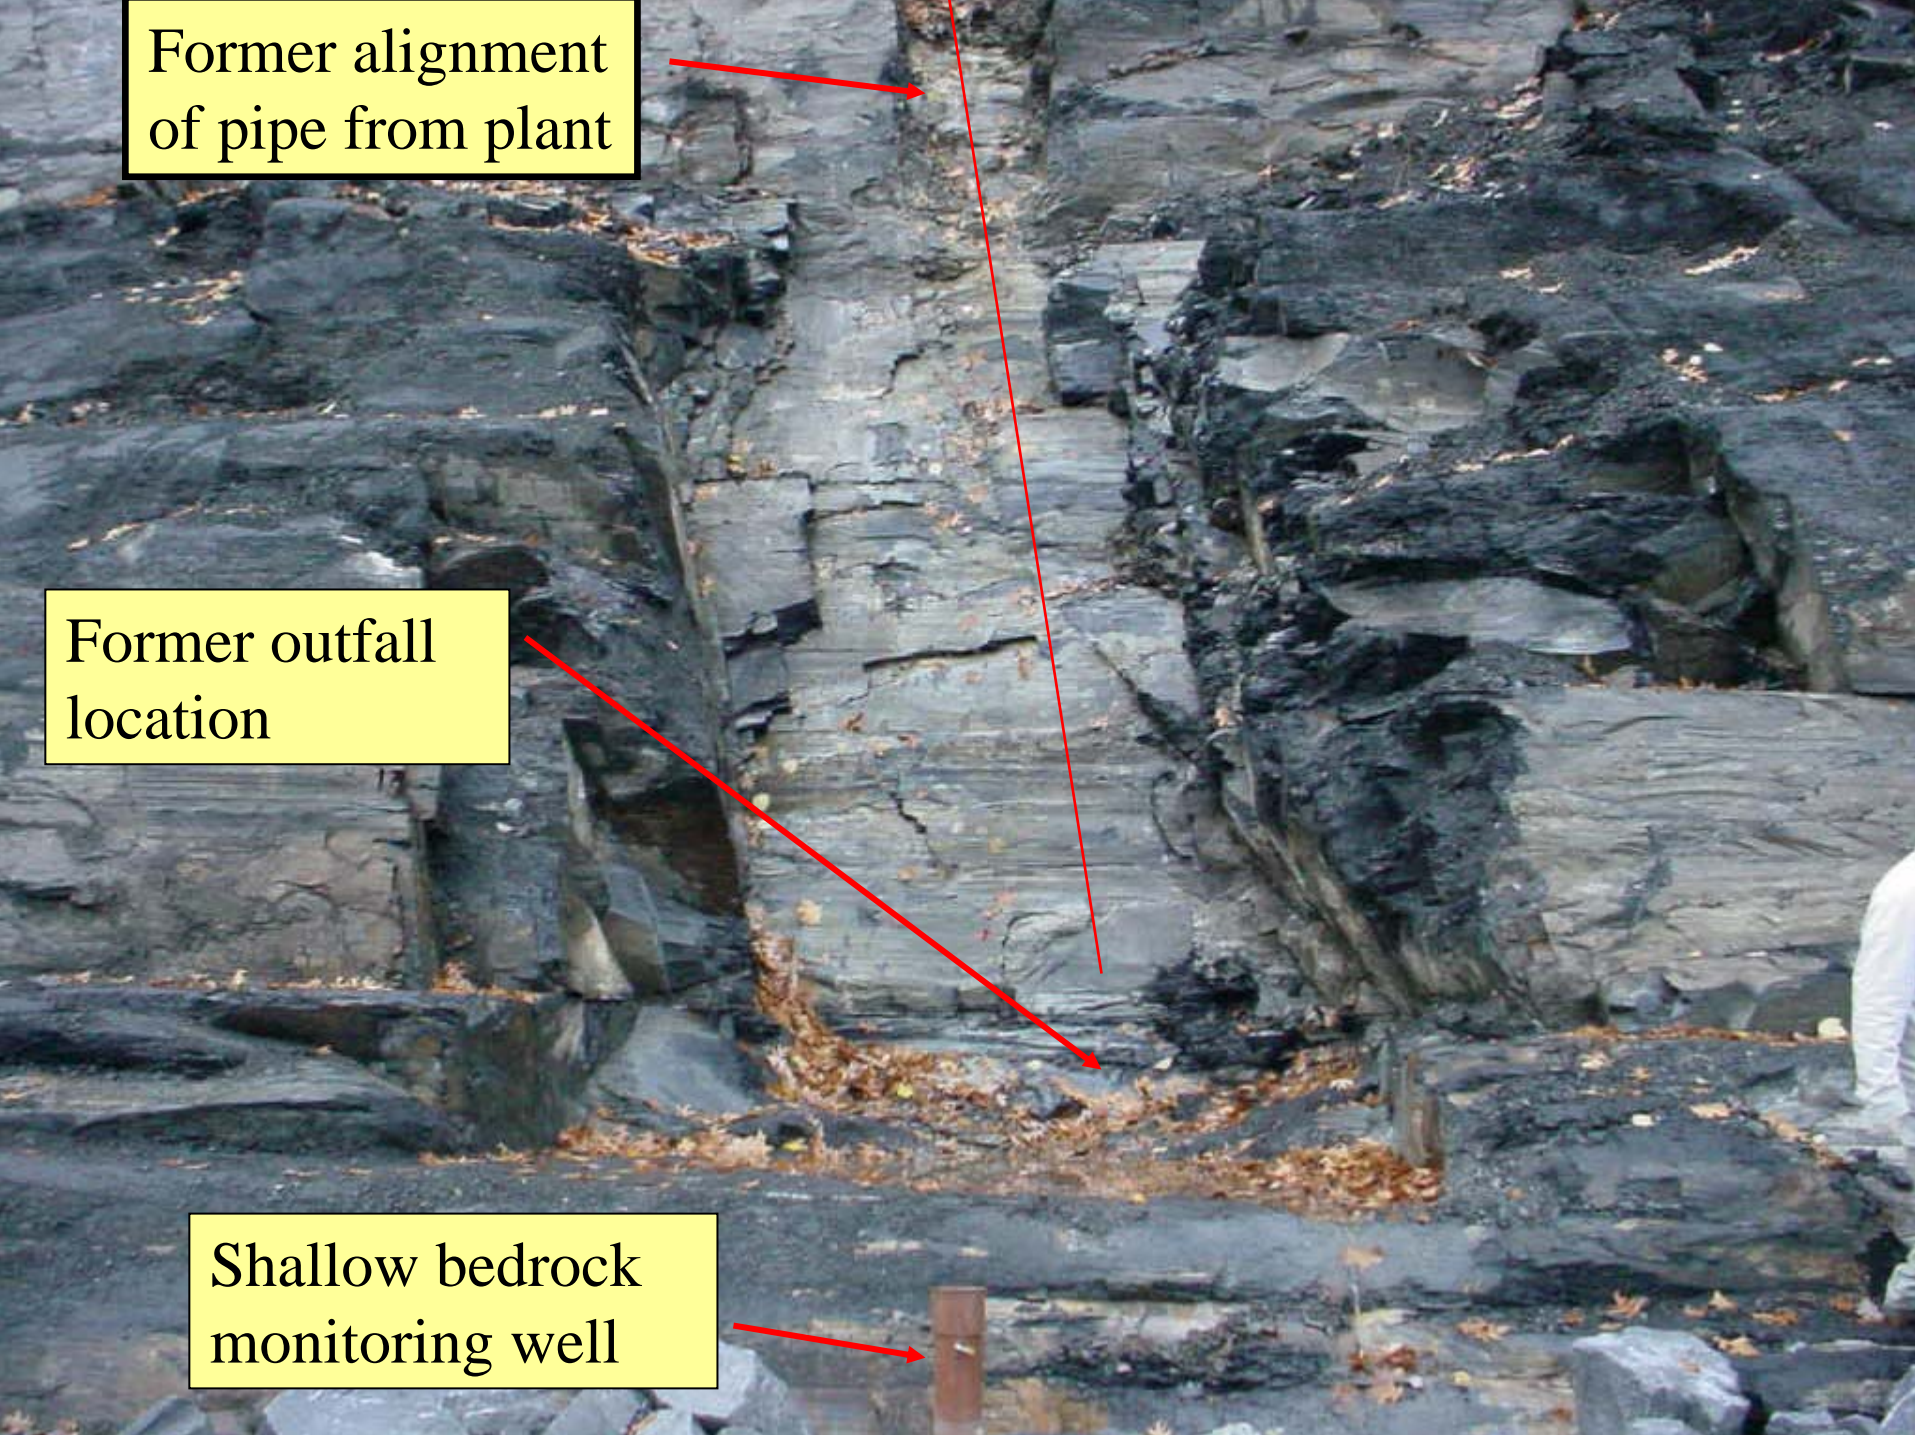
Shallow bedrock monitoring well ~
50 feet south of outfall location

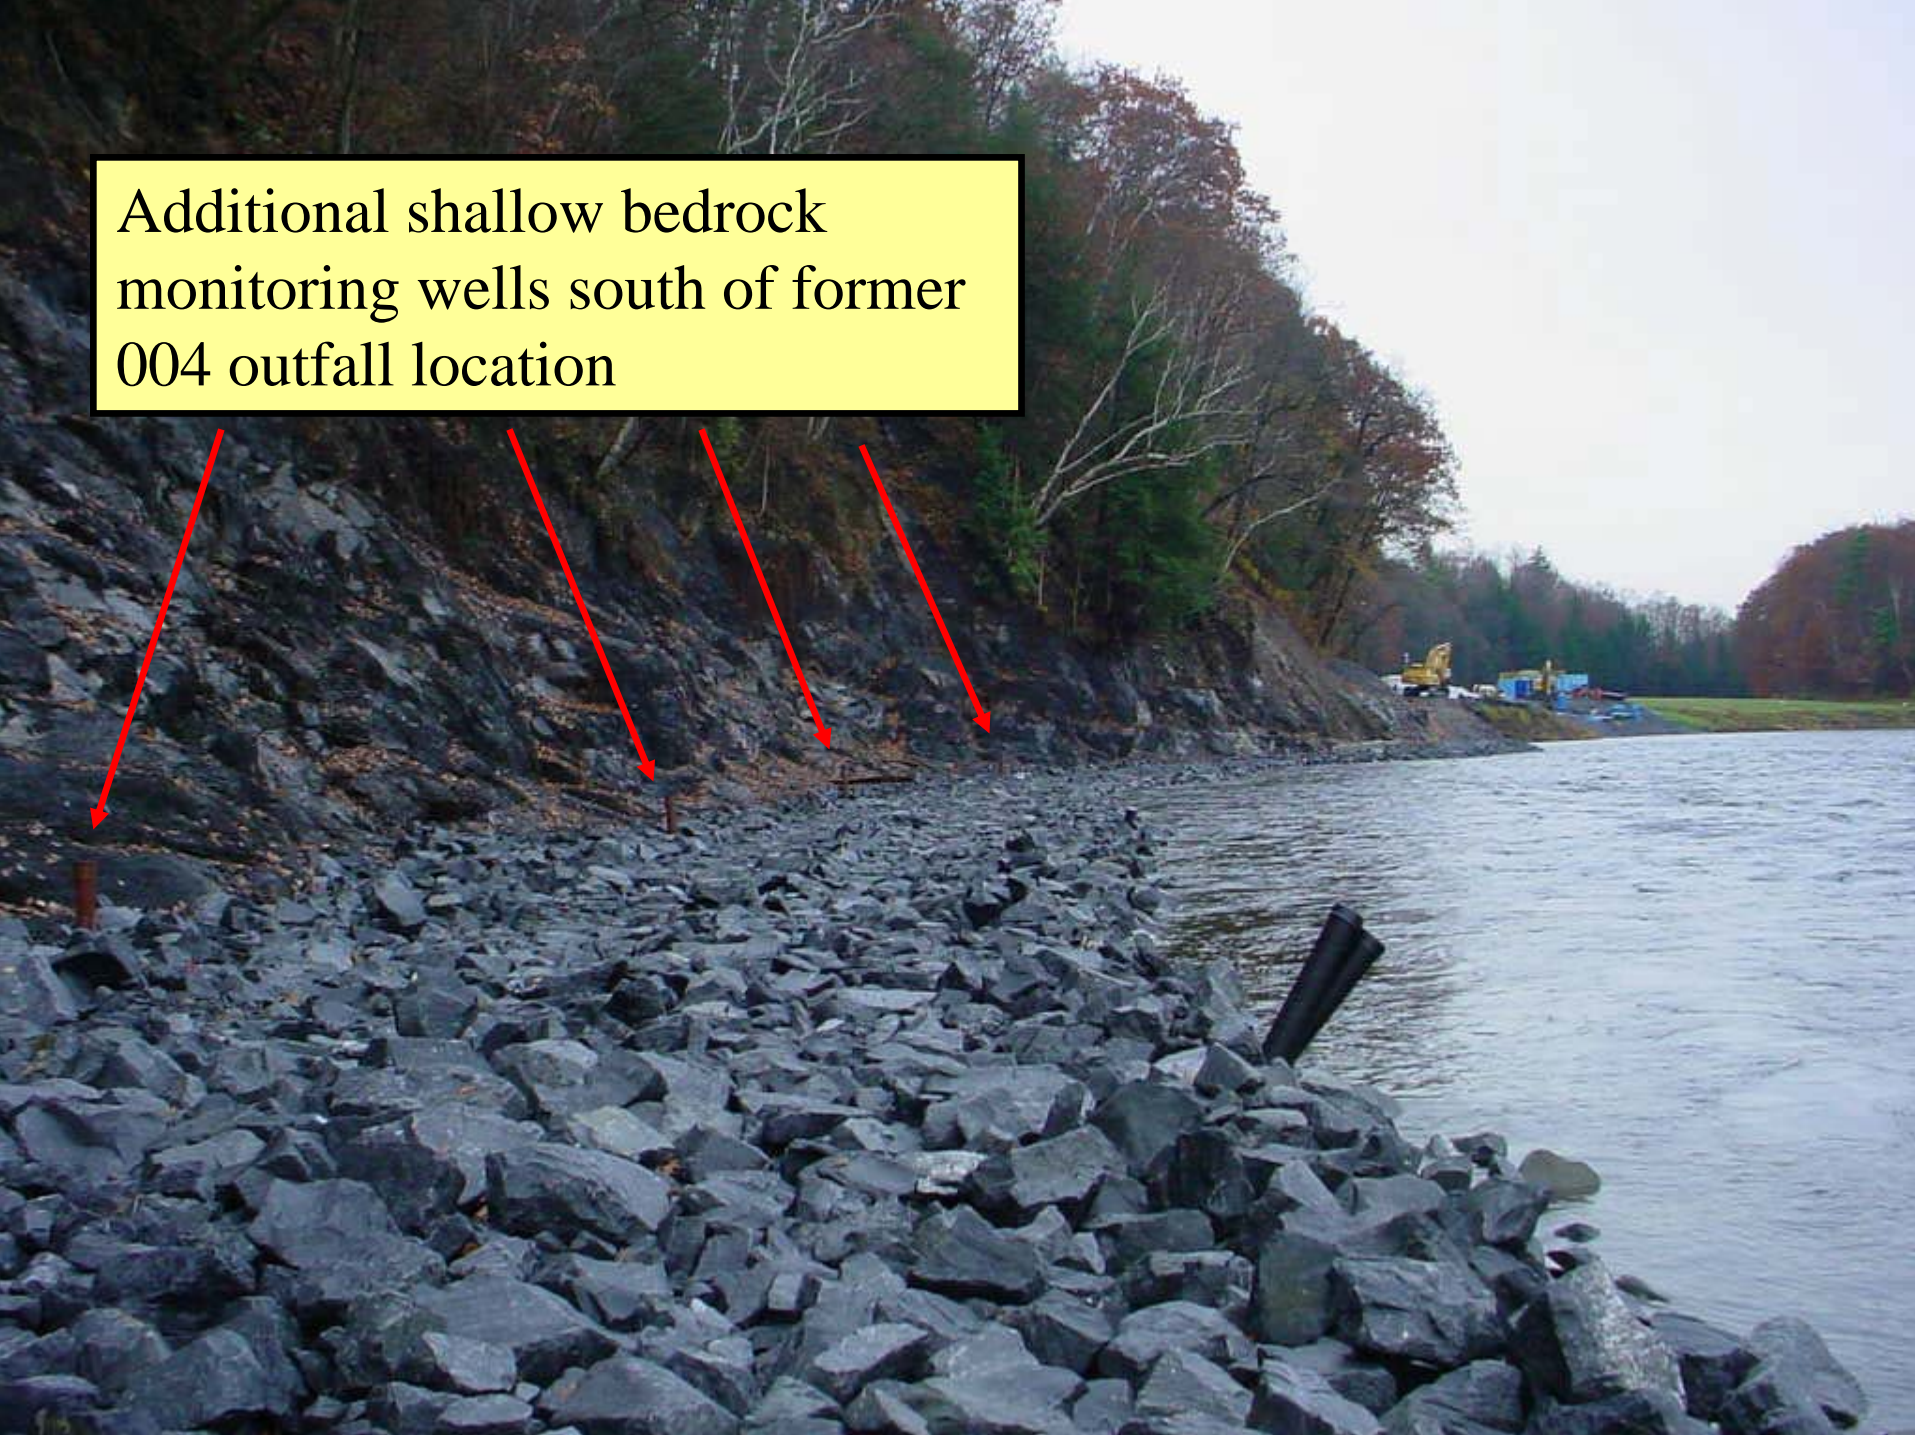
Additional shallow bedrock monitoring wells south of former 004 outfall location

Sample Results – June 2004

MW 01: 86,200 ug/l

MW 02: 70.3 ug/l

MW 03: 85.2 ug/l

MW 04: 0.250 ug/l

MW 05: 1.14 ug/l

MW 06: 2.20 ug/l

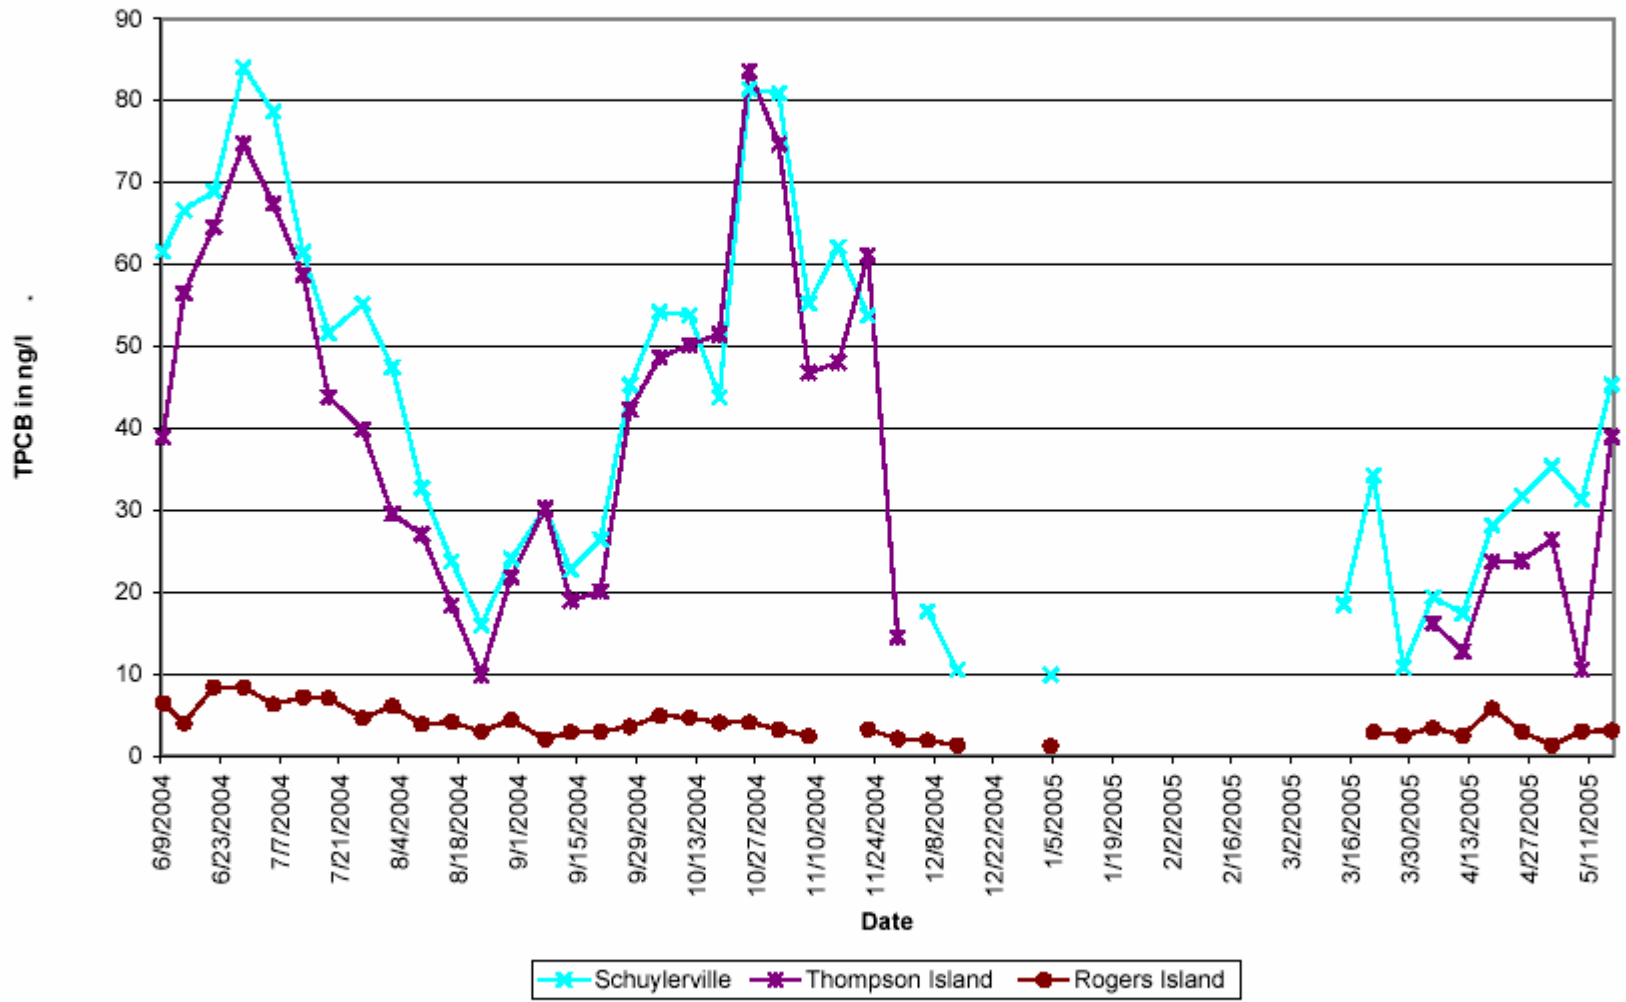
GE HR BMP Surface Water Total PCB

- GE Baseline Monitoring Program (BMP) – part of dredging project remedial design effort
- Sampling done in upper Hudson River at Bakers Falls, Rogers Island, Thompson Island Dam, Schuylerville, Stillwater, Waterford
