Upper Hudson River Surface Water and Fish Data Overview

Hudson River Community Advisory Group

PCBs in Upper Hudson River Fish

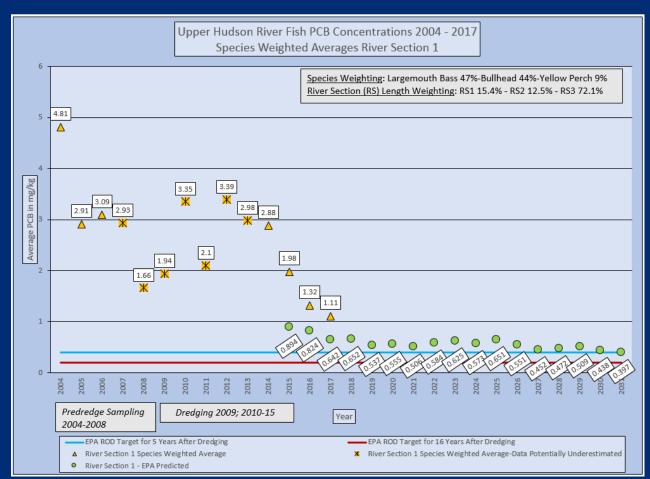
Reach 8 / River Section 1 Thompson Island Pool

Dredging at these sampling locations: 2009 (*TD1*), 2011 (*TD1-TD2*), 2012 (*TD3-TD4*) and 2013 (*TD5*).

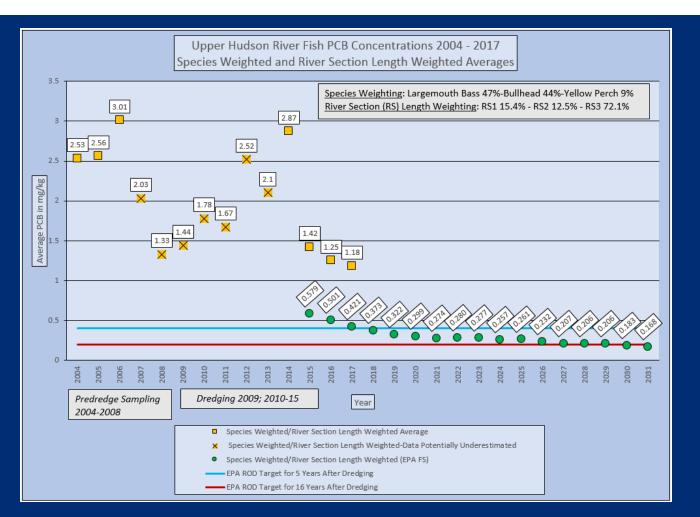
The overall weighted average fish PCB concentration is ~ 3X the target to be reached in 2020.

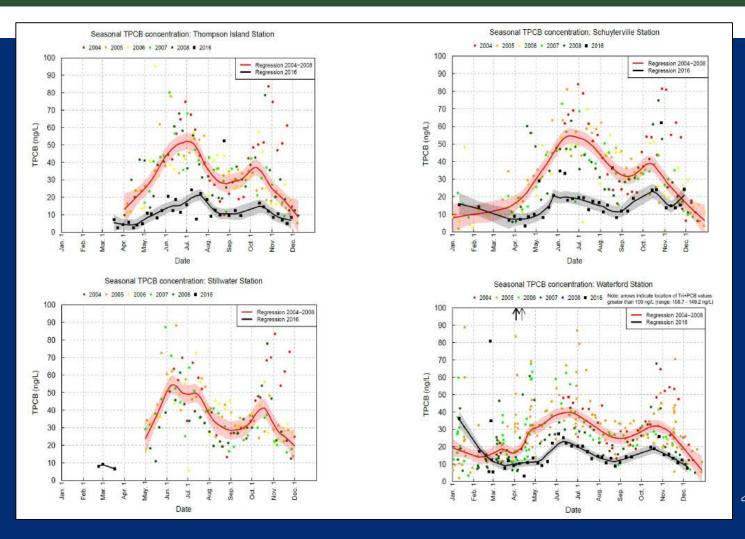
Figure A1-8 from EPA's "Second Five Year Review Report", Appendix 1

Total PCB in surface water - 2016 vs baseline

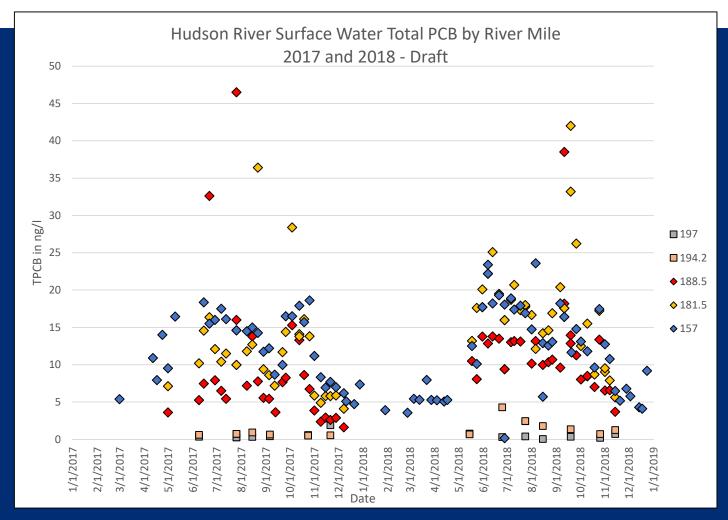
Surface water data from GE Monthly Reports

Total PCB by River Mile -2017 and 2018

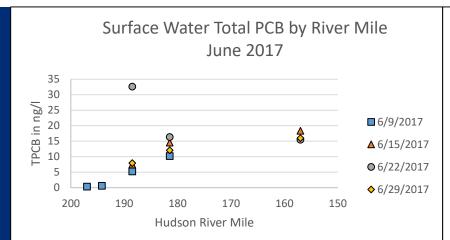
Surface Water Total PCB Mass Flux by River

- GE's data set PCB concentrations at multiple locations
- USGS flow data Fort Edward, Thompson (Lock 5), and Lock 1 above Waterford
- Use flow rate and PCB concentration to calculate rate of PCB transport by surface water

(Flow rate) x (PCB conc.) x (units factor) = PCB mass flux rate)

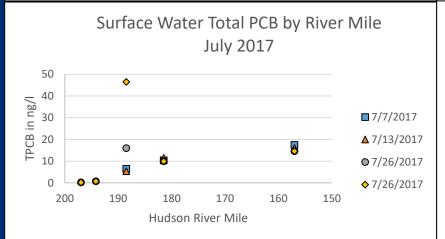
Surface Water Total PCB Mass Flux by River

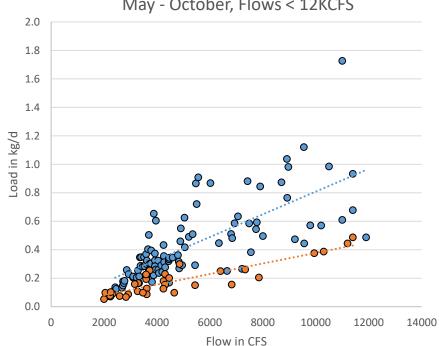
At Waterford, there may have been an overall reduction in PCB load, and a reduction in the degree to which increasing flow results in an increase in load.

(2016 and 2017 TPCB data from GE reports; flow from USGS)

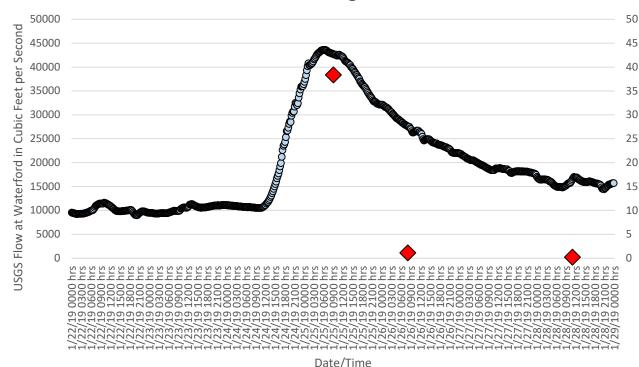
The peak postremedy high flow event occurred in January 2019.

Load calculated from a sample collected after the peak was ~38 kg/day Total PCB.

Calculated Total PCB Mass Flux Rate During January 2019 High Flow Event

USGS Flow @ Hudson River Near Waterford - GE Preliminary High Flow Monitoring Data

○ Flow at WF ◆ PCB Mass Flux Rate

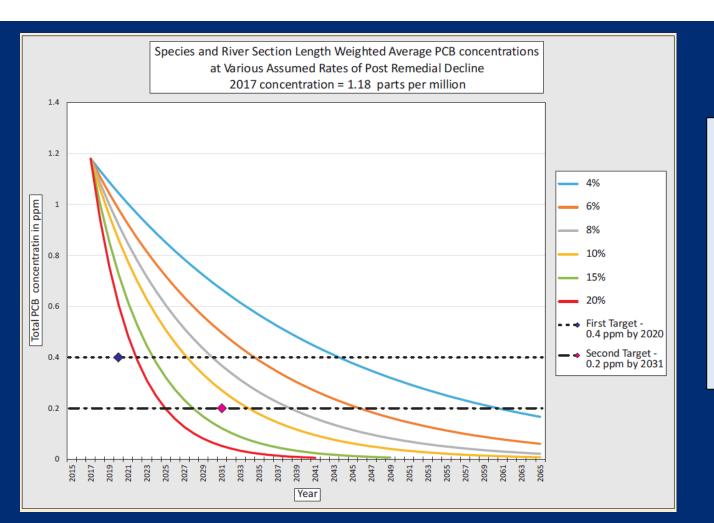
The rates of decline would need to exceed 20% per year to achieve the first target, and exceed 10% per year to achieve the second target.

To achieve the RAOs for the site, the rate of decline would need to exceed 20% per year to reach the five year target of 0.4 ppm by 2020, and exceed 10% per year to reach the 16 year target of 0.2 ppm by 2031.
