Hudson River PCBs Superfund Site Project Update

Community Advisory Group Meeting
Tuesday, May 14, 2019
Gideon Putnam Hotel

Project Update

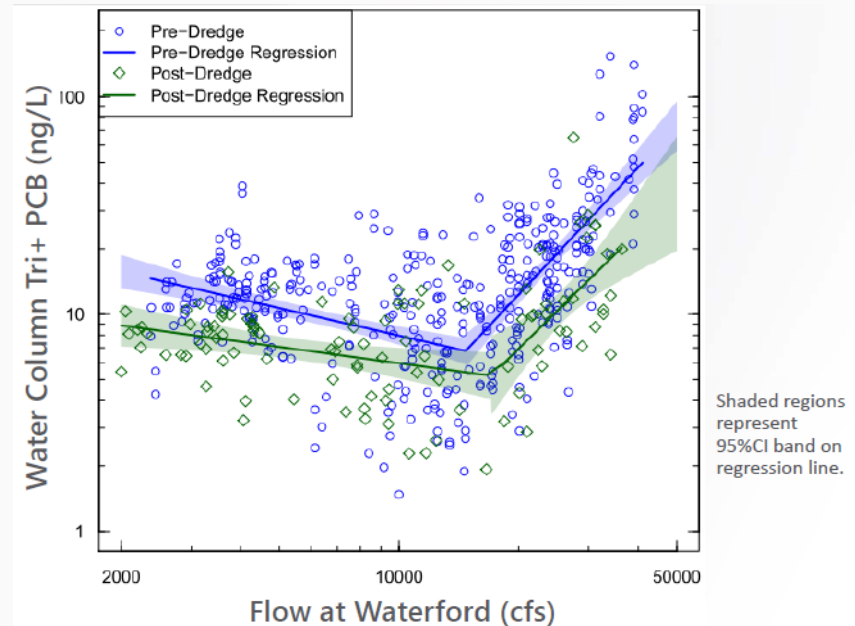
- Work plan is under development (ongoing discussions with NYSDEC and GE)
 - baseline/off-season monitoring continues
 - Details to be worked out include: additional locations and frequency
- Three locations sampled weekly (Thompson Island, Schuylerville, Waterford)
- Other locations monthly (Bakers Falls, Lower Hudson River)
- Sampling from bridges and by boat
- Samples analyzed for
 - Total suspended solids
 - PCBs using congener methods
- PCB loads to the Lower Hudson have decreased between 30 and 50% relative to baseline

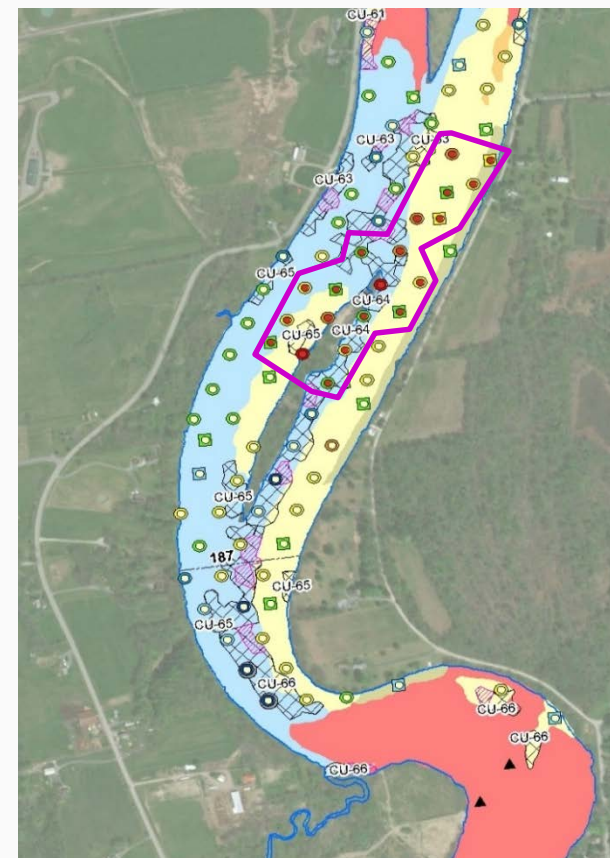
- Initial scope of work established in 2016
- Sediment samples to be collected every 5 Years – 2016, 2021, 2026, etc
- Program designed to detect 5% annual change in concentration after 10 years
 - Scope of work evaluated prior to each sampling event to confirm statistical power
 - Time is an important consideration in statistical power
- 2016/2017 EPA/NYSDEC Evaluation (>1,400 samples)
 - ~99% of samples are below ROD criteria in both dredged and non-dredged areas
 - 4 locations above ROD criteria
 - 8 locations above RS1 ROD criteria
 - Three localized “areas of interest” were identified - EPA will continue to track
 - As expected, some movement of sediment has occurred into dredged areas
 - Substantial reductions have occurred in surface sediment

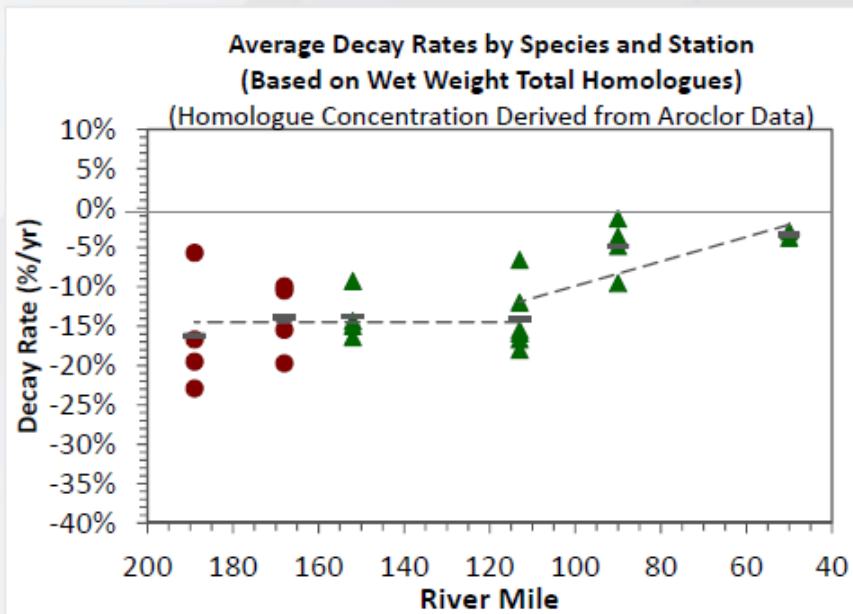
Wet Weight Basis

- In general fish tissue recovery rates decline with distance downstream in the Lower Hudson – some locations do not show a statistically significant recovery
- Data/information collection and supplemental studies necessary to evaluate next steps

● Upper River ▲ Lower River — Average Decay Rate

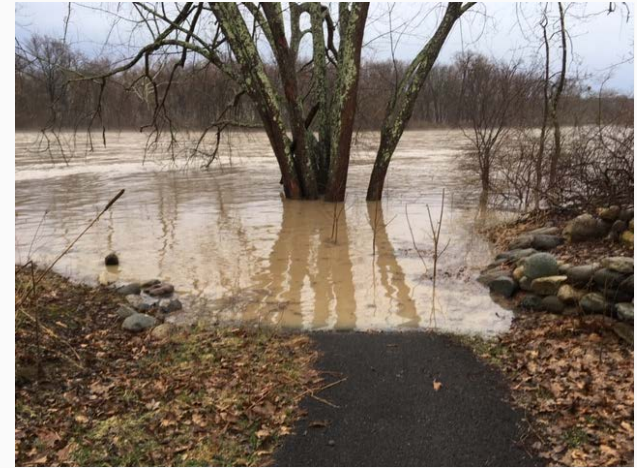
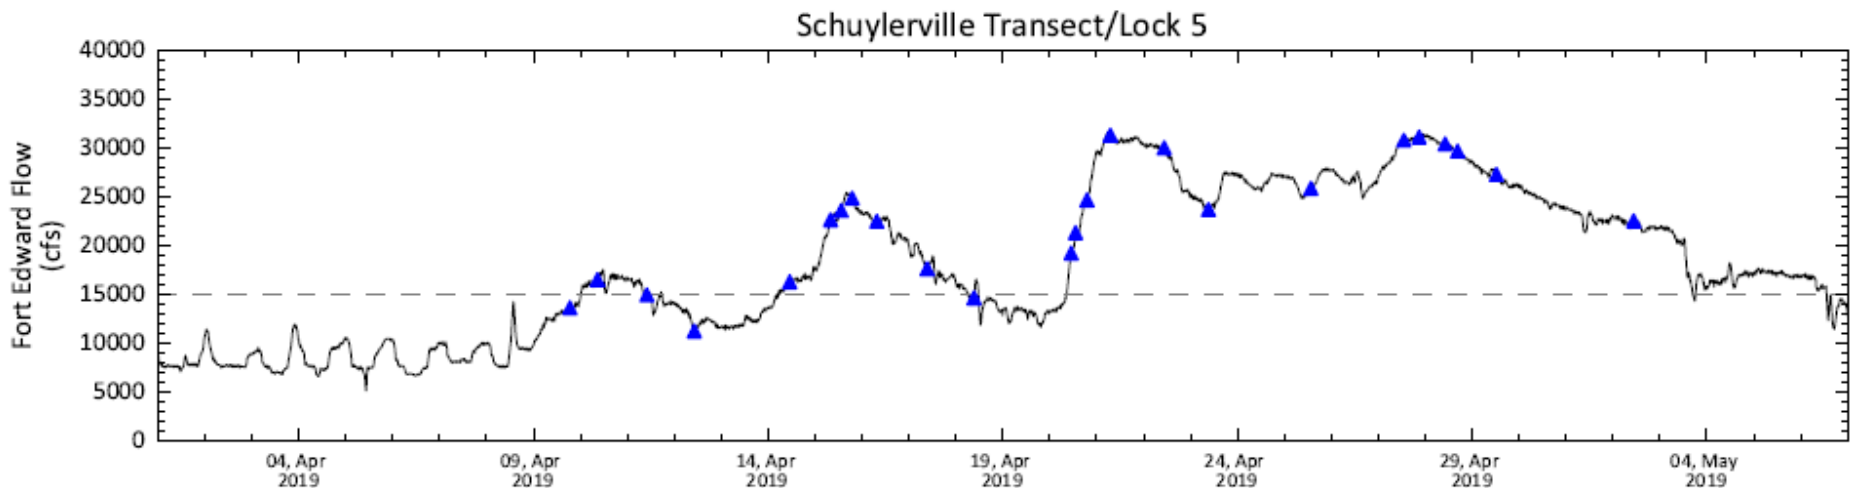
- Samples collected when River has high flows (15,000 cubic feet per second at Fort Edward or 22,500 at Waterford)
- Samples collected at Waterford and Schuylerville
- Samples collected to capture the rising limb to the high flow event and falling limb
- 2019 events: January, April – May
- High flow sampling will be included in OM&M work plan
 - Details to be worked out include additional locations and frequency
