Hudson River Floodplains Update

Community Advisory Group Meeting
Thursday, November 16 2017
1-4 pm
Saratoga Town Hall

Hudson River Floodplain – Remedial Investigation (RI)

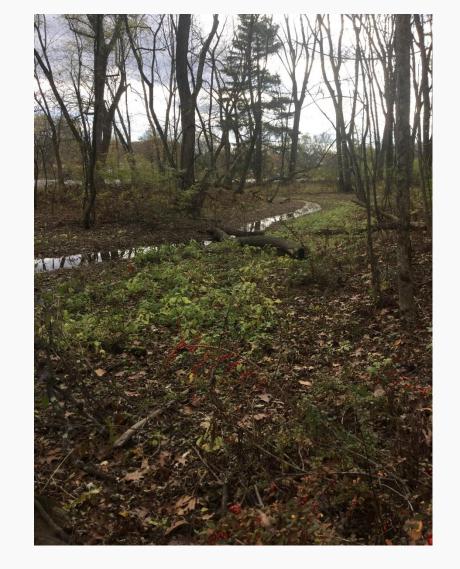
Floodplain Soil Sampling

- Sampling began in early October 2017 and is ongoing
- 340 sample locations targeted on over 150 properties
 - Number of samples determined by statistical analysis (data gap analysis)
- Property access is ongoing
 - Large effort that takes time
- Alternate sample locations sometimes needed
- Sample results will be provided directly to property owners (letter with map showing results)

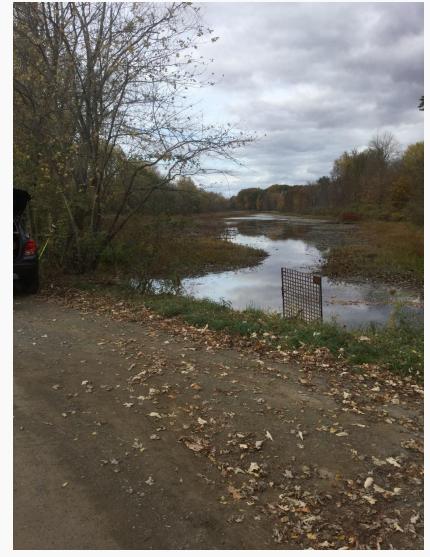
- Standing Water Areas (SWA) being evaluated as part of the RI
- SWA are areas of the floodplain, excluding tributaries, that typically have water year-round
 - Old Champlain Canal is a SWA
- Field verification was done in 2015 and 2016
- 62 SWAs identified on 76 properties
- Sampling began late October 2017
 - Collection of sediment and surface water samples
- Important data related to ecological risk assessment

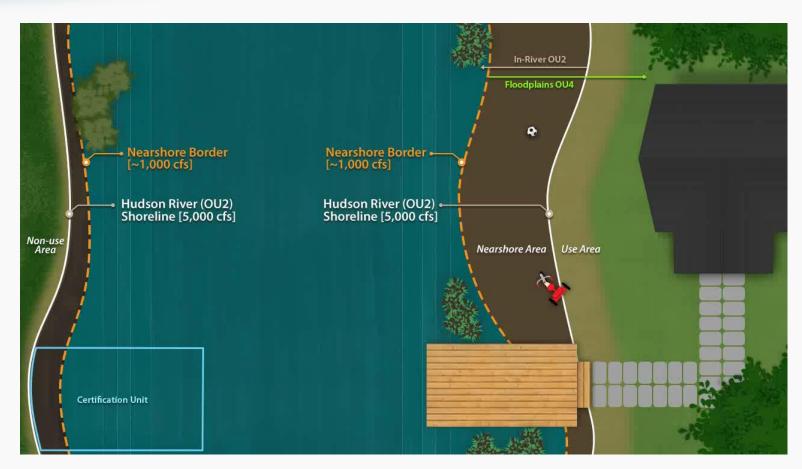
Near Shore Area

- Near shore being evaluated as part of RI
 - Area between the typical low water level of the river and the "normal" water level
 - Often exposed during summer months
- Focus is on human use areas

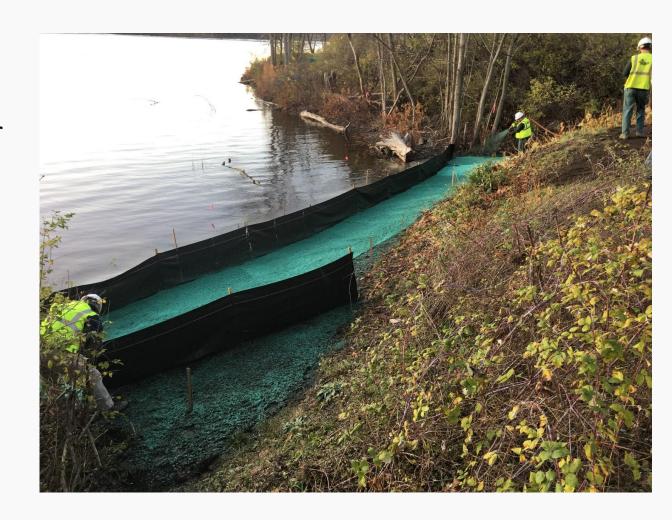
Short Term Response Actions (STRA)

- STRAs are protective measures implemented when soil concentrations of PCBs are found to generally exceed 10 ppm.
 - Typically consist of a protective soil cover
 - May be signage if limited human use
 - 66 STRAs implemented to date
- Inspected and repaired annually
- 2017 GE installed one additional soil cover at a residential property
- As data is collected other STRAs may be implemented
- These actions are considered temporary
