Hudson River
PCBs SUPERFUND SITE

Community Advisory Group Meeting

March 30, 2010

Assessment of Phase 1 Underway

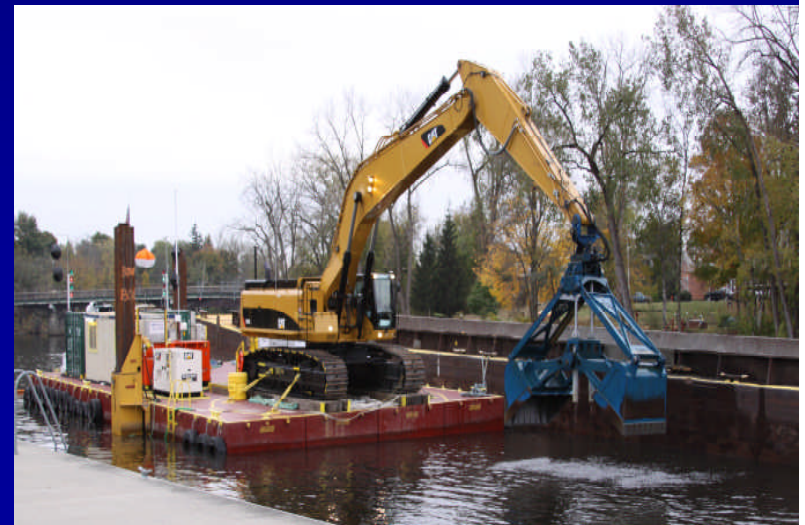
Phase 1 Challenges (Overview)

- **Depth of Contamination (DoC) consistently underestimated**
- **Extent of wood debris**
- **NAPL releases**
- **Higher than normal flows**
- **Limitations on scow unloading**

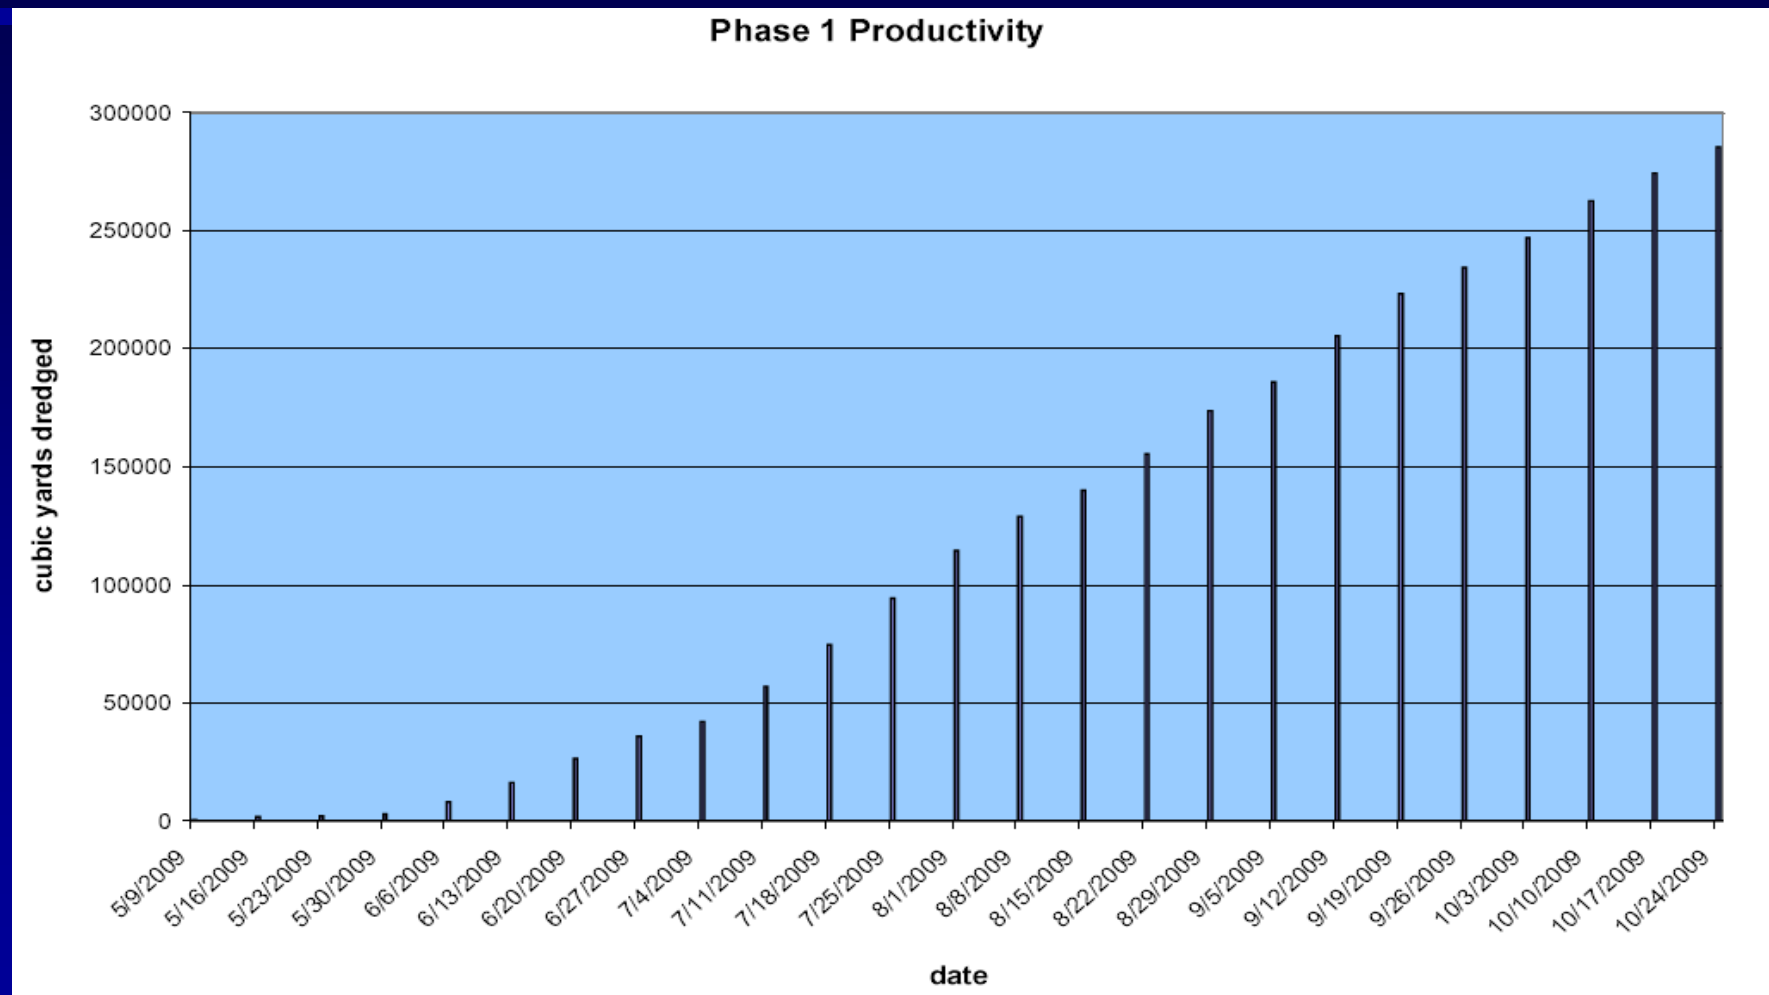
Phase 1: Cubic Yards Dredged

- Targeted 265,000 cubic yards (cy) of sediment from 88 acres in Thompson Island Pool
- Actual volume removed, 283,000 cy from 48 acres
- 1.5 times more PCB mass removed than expected
 - About the same mass as estimated in design, but from fewer acres

Both the sediment volume and the PCB mass removed in Phase 1 met or exceeded the amounts initially estimated for Phase 1

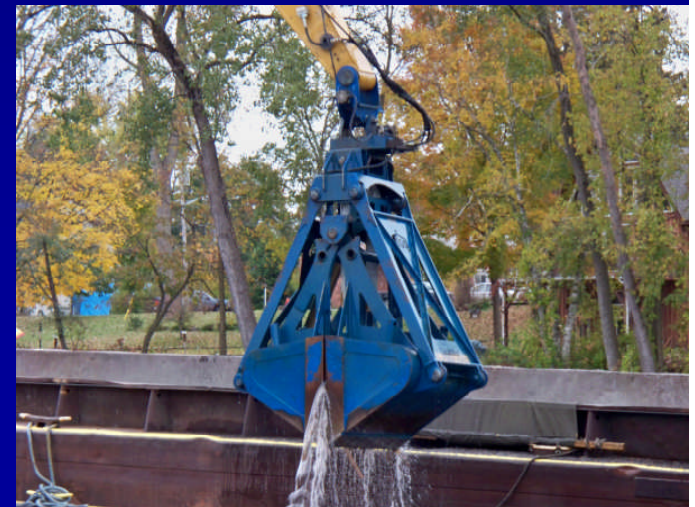
PCB-oil is a potentially important vector for PCB release

(Sheens observed during dredging)

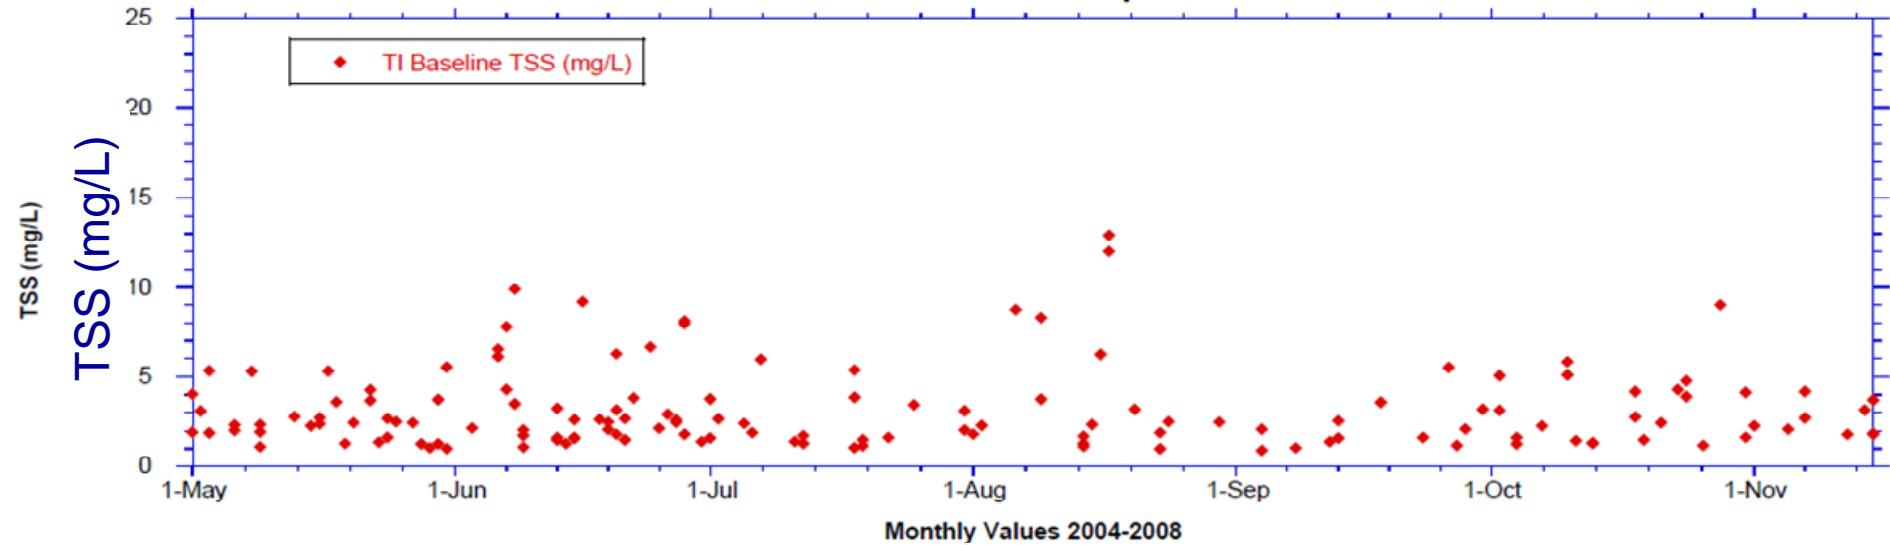
Baseline TSS at Thompson Island

Little significant release of solids during dredging

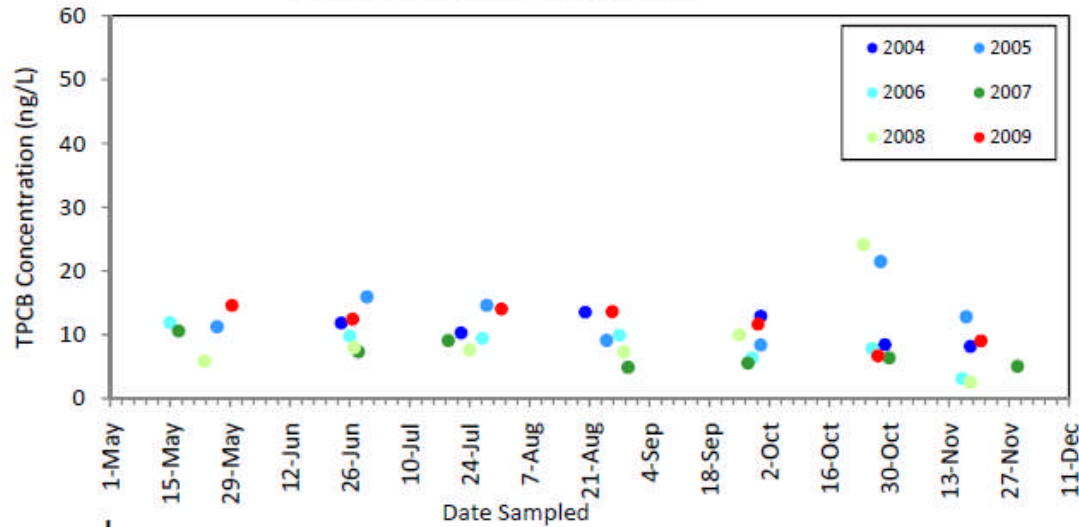
Tri+ PCB Water Coulmn Concentration atAlbany
GE BMP and 2009 Phase 1 Data

There were no observable impacts of dredging to Tri+ PCB water column concentrations downstream of Waterford

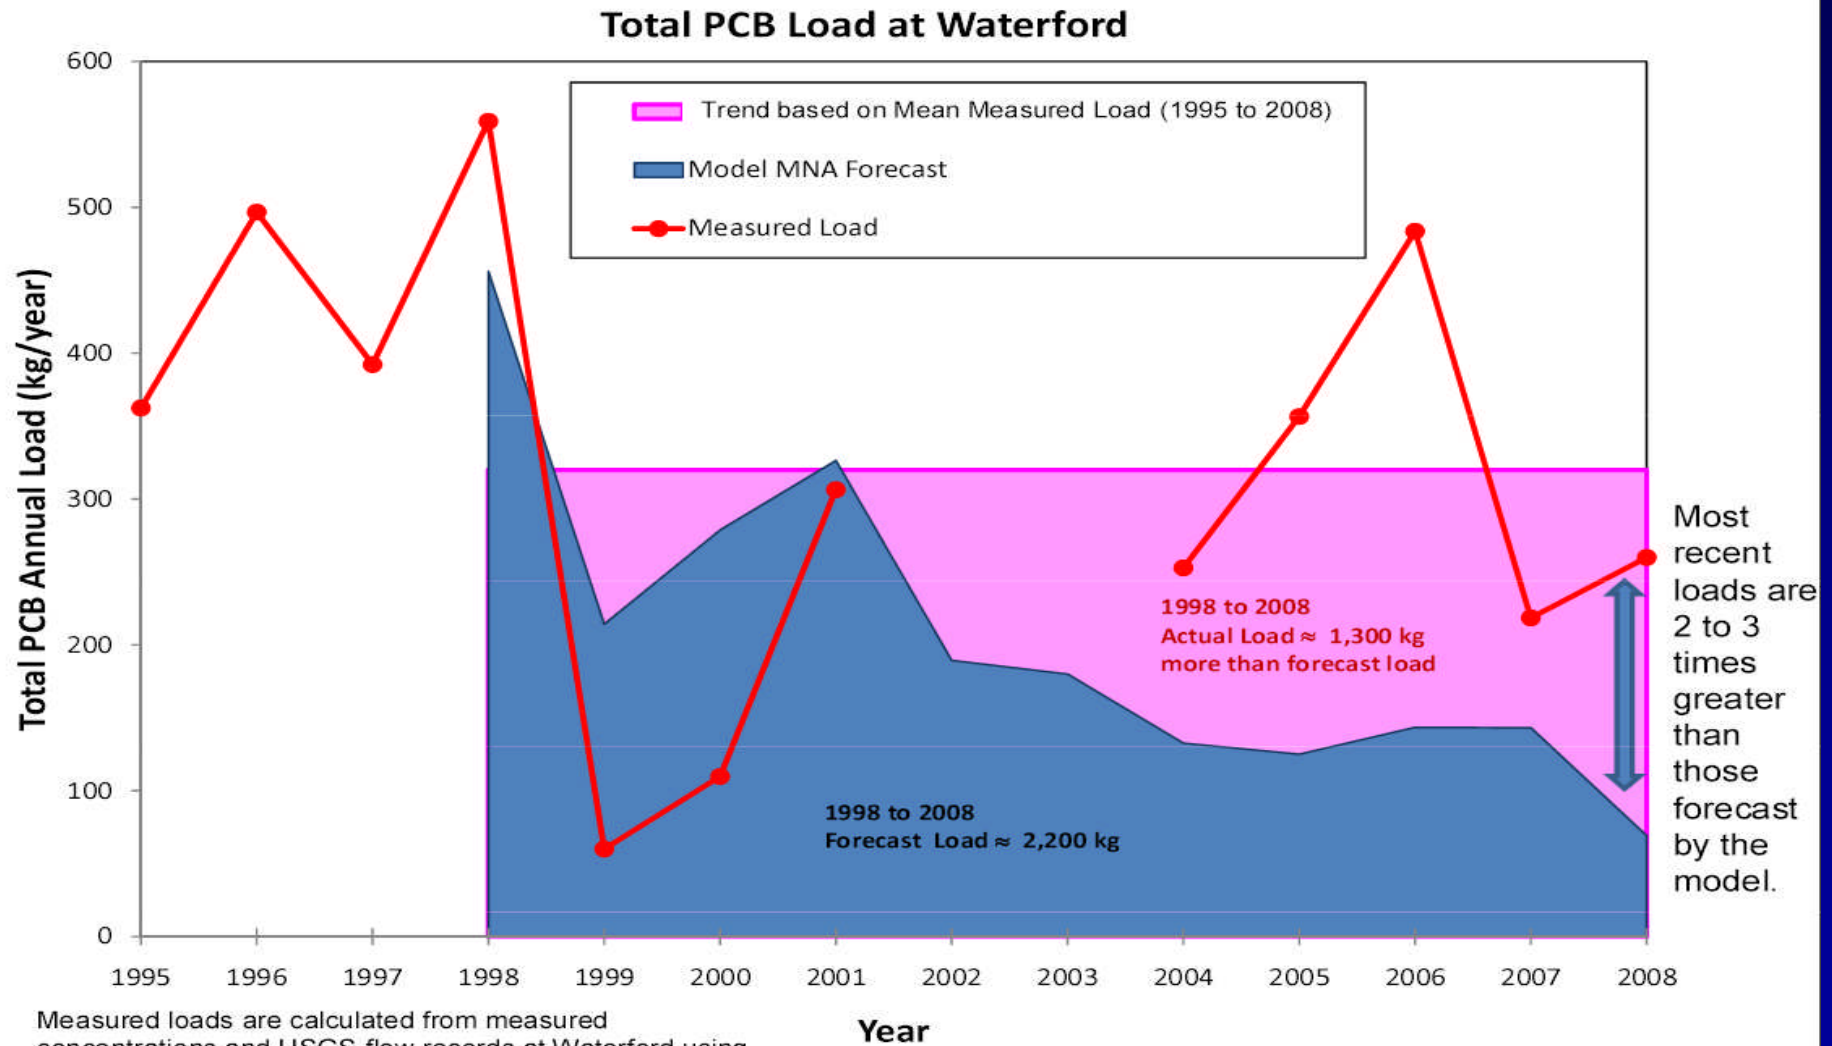
Total PCB Load at Waterford 1995-2008

Measured loads are calculated from measured concentrations and USGS flow records at Waterford using Biele's estimator.

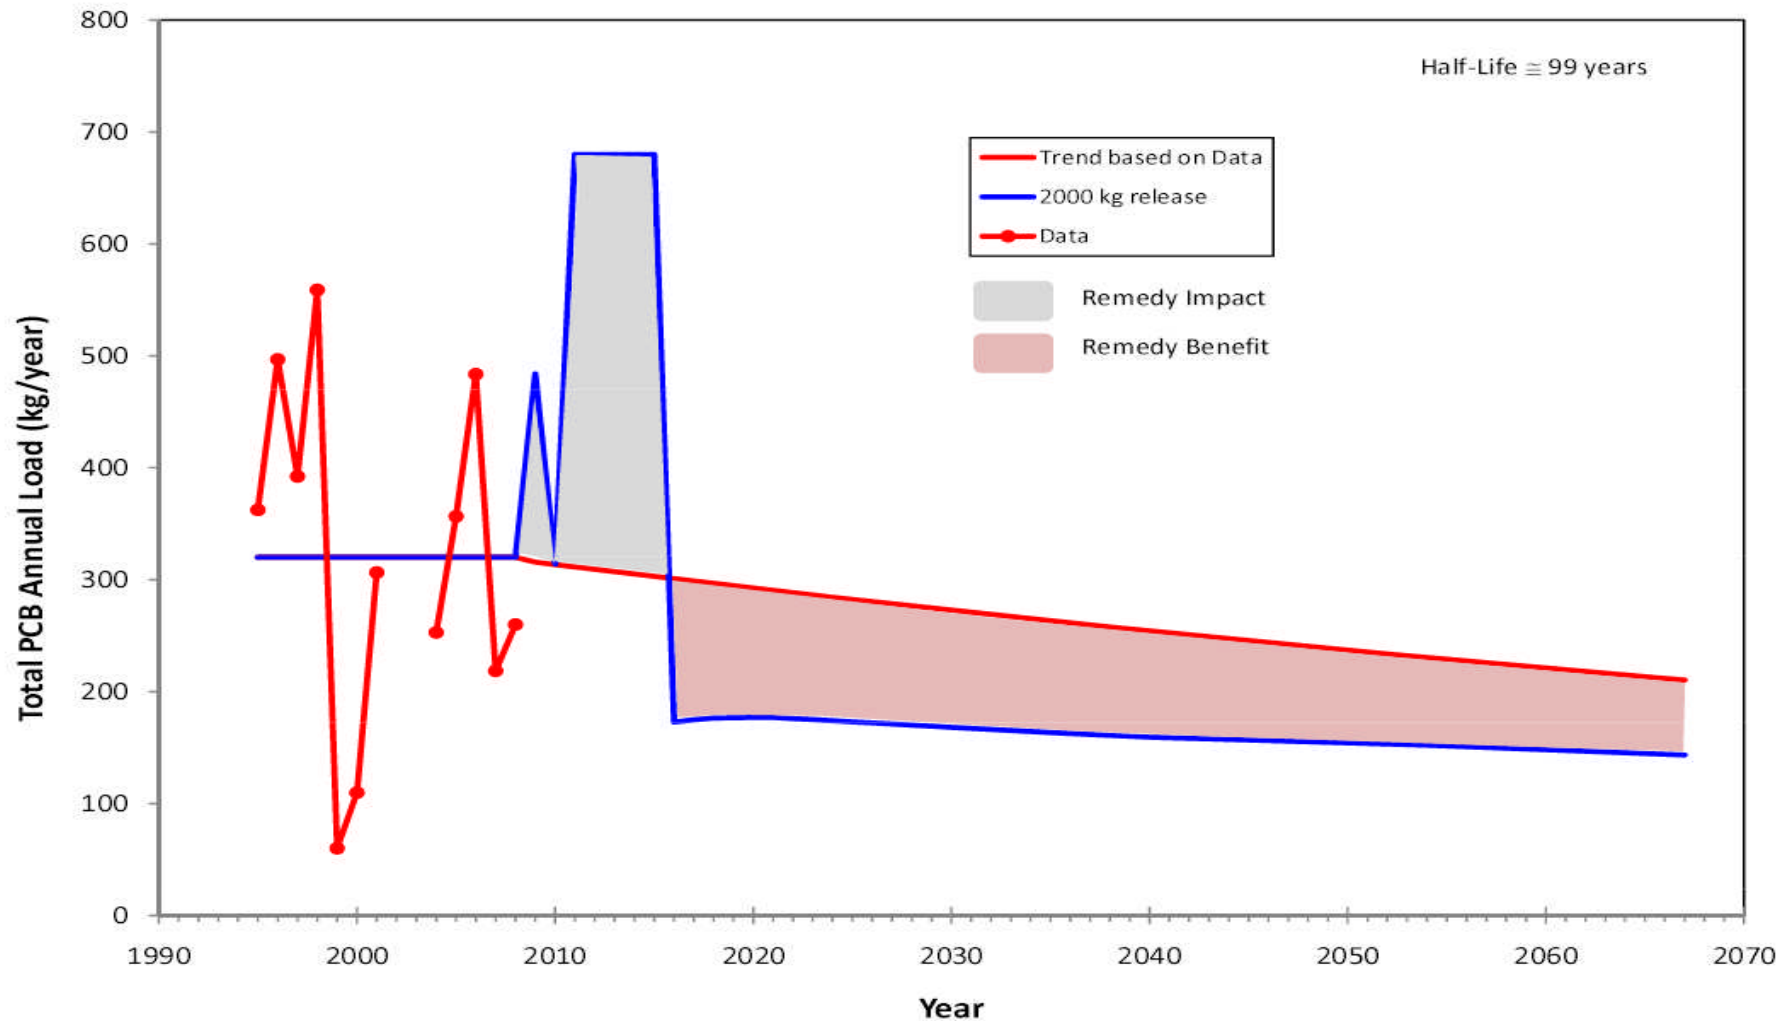
Total PCB Annual Load at Waterford

The load at Waterford did not exceed 1% of the mass removed

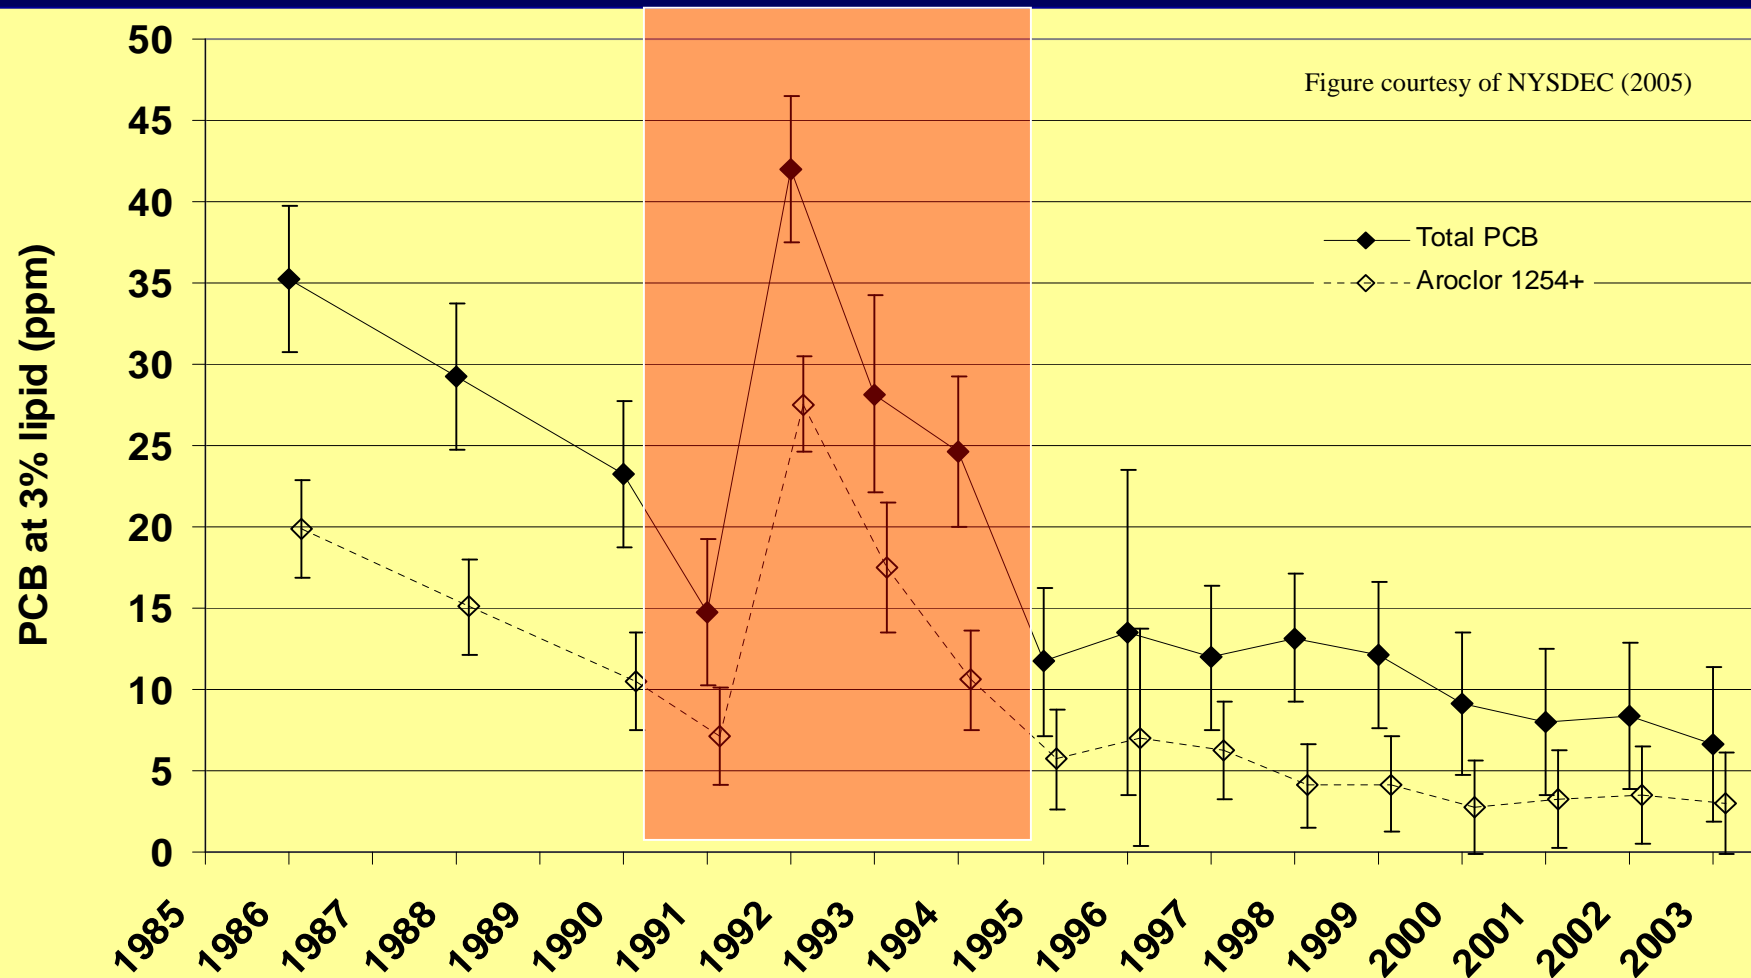
Brown Bullhead - Thompson Island at Griffin Island (RS-1; RM 189)

Spikes in tissue concentrations linked to exposure events have been observed to recover

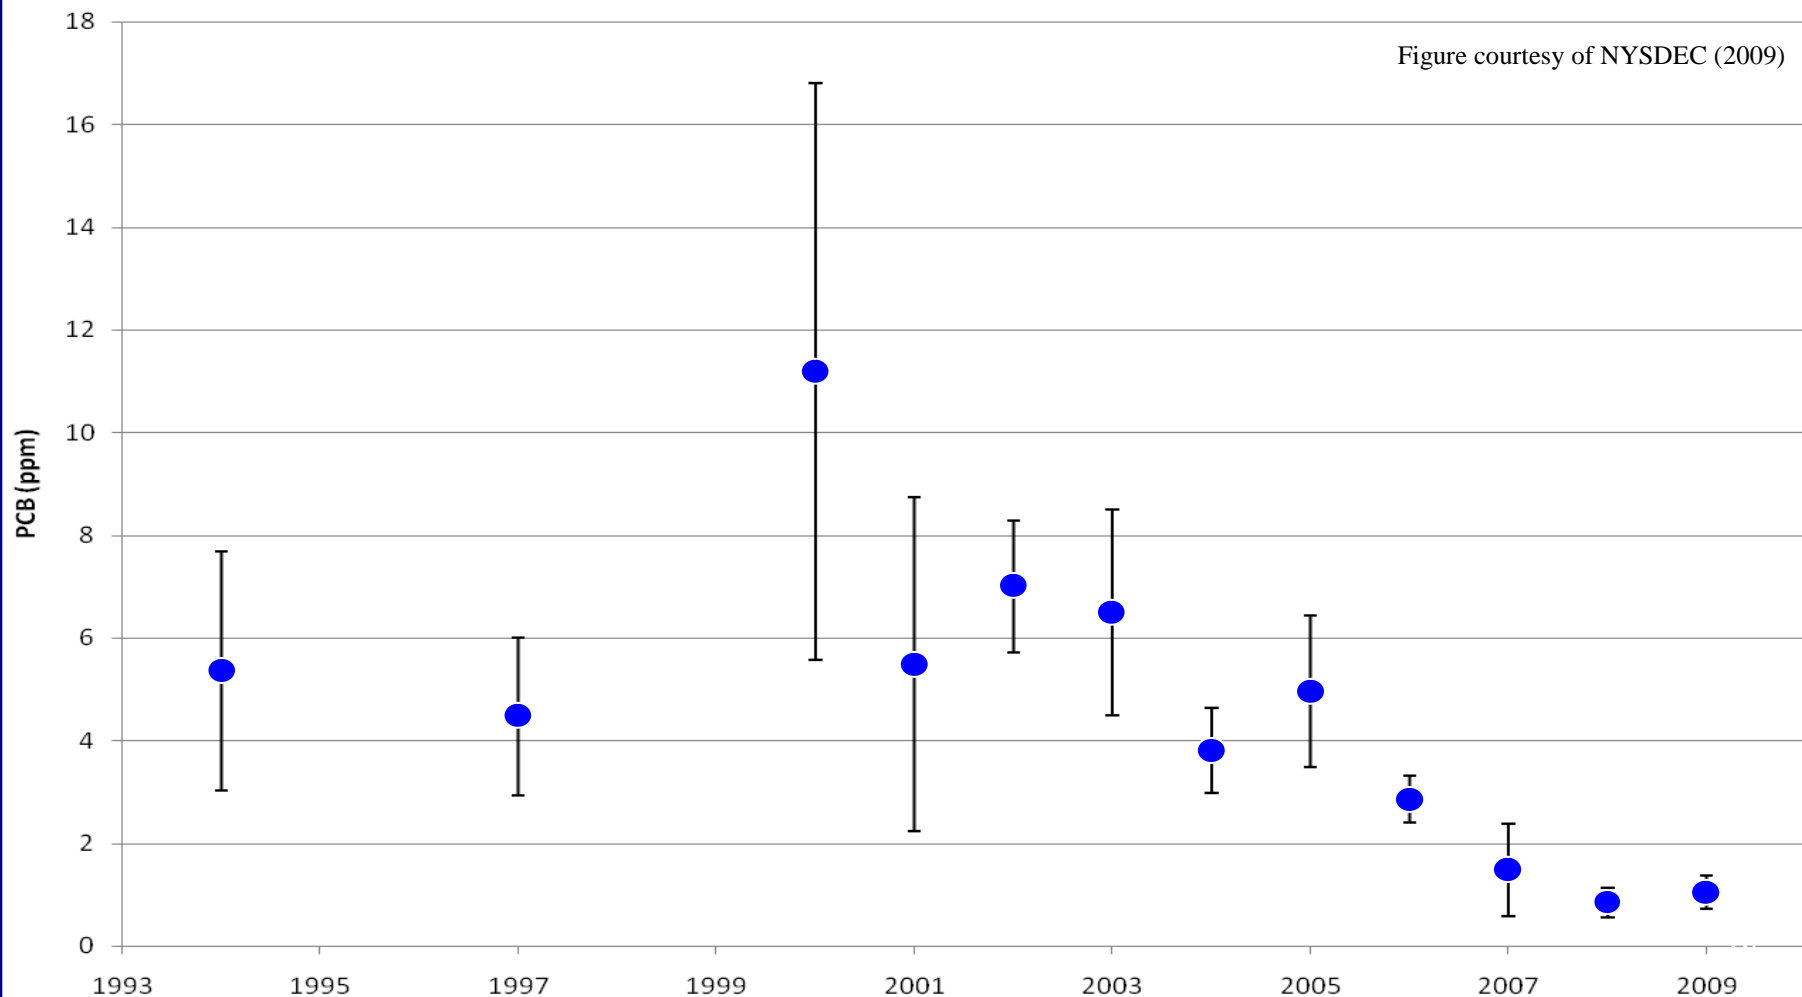
Cumberland Bay Site, Plattsburgh, NY – Yellow Perch, Wilcox Dock

Spikes in tissue concentrations linked to dredging events have been observed to recover

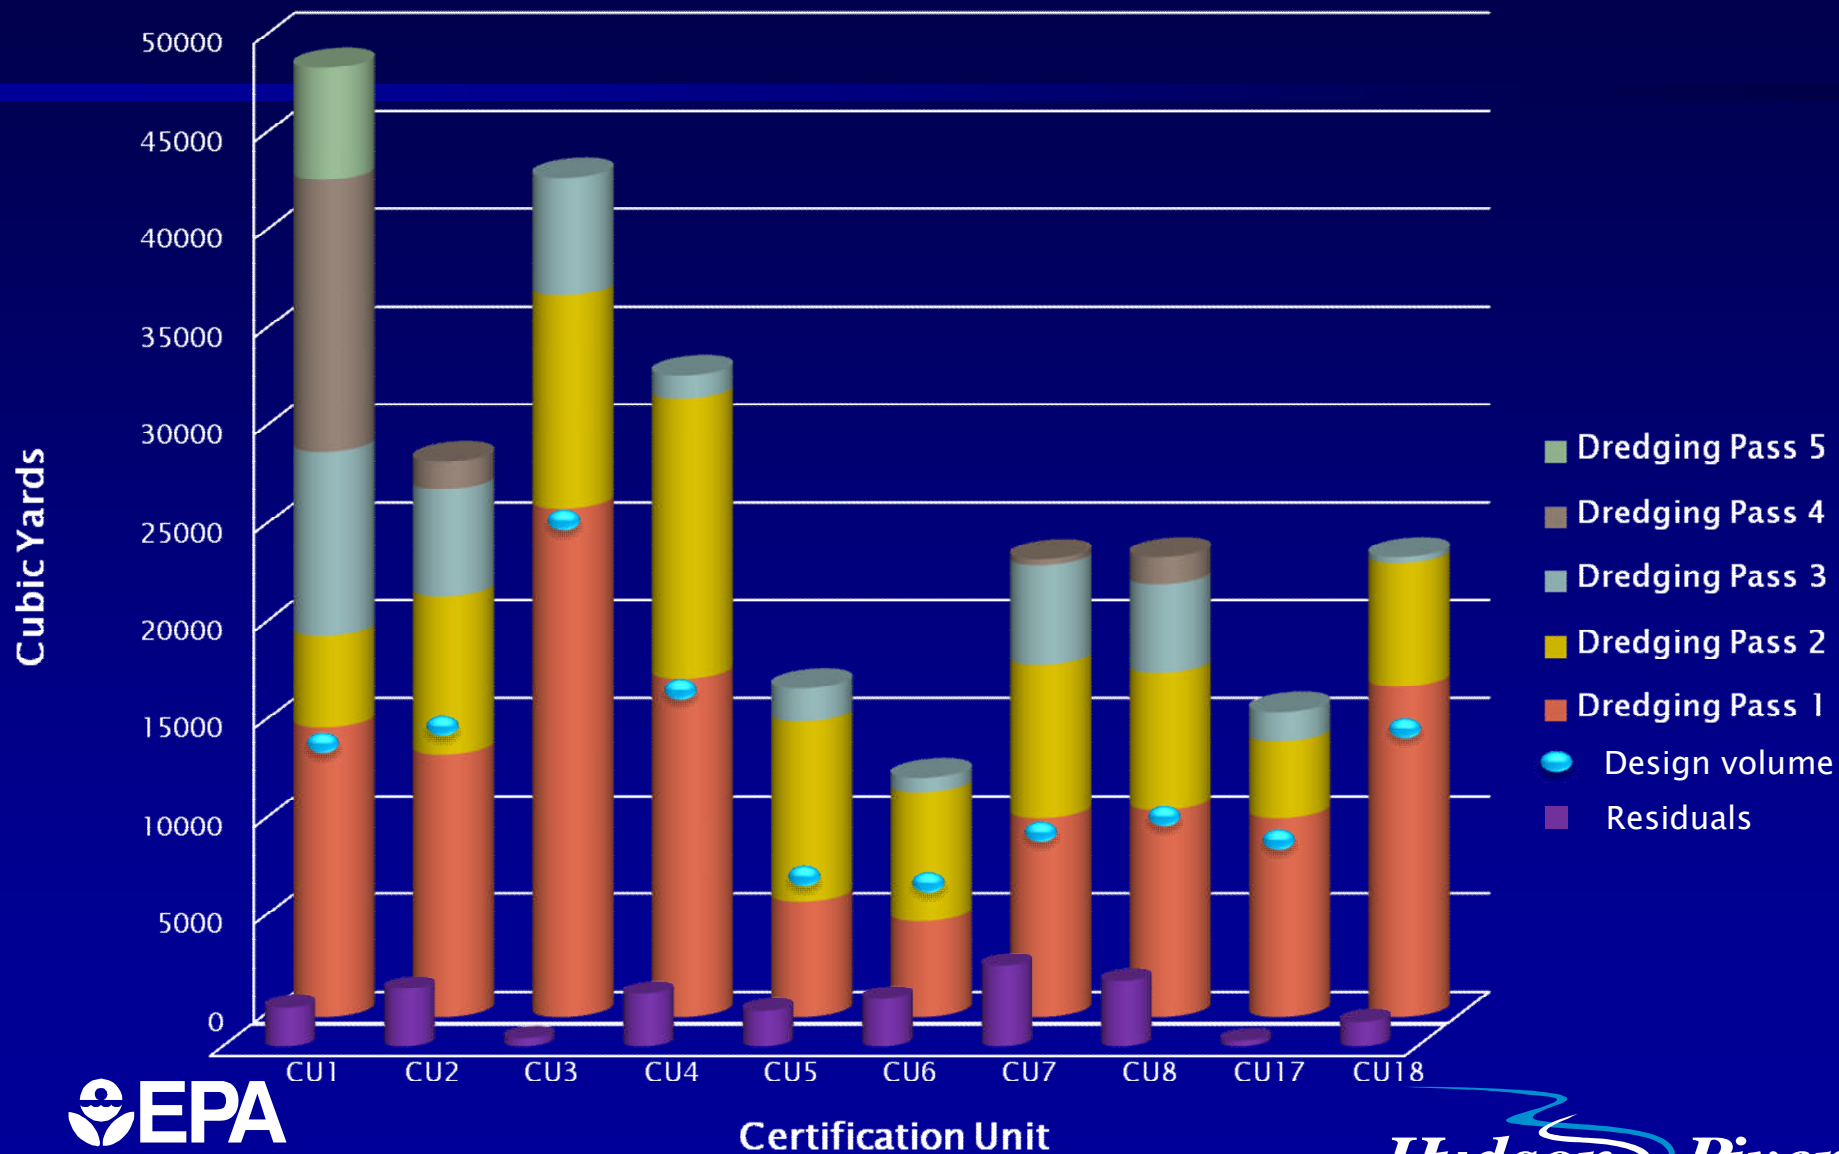
Sediment Volume Removed By CU

Impact of inaccurate DoC resulted in removing only 49% of the actual inventory by volume and only 58% of actual inventory by mass in the first dredge pass

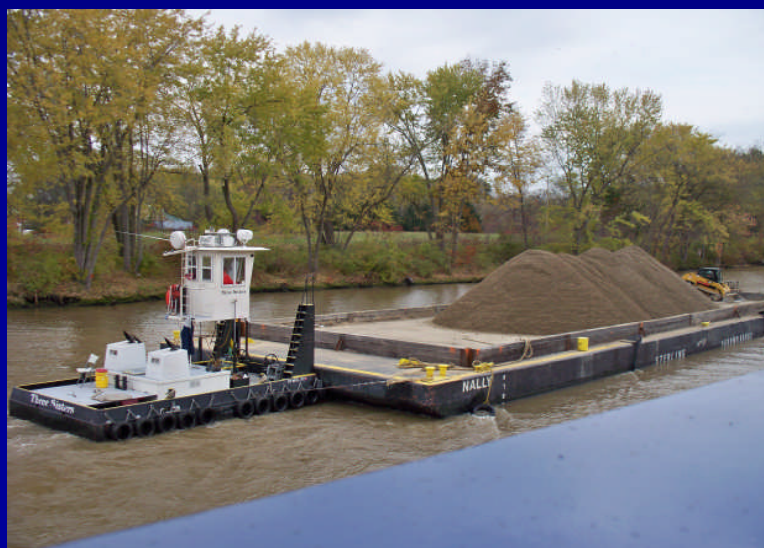
Backfilling/Capping

- Substantial removal of inventory confirmed in all CUs
- In some areas, uneven bedrock and boulders hindered sediment removal
- Where inventory left in place, engineered caps were constructed to isolate the remaining inventory (per the requirements of the standard)

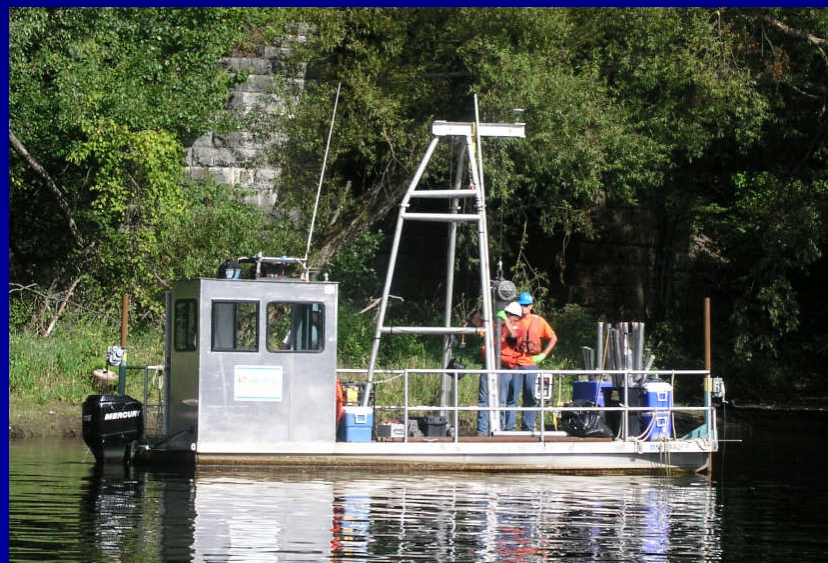
Collection of Post Dredging Cores

- When design depth is reached, collect post dredging cores
 - Analyze full length of 24” core to identify depth of contamination
 - Achieve at least two successive 6-in segments below 1 mg/kg at the bottom

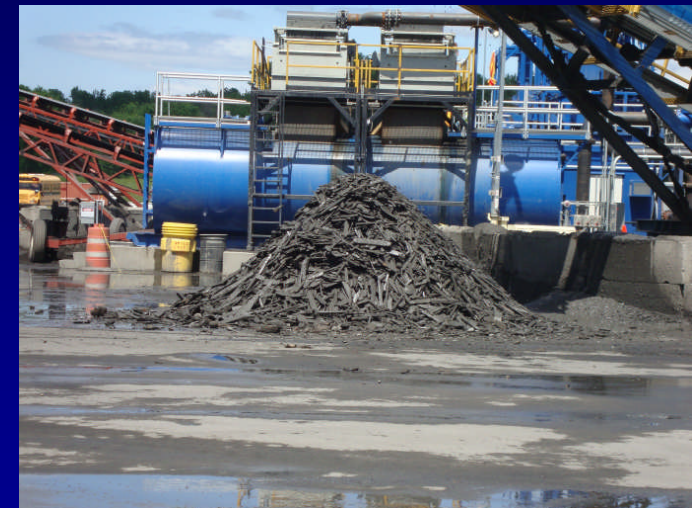
The production rate was largely limited by an inability to unload scows (barges) arriving at the dewatering site at the rate that they were filled by the dredges

Scow Unloading Capacity

- Unloader Operated 7 Days/Week
- Max. Volume Unloaded: 17,921 CY/Week
- Avg. Volume Required for Phase 2: 22,000 CY/Week
- Max. Volume Required for Phase 2: ~25,000 CY/Week

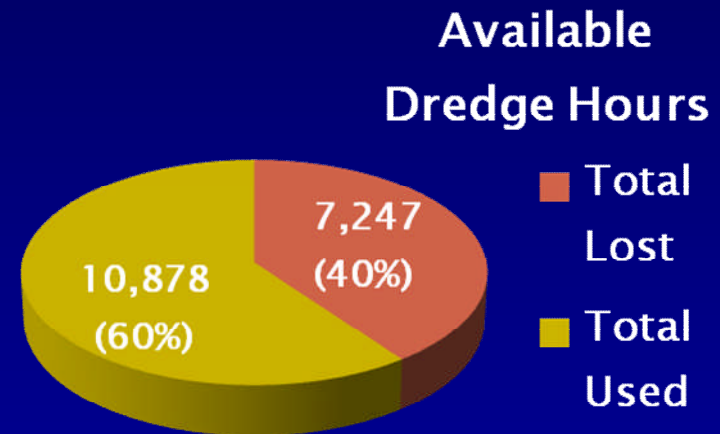
Lost Dredging Time

PCB resuspension resulted in a loss of only approx. 6% (1,000hrs) of available dredging time during Phase 1

**Total Available Hours
18,125**

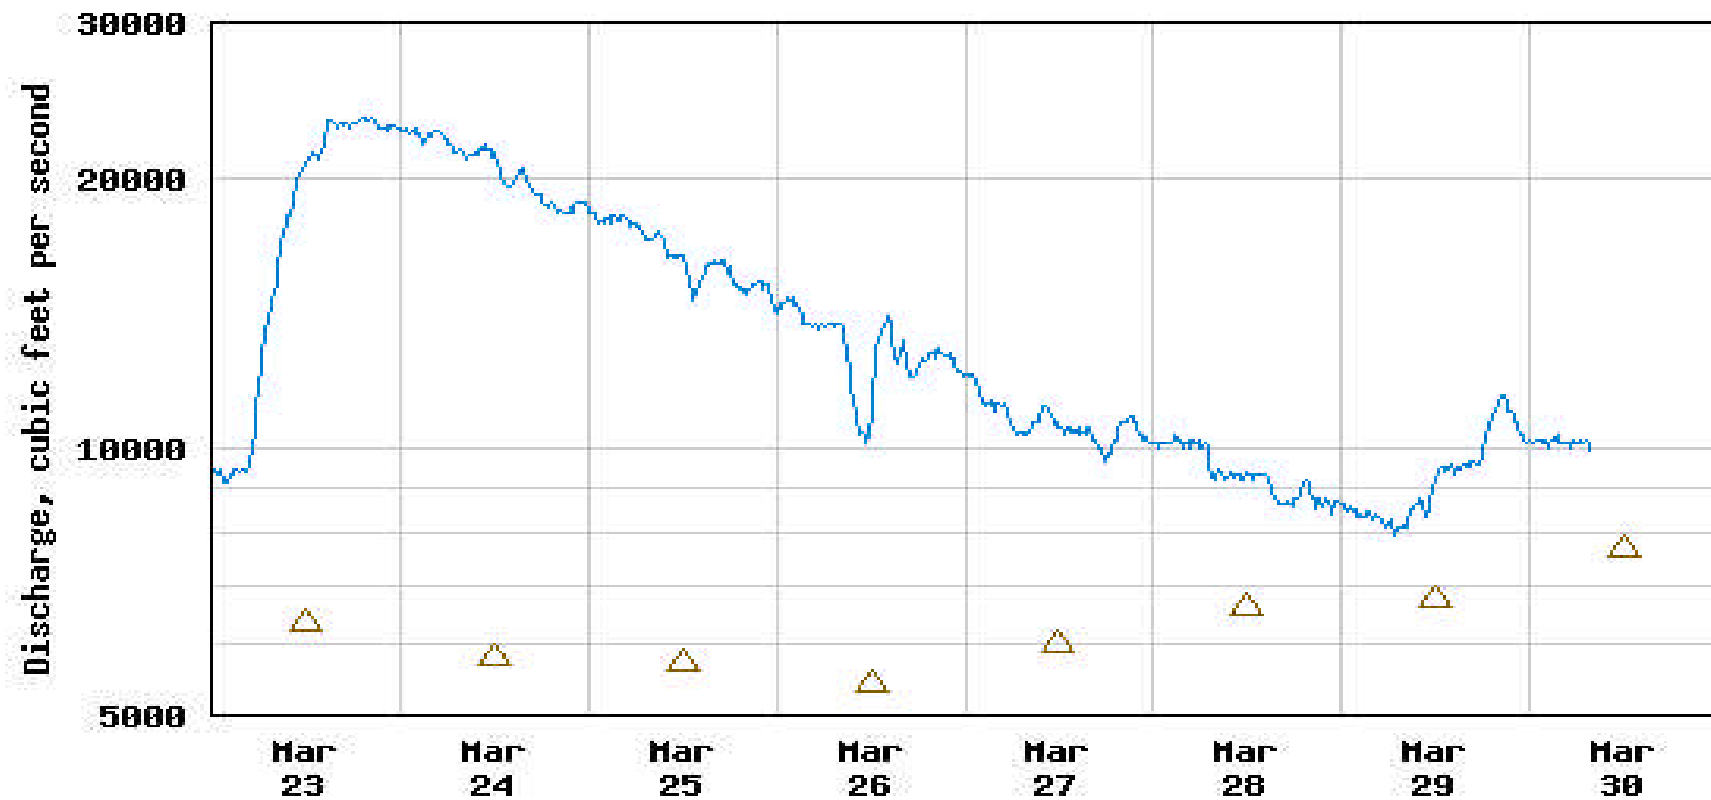
USGS 01327750 HUDSON RIVER AT FORT EDWARD NY

Recent Flow Data – Fort Edward

△ Median daily statistic (32 years) — Discharge
