PCB CONTAMINATION OF THE HUDSON RIVER ECOSYSTEM

COMPILATION OF CONTAMINATION DATA THROUGH 2008

HUDSON RIVER NATURAL RESOURCE DAMAGE ASSESSMENT

JANUARY 2013

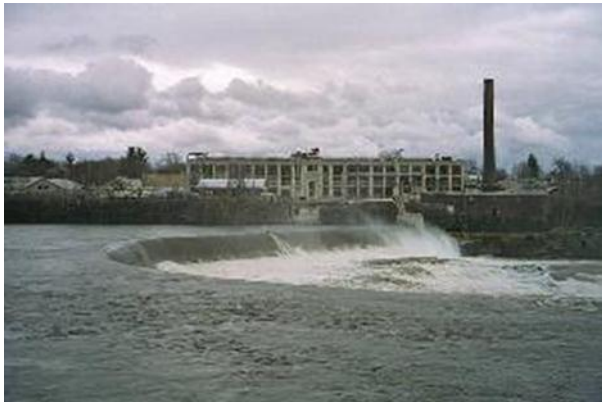
EXHIBIT 2: THE GENERAL ELECTRIC HUDSON FALLS PLANT ON THE HUDSON RIVER

The General Electric Hudson Falls plant used PCBs for manufacturing operations beginning in 1947. The abandoned Allen Mill structure situated just below the Hudson Falls Plant failed in 1991, leading to a temporary spike in outflow of PCBs to the Hudson River.

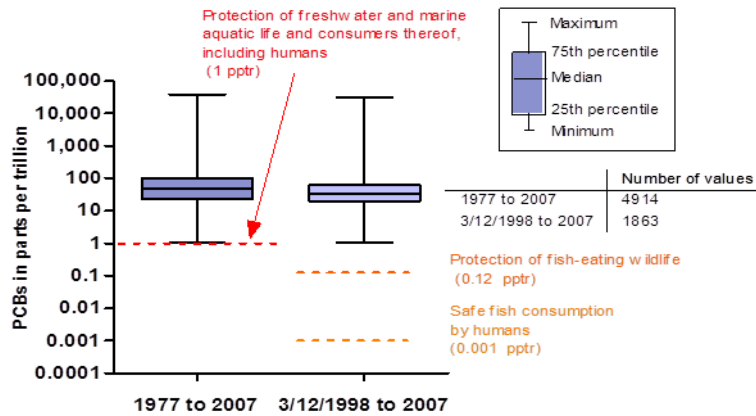
EXHIBIT 5: PCBs IN HUDSON RIVER SURFACE WATERS, ALL LOCATIONS, 1975-2007

Data sources: Measurements taken by the U.S. Geological Survey, which in 1975 initiated regular monitoring of PCBs in the water column at Waterford and then expanded its monitoring program to a total of seven stations, all within the Upper Hudson. Additional data sources include measurements taken by GE, whose sampling program began in 1989, and which encompasses 124 locations, 120 of which are located in the Upper River, and smaller datasets provided by EPA (2000b), Litten (2003), and Bopp et al. (1985), all three of which included some sampling in both the Lower and Upper Hudson.

Notes: Data are shown for all years (1977-2007) and for the period after 3/12/1998 to 2007. The depicted 1 ppt EPA guidance criterion was established in 1976, while the 0.12 ppt and 0.001 ppt New York State water quality standards were promulgated on 3/12/1998. Because water quality criteria apply only after their issuance, only measurements taken after availability of the relevant criteria are included in this figure. The presented data also reflect only those samples in which PCBs were detected (about 80% of all measurements).

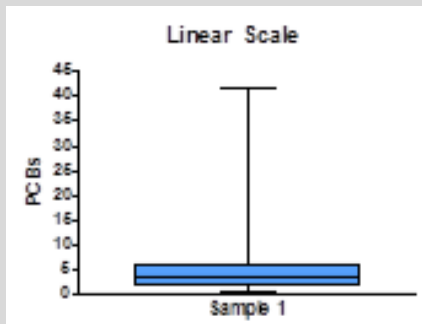
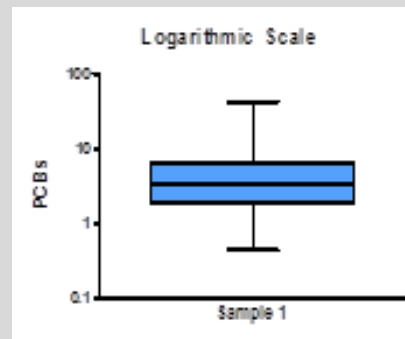
In addition, because of the wide range in PCB concentrations depicted in many of the graphs in this report, the information is shown in logarithmic scale to allow all the data to appear visible on the same graph. On a logarithmic scale, every ten-fold difference (such as between 1 and 10, or between 10 and 100) is depicted as an equally-sized interval. The sample figures below illustrate the visual difference between the same sample dataset plotted on both a linear and a logarithmic scale.

It is not possible to show values of zero on a logarithmic scale; therefore, samples in which PCBs are not detected (and which are assumed for purposes of this report to contain no PCBs) are discussed in the figure legends.

Graphs in this report generally are presented in two styles. Where data are relatively few, individual measurements are shown. Where data are more numerous, a box-and-whisker style is used to illustrate the general distribution of the values. The whiskers represent the minimum and maximum values. The top and bottom of the colored box represent the 75th and 25th percentiles, respectively, and the central line represents the median value.

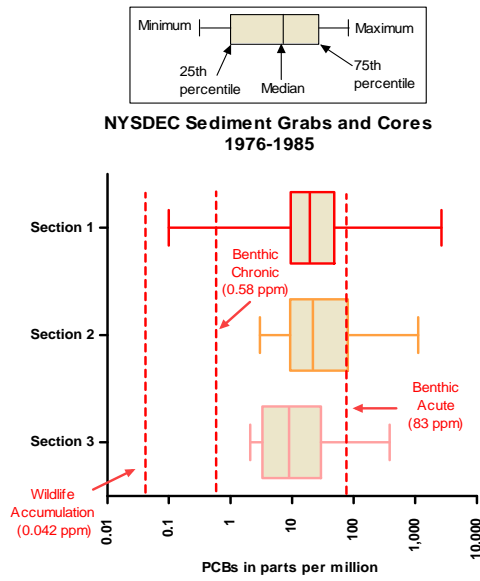
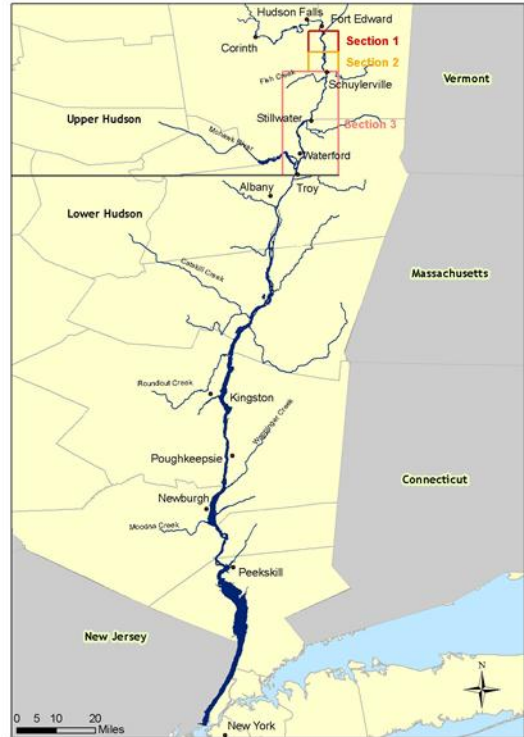
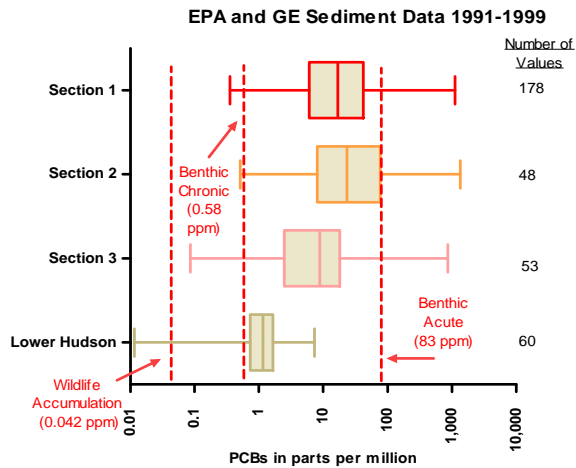
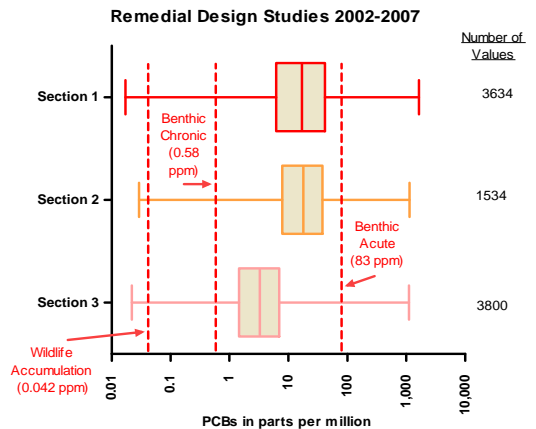
EXHIBIT 6: PCB CONCENTRATIONS IN HUDSON RIVER MAINSTEM SURFACE (≤ 12 INCHES) SEDIMENTS BY RIVER SECTION, 1975-2007

Sediment data are grouped by data-generation project. This roughly approximates time periods and also reflects the different sampling strategies employed. Non-detects (less than 1% of the samples) are not included in this analysis and lab/field duplicates have also been removed, as have samples not taken in the river's mainstem. Surface sediments samples are defined as those that begin at the surface and have a lower depth of 12 inches or less. NYSDEC (1999) developed the depicted criteria for wildlife accumulation (1.4 µg/g OC), chronic benthic toxicity (19.3 µg/g OC), and acute benthic toxicity (2760.8 µg/g OC). Assuming 3% organic carbon in sediments (average for the Hudson River), these values become 0.042, 0.58, and 83 mg/kg sediment.

PCBs in the riverbed continue to contaminate aquatic insects, mussels and other invertebrates that live in the sediment. During sampling conducted by GE in the Upper Hudson between 2002 and 2007, PCBs were detected at levels as high as 1,650 ppm in surficial sediments (top 12 inches), and this particular value was measured within the top two inches. This level of contamination creates a hazardous environment for exposed biota: for instance, NYSDEC (1999) developed sediment-based PCB screening criteria of 0.042 ppm for wildlife bioaccumulation, 0.58 ppm for chronic benthic effects, and 83 ppm for acute benthic effects.¹ Sediments with concentrations above these levels “are considered to be contaminated, and [are] potentially causing harmful impacts to marine and aquatic ecosystems” (ibid.). Approximately 99% of surficial (\leq 12 inches deep) remedial design samples exceed the NYSDEC 0.042 ppm criterion, while about 97% and 17% of these samples exceed the 0.58 ppm and the 83 ppm criteria, respectively.²

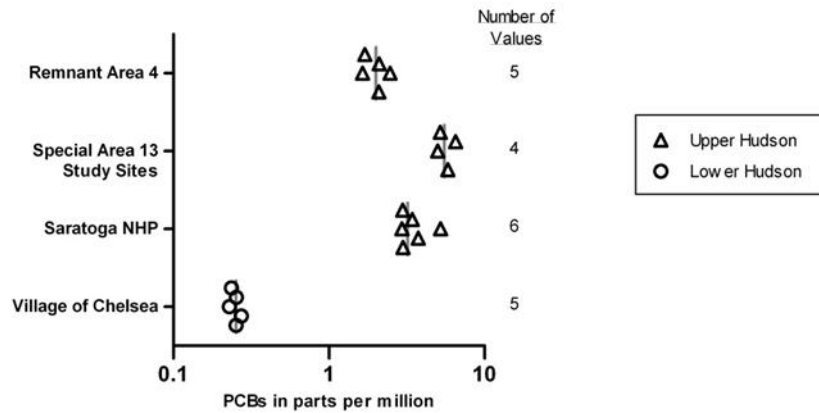
EXHIBIT 7: PCBs IN INSECTS EMERGING FROM THE HUDSON RIVER, 1998

Notes: These insects inhabit the Hudson riverbed during their larval stage. As adults, they can fly and thereby provide a potential pathway for contamination of the floodplain food web. All samples contained detectable concentrations of PCBs. Each value represents a composite sample.

Hudson River fish, birds, and wildlife can also become contaminated with PCBs through consumption of aquatic insects such as dragonflies, mosquitoes and mayflies, which live in or on the river’s bottom as larvae but emerge from the river as flying insects in their adult forms. A 1998 study found PCB levels in these emerging adult insects along the banks of the Upper Hudson to be as high as 6.3 ppm (HRNRT 2009a). The study also found that PCB levels in insects captured in the Upper Hudson were over ten-fold higher than levels in insects captured in the Lower Hudson, about 90 miles downstream of the Troy Dam (Exhibit 7).

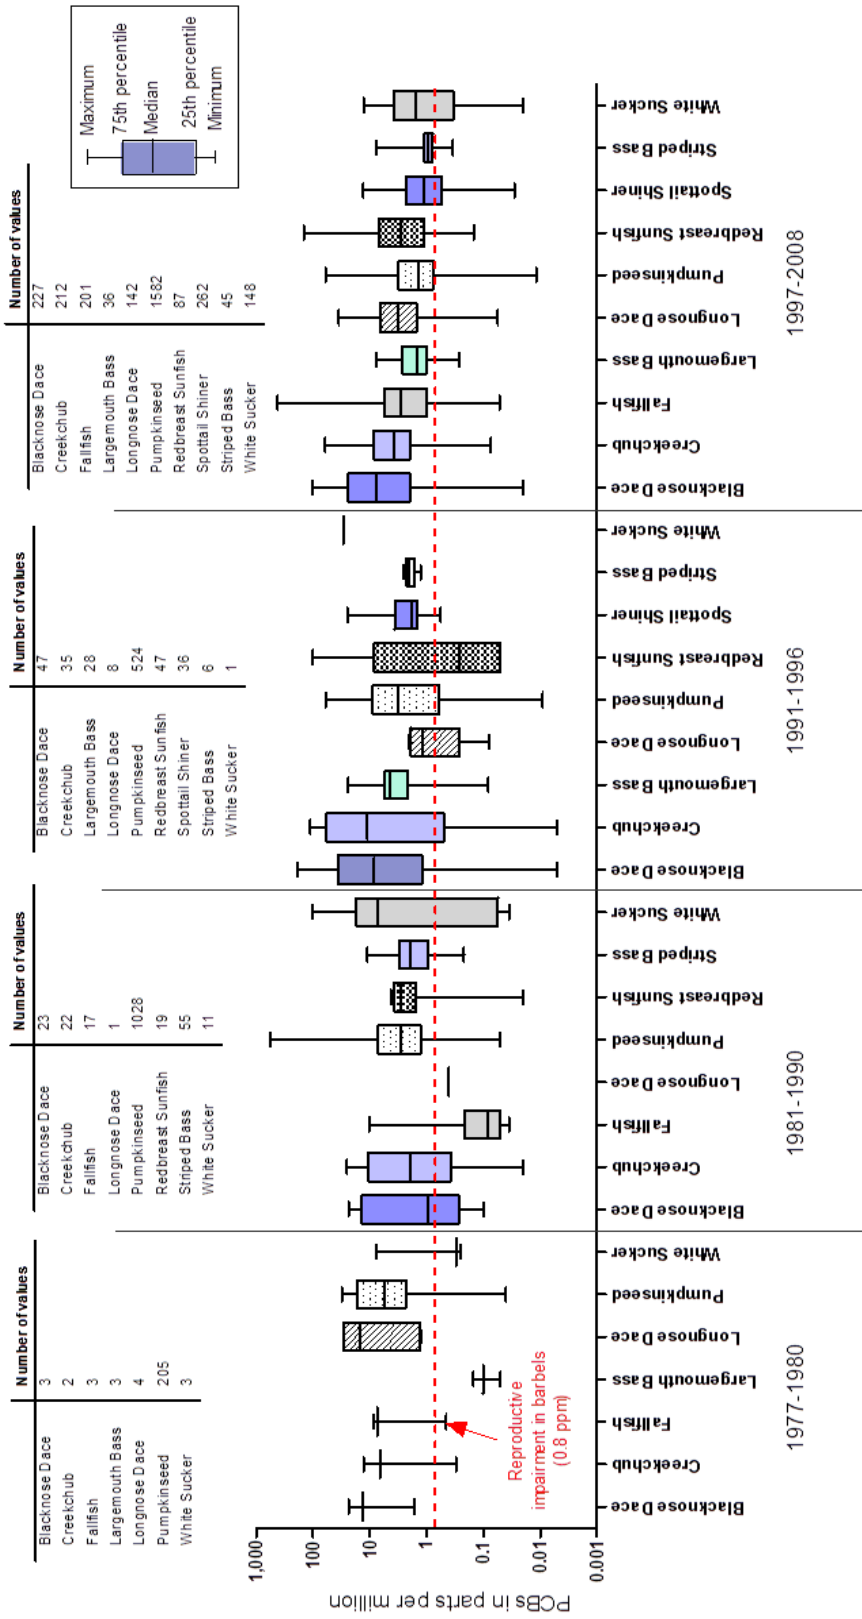
EXHIBIT 10: TOTAL PCBs (PPM) IN WHOLE FISH CAUGHT SOUTH OF THE GENERAL ELECTRIC PLANTS, 1977-2008

Notes: Data are presented for the 10 species of Hudson River fish with the highest number of whole body samples. Samples identified as duplicates and non-detects (less than 2%) are not included in the analysis. Some records represent composites of multiple fish such that the listed number of values is less than the number of fish caught and analyzed. Fish data are broken into the following time periods: 1977-1980; 1981-1990 (passage of CERCLA through just before the Allen Mill event); 1991-1996 (representing the immediate post-Allen Mill period); 1997-2008 (up through the time just before Phase 1 dredging began). Data are compared to the level at which egg mortality has been observed to increase by 20% over control levels in barbels (a fish in the same family as Hudson River carp and minnows, Hugla and Thomé 1999). The 0.8 ppm wet weight value reflects the paper's 0.40 µg/g dry weight egg threshold converted into whole body wet weight using an egg-to-adult PCB dry weight ratio (calculated from Table 2 in the Hugla and Thomé 1999), assuming 80 percent moisture. Note: additional data for fish filets is available, but is not depicted in the exhibit above.

Sampling in the Upper Hudson River between 2000 and 2008 found PCB levels in whole fish up to 470 ppm, with the maximum value from earlier years reaching 571 ppm (Exhibit 10). For comparison, the scientific literature documents biochemical changes in fish with PCB levels less than 1 ppm (Niimi 1996). Also, research has found that PCBs can severely affect reproduction in the barbel, a species of fish in the same biological family as Hudson River carp and minnows. Barbels with whole body PCB levels of approximately 0.8 ppm wet weight (ww) experienced an excess egg mortality of 20% (Hugla and Thomé 1999). Follow-up studies on fish are currently underway (HRNRT 2001, 2009b).

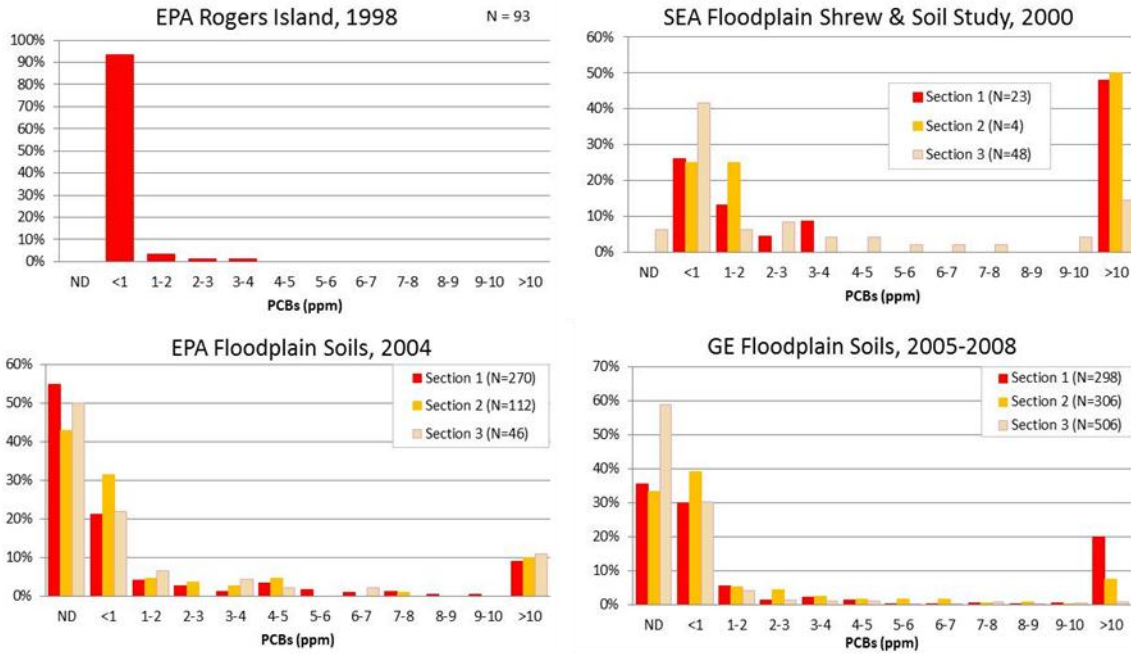
EXHIBIT 12: PERCENT OF SAMPLES BY PCB RANGE (PPM) IN SURFICIAL (≤ 6 INCHES DEEP) SOILS ASSOCIATED WITH THE UPPER HUDSON RIVER, 1998-2008

Notes: ND = non-detect. Samples identified as duplicates and apparent field replicates have been eliminated from the analysis. Samples have a lower depth of not more than 6 inches. Results are grouped by study effort(s). Of note, Efraymson et al. (1997) developed a PRG for total PCBs of 0.371ppm, a level that generally “correspond[s] to small effects on individual organisms which would be expected to cause minimal effects on populations and communities.”

Several studies have measured PCB concentrations in the Upper Hudson floodplain soils. Concentrations in surficial soils (considered for purposes of this report to be soils six or fewer inches deep) range up to 1,040 ppm in River Section 1, up to 358 ppm in River Section 2, and up to 63 ppm in River Section 3 (NOAA 2010). Some studies found that PCB concentrations in floodplain soils tend to be highest in soils closer to the river (SEA 2002, Weston Solutions 2005), and closer to the GE plants, with concentrations decreasing downstream (SEA 2002). Exhibit 12 presents distributional information on PCB concentrations in surficial (≤ 6 inches deep) soils, grouped first by study source and secondarily by river section. Of note, the data presented represent a range of distances from the river and have their origin in collection efforts that utilized different sampling strategies.

For comparison, Efroymsen et al. (1997) developed a preliminary remediation goal (PRG) for total PCBs (tPCBs) in soils of 0.371 ppm. This level generally "correspond[s] to small effects on individual organisms which would be expected to cause minimal effects on populations and communities" of wildlife. The PRGs may not be sufficiently protective of species of special concern which are based on effects on individual organisms and should be based on no-observed adverse-effects levels." Of the datasets shown in Exhibit 12, over a third of samples in River Sections 1 and 2 exceed this value, and approximately a fifth of samples in River Section 3 exceed this value.

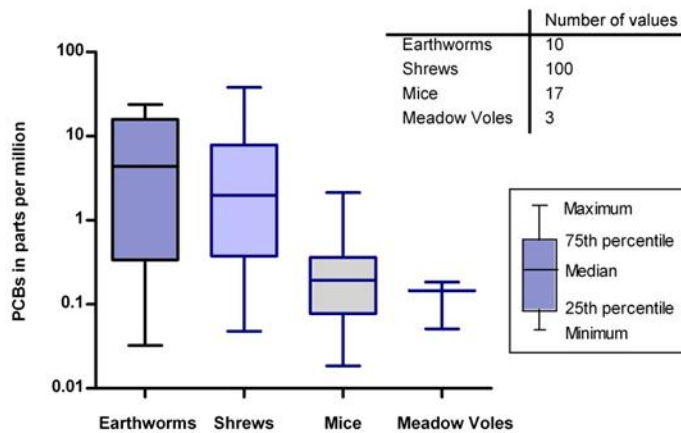
EXHIBIT 13: PCBs (PPM) IN EARTHWORMS AND SMALL MAMMALS FROM THE UPPER HUDSON FLOODPLAIN, 2000-2001

Data sources: SEA (2002), HRNRT (2010), NOAA (2010). All samples contained detectable concentrations of PCBs. The mouse and vole values each represent composites of four to five animals, whereas the shrew data represent individual animals.

Shrews, mice, and meadow voles are important prey items for larger animals such as mink and raptors. Their contamination levels suggest that these small mammals may be an important pathway for PCB exposure to their predators.

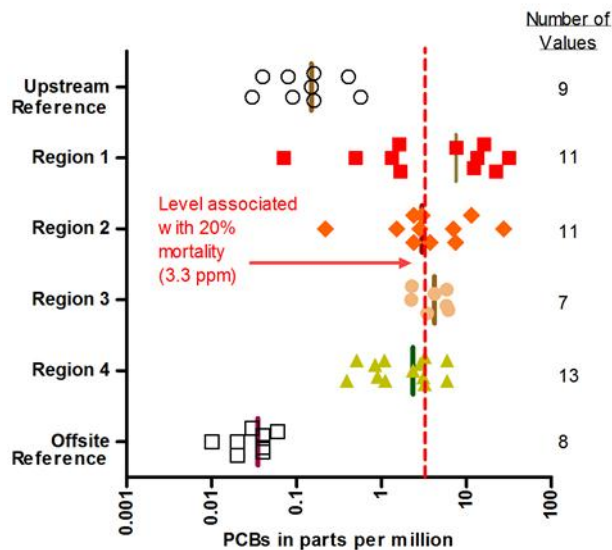
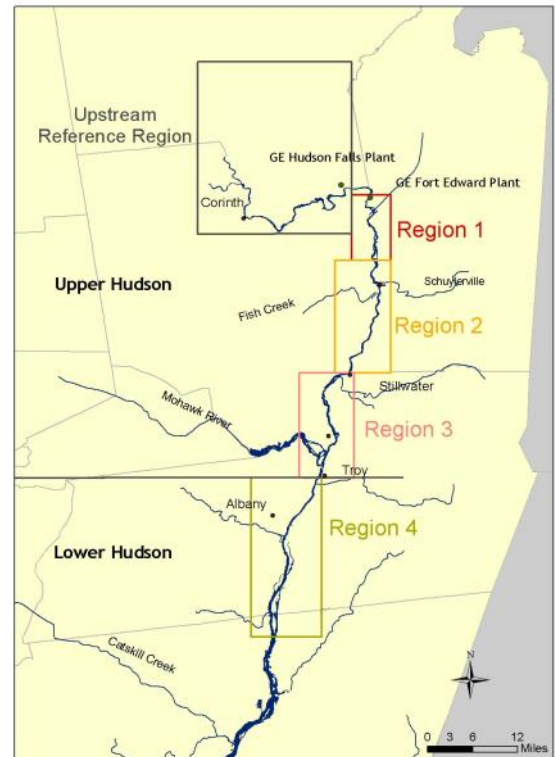
EXHIBIT 14: PCBs IN SNAPPING TURTLE EGGS FROM THE HUDSON RIVER VICINITY, 2002

Notes: PCBs were detected in all samples. Each sample represents a composite of three to five eggs. “Regions” are defined as shown in this figure (from HRNRT (2005a)); these regions differ from the “river sections” discussed elsewhere in this report. The vertical lines within the sampling data represent median values. The 3.3 ppm value associated with 20% mortality is derived from Eisenreich et al. (2009).

PCBs have been associated with behavioral abnormalities and changes to biochemistry in adult snapping turtles (HRNRT 2002), and PCBs are also passed from adult female turtles to their eggs. Snapping turtle eggs collected in 2002 contained elevated PCB levels, ranging up to 31.8 ppm (HRNRT 2005a, Exhibit 14). PCBs in snapping turtle eggs have also been linked to latent mortality: Eisenreich et al. (2009) found that snapping turtles hatched from Upper Hudson River PCBs eggs suffered a 60 percent mortality rate through 14 months of age, compared with a 10 percent rate for animals hatched from reference area eggs. Furthermore, the mortality rate was correlated with total PCBs in the collected eggs: the authors calculated a relationship between PCB egg concentrations and mortality, which suggests that levels of approximately 3.3 ppm decrease survival to about 80% of what it would have been absent PCB exposure (Eisenreich et al. 2009). Turtle eggs are also a pathway for PCB contamination to animals that consume these eggs, such as other reptiles, birds, and mammals, and potentially humans.

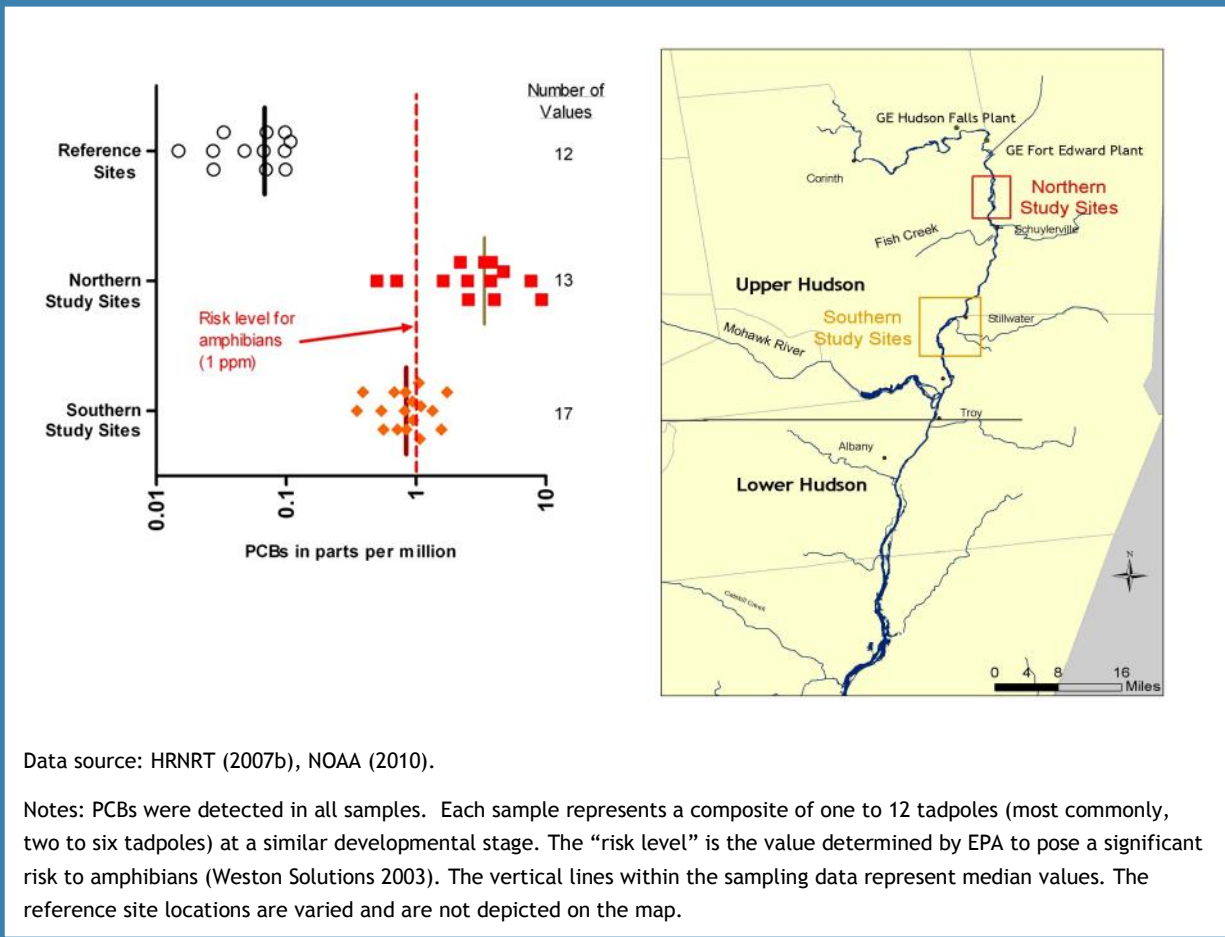
EXHIBIT 15: PCBs IN BULLFROG TADPOLES FROM THE UPPER HUDSON RIVER, 2003

Notes: PCBs were detected in all samples. Each sample represents a composite of one to 12 tadpoles (most commonly, two to six tadpoles) at a similar developmental stage. The “risk level” is the value determined by EPA to pose a significant risk to amphibians (Weston Solutions 2003). The vertical lines within the sampling data represent median values. The reference site locations are varied and are not depicted on the map.

Amphibians from the Hudson River are also contaminated with PCBs. Bullfrog tadpoles collected in 2003 had levels as high as 9.3 parts per million (HRNRT 2007b; also see Exhibit 15). For comparison, in the Housatonic River (another PCB-contaminated site), EPA determined that PCB concentrations of 1 ppm in wood frogs is the level at which “significant adverse effects begin to occur, and response became frequent and more severe at approximately 10 mg/kg” (Weston Solutions 2003). These responses include the frequency of malformations in metamorphs and male:female sex ratios of 0.7 or less.

In the Hudson, the levels and specific types of PCBs detected in bullfrog tadpoles closely mirror those found in the sediments where the tadpoles were living. This suggests that in addition to receiving a burden of PCBs from their parents in the egg, these tadpoles are acquiring PCBs from the river environment they inhabit. Furthermore, PCB levels in sediments from known amphibian breeding areas of the Hudson River are at ecologically significant levels, suggesting the potential for injury to these organisms (HRNRT 2008a). The Trustees are investigating additional options to assess amphibian injury (HRNRT 2008c).

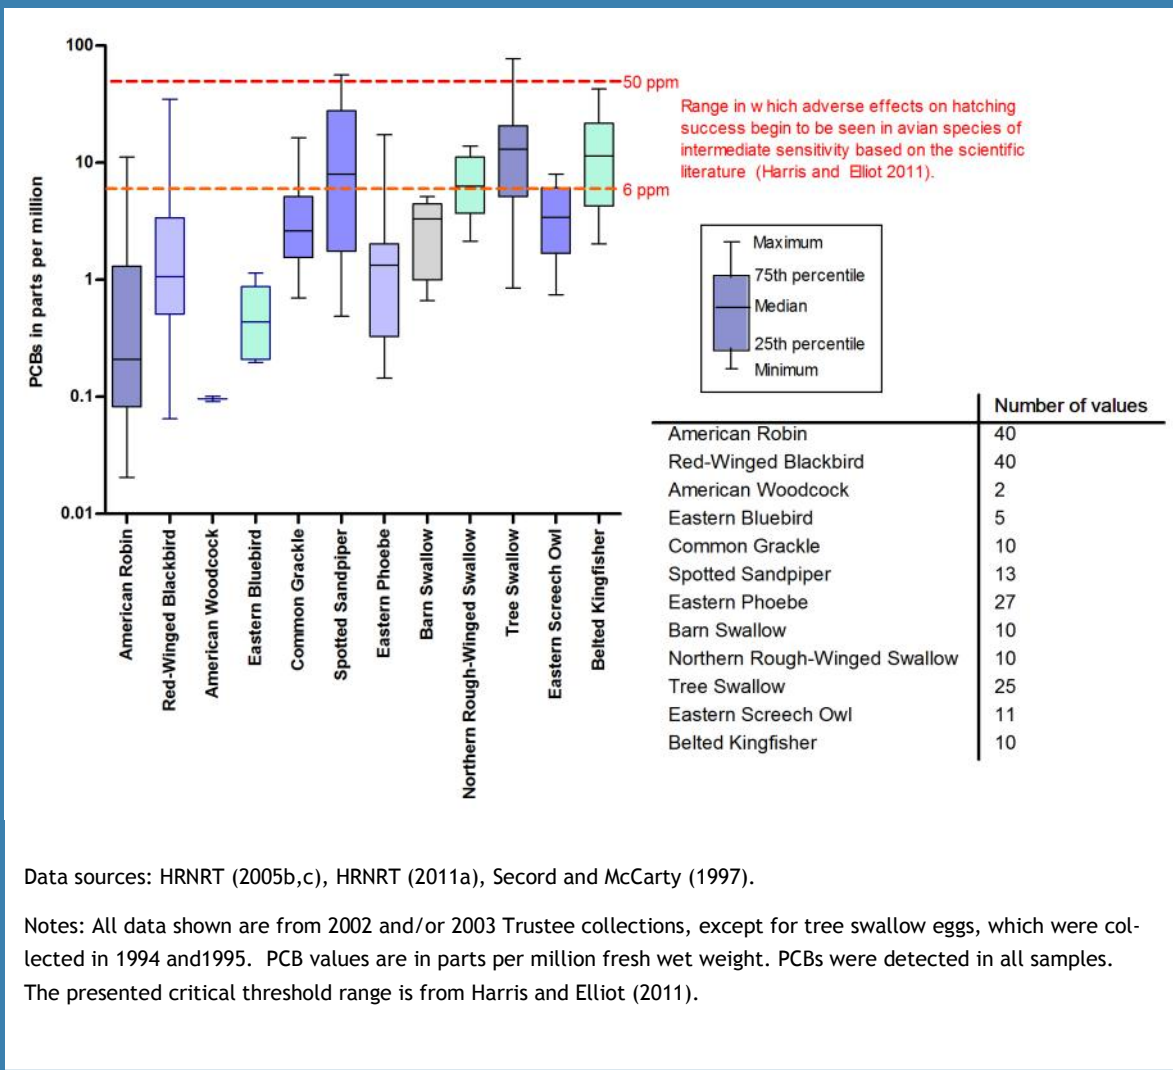
EXHIBIT 16: PCBs in Bird Eggs Collected Near the Hudson River, 1994-2003

Notes: All data shown are from 2002 and/or 2003 Trustee collections, except for tree swallow eggs, which were collected in 1994 and 1995. PCB values are in parts per million fresh wet weight. PCBs were detected in all samples. The presented critical threshold range is from Harris and Elliot (2011).

Several studies have confirmed that birds and their eggs in the Hudson River region are contaminated with PCBs (Exhibit 16). Tree swallows, which eat insects that inhabit the river bottom as larvae, are particularly likely to accumulate PCBs. In the mid-1990s, tree swallows were found to contain extremely high levels of PCBs, ranging up to 62 parts per million in nestlings (McCarty and Secord 1999a) and 190 parts per million in adult swallows (HRNRT 2011b). These are among the highest PCB levels ever reported in tree swallows from any location (McCarty and Secord 1999a). Tree swallow eggs were also found to be highly contaminated with PCBs, containing levels up to 77 ppm (McCarty and Secord 1999a).⁷ In addition, studies conducted on tree swallows along the Upper Hudson during the 1990s found indications of disrupted reproductive functioning, including high incidence of nest abandonment (McCarty and Secord 1999a), inability to build normal nests (McCarty and Secord 1999b), and abnormal appearance of younger females during the breeding season (McCarty and Secord 2000). Similar signs have been associated with the effects of PCBs on hormone levels in other species (McCarty and Secord 1999b).

In 2002-2003, the eggs from several species of birds were collected from areas adjacent to the Hudson River (HNRTC 2005b,c). PCB levels as high as 56 ppm were detected, with the highest levels of contamination found in kingfisher and spotted sandpiper eggs (HRNRT 2005b). Harris and Elliott (2011) reviewed the effects of PCBs on wild birds and note that species exhibit varying sensitivity to PCBs. Among wild birds of “intermediate” (or possibly intermediate) sensitivity, critical egg thresholds for reproduction have ranged from 6 ppm to 50 ppm (Table 14.8, Harris and Elliott 2011). The lower level of 6 ppm has been exceeded in some eggs of many species of Hudson River birds, including the American robin, red-winged blackbird, common grackle, spotted sandpiper, Eastern phoebe, northern rough-winged swallow, tree swallow, Eastern screech owl, and belted kingfisher (Exhibit 16). Hudson River peregrine falcon eggs have also been shown to contain elevated levels of PCBs (HRNRT 2004a).

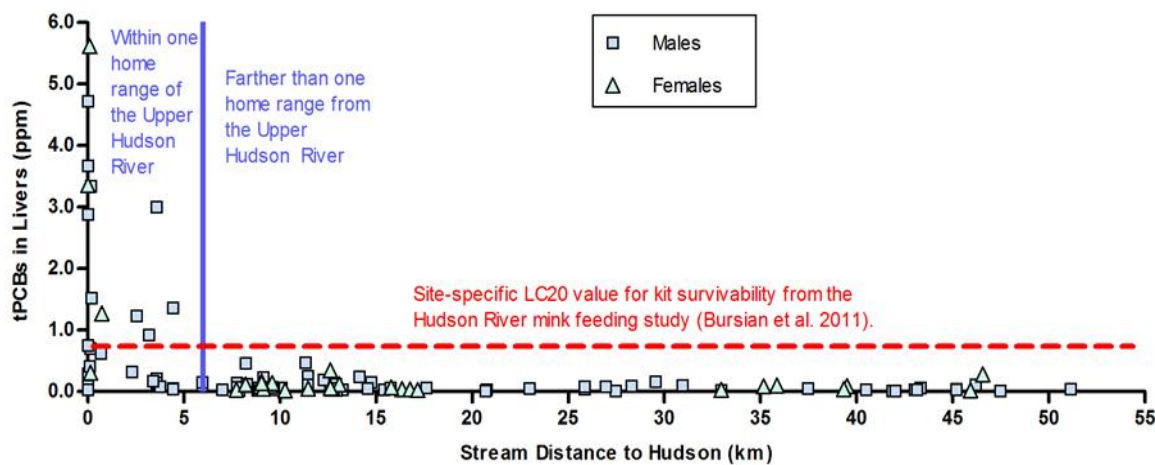
EXHIBIT 18: PCBs (PPM) IN MINK LIVERS AS A FUNCTION OF STREAM DISTANCE FROM THE UPPER HUDSON RIVER, 1989-2002

Data source: D. Mayack, New York State Department of Environmental Conservation. A subset of these data is available in NOAA (2010). Notes: The vast majority of mink were caught adjacent to streams. Stream distance to the Hudson is calculated as the stream length (not the straight-line distance) between the collection location and the Hudson River. Except for three samples, all data depicted represent animals collected between 1998 and 2000. This figure uses an estimated home range for mink of 6 km (D. Mayack, personal communication). PCBs were detected in all samples. The liver threshold of 0.8 ppm represents a site-specific LC20 value for kit survivability from the Hudson River mink feeding study (Bursian et al. 2011).

Measured concentrations of PCBs in Hudson River mink livers also suggest past and ongoing risks to mink (Exhibit 18). PCB levels in mink livers from the Hudson River watershed ranged up to 5.6 ppm, while Heaton et al. (1995) found PCB levels in livers of about 2 ppm to be sufficient to impair reproduction. Eight of the 33 mink (about 24%) caught within approximately one home range¹⁰ (6 km) of the Hudson River between 1998 and 2002 had liver PCB concentrations that exceeded this value.
