Hudson River
PCBs SUPERFUND SITE

Community Advisory Group Meeting

Fort Edward, Sept. 24, 2009

Dredging Project Update

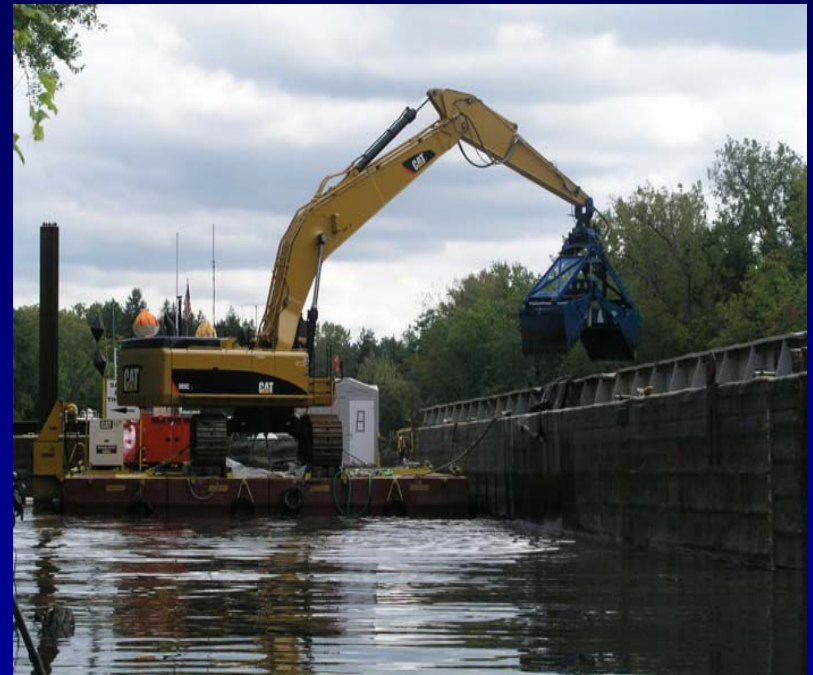
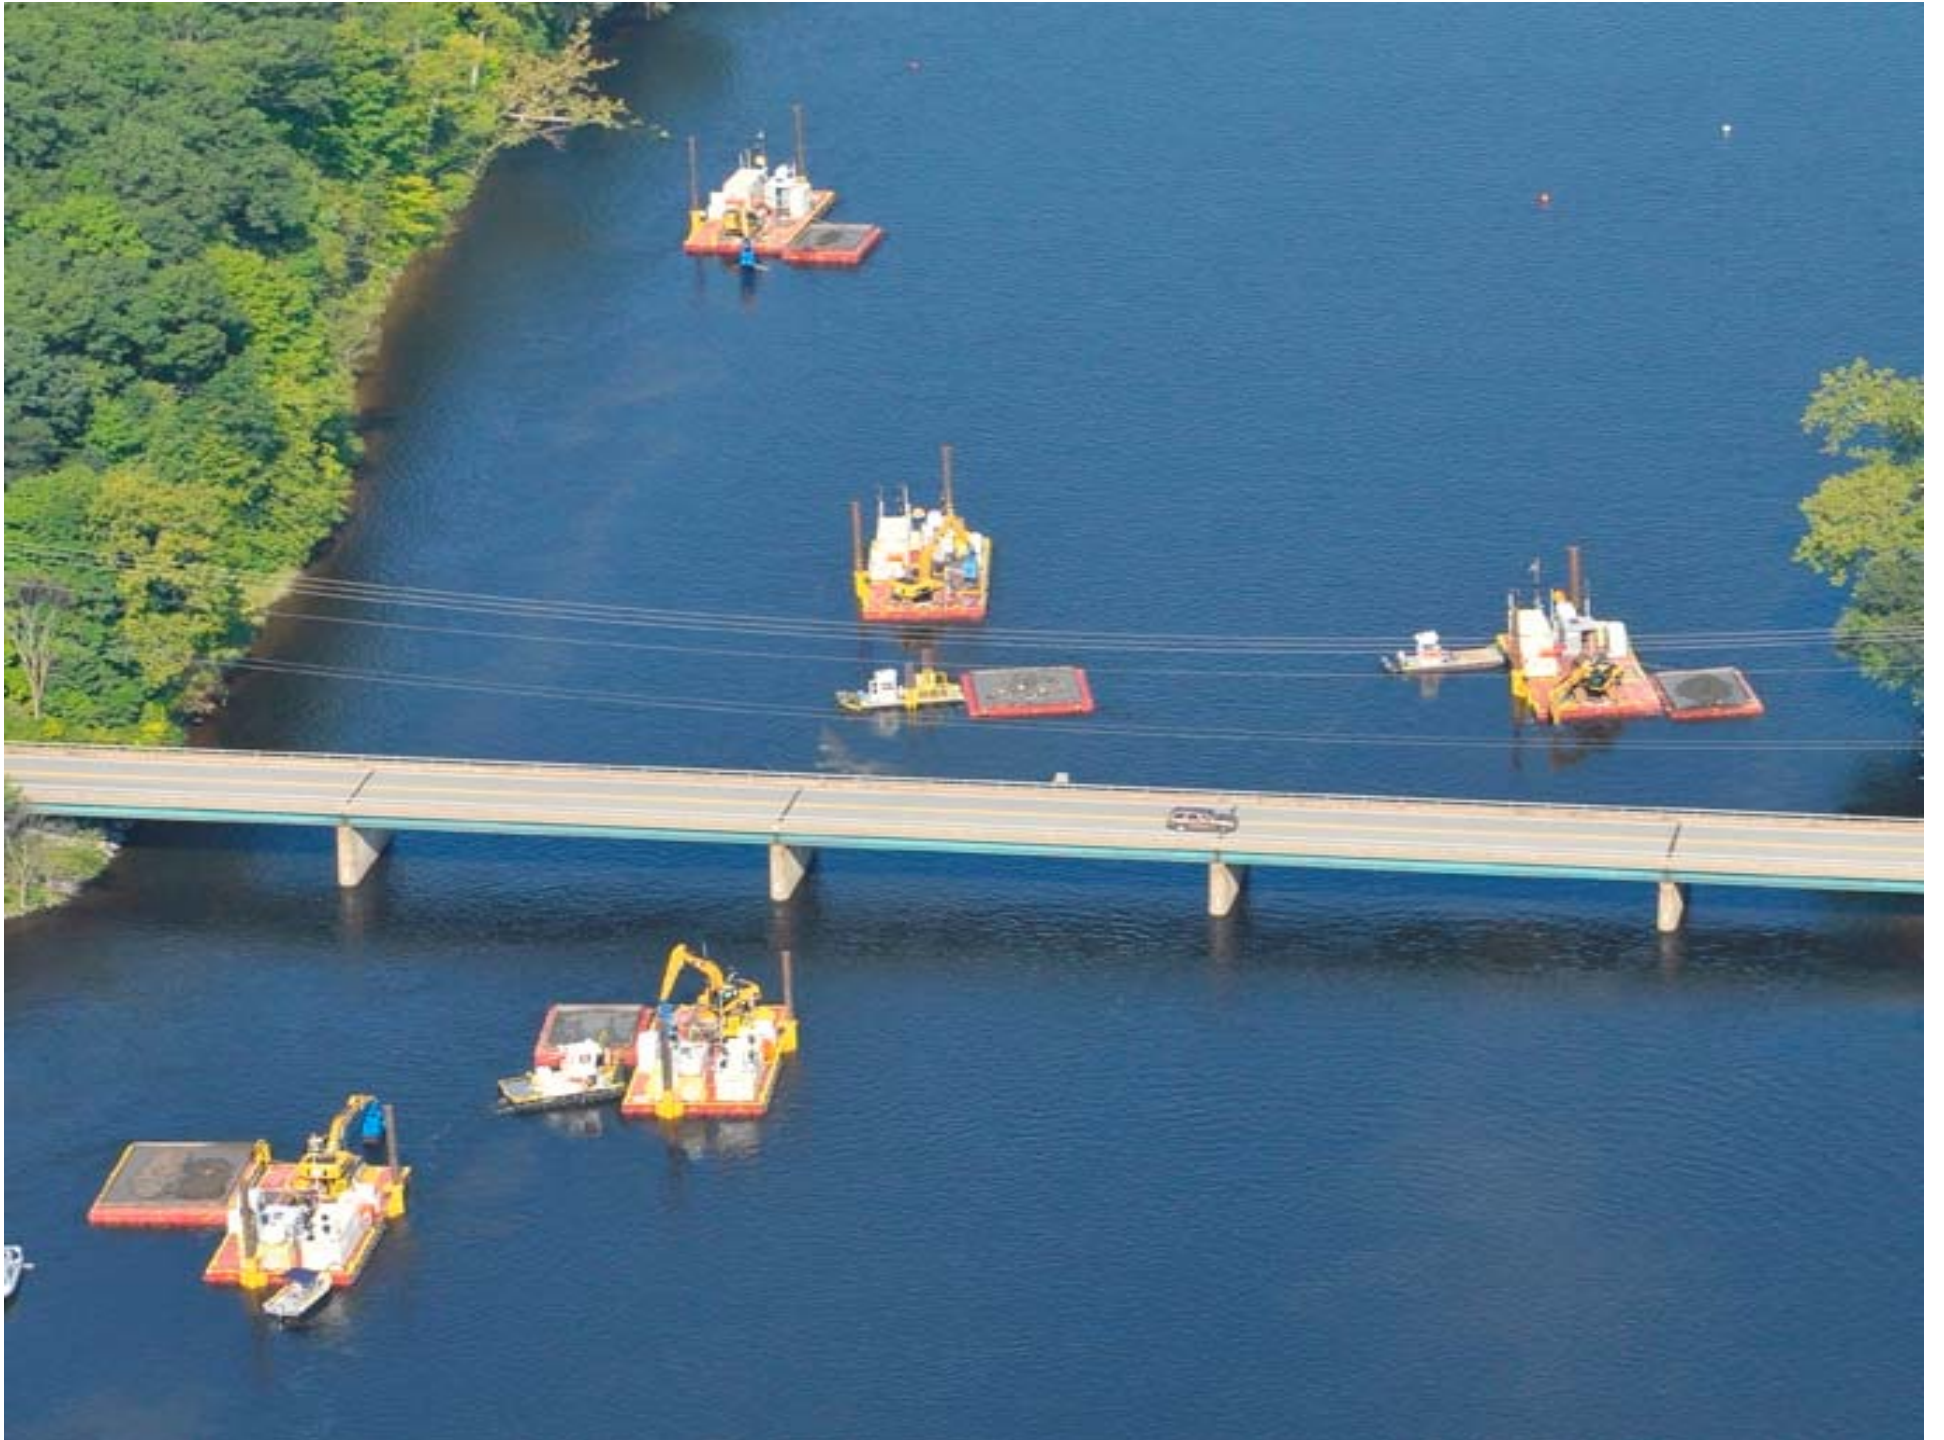
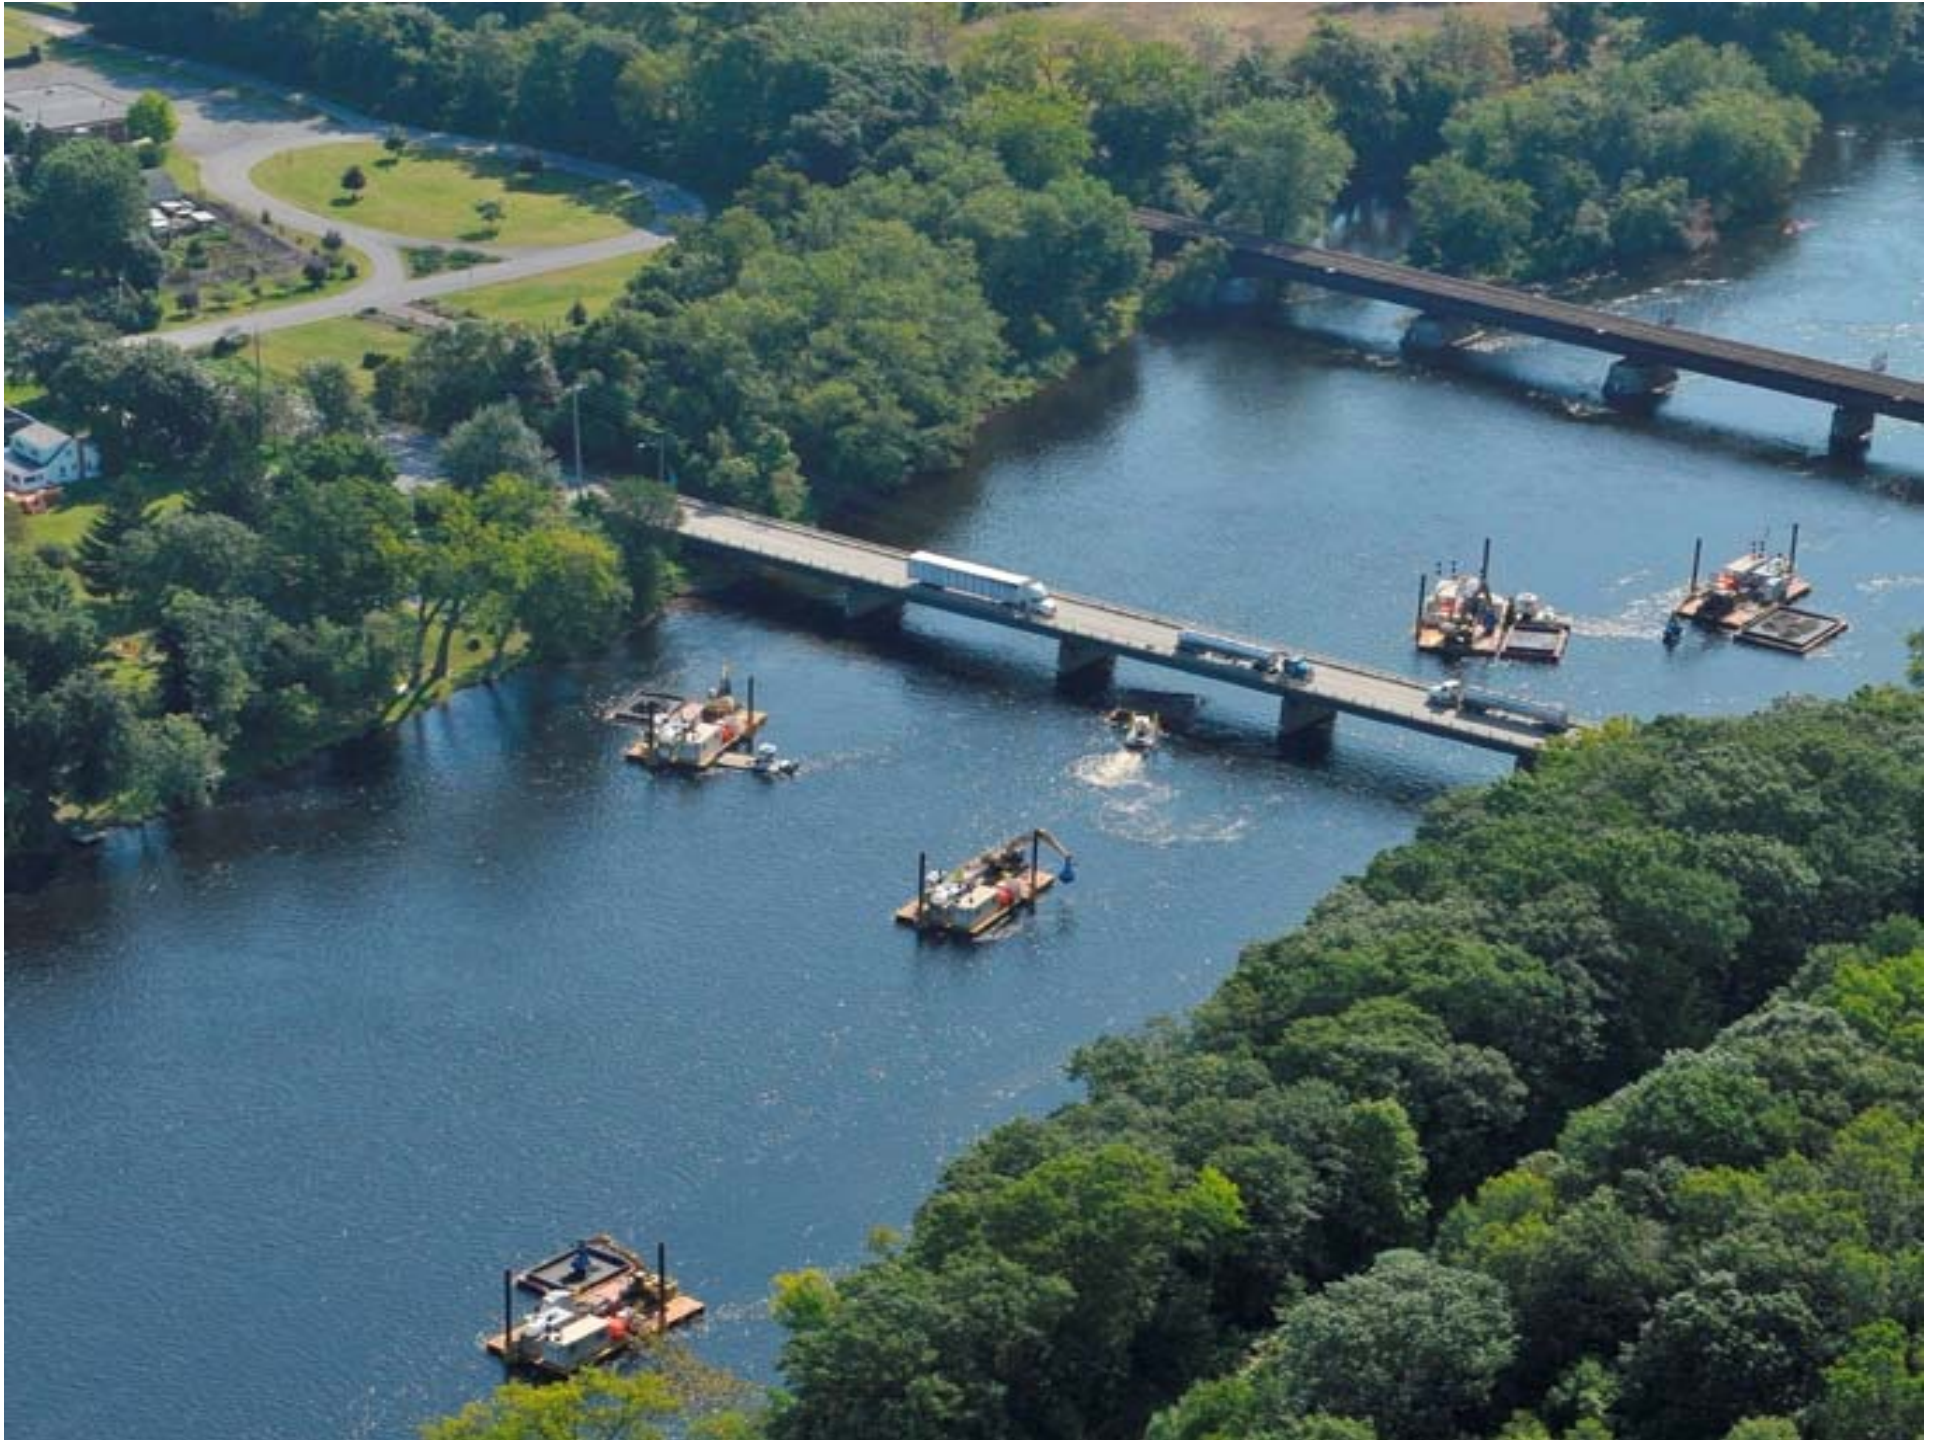
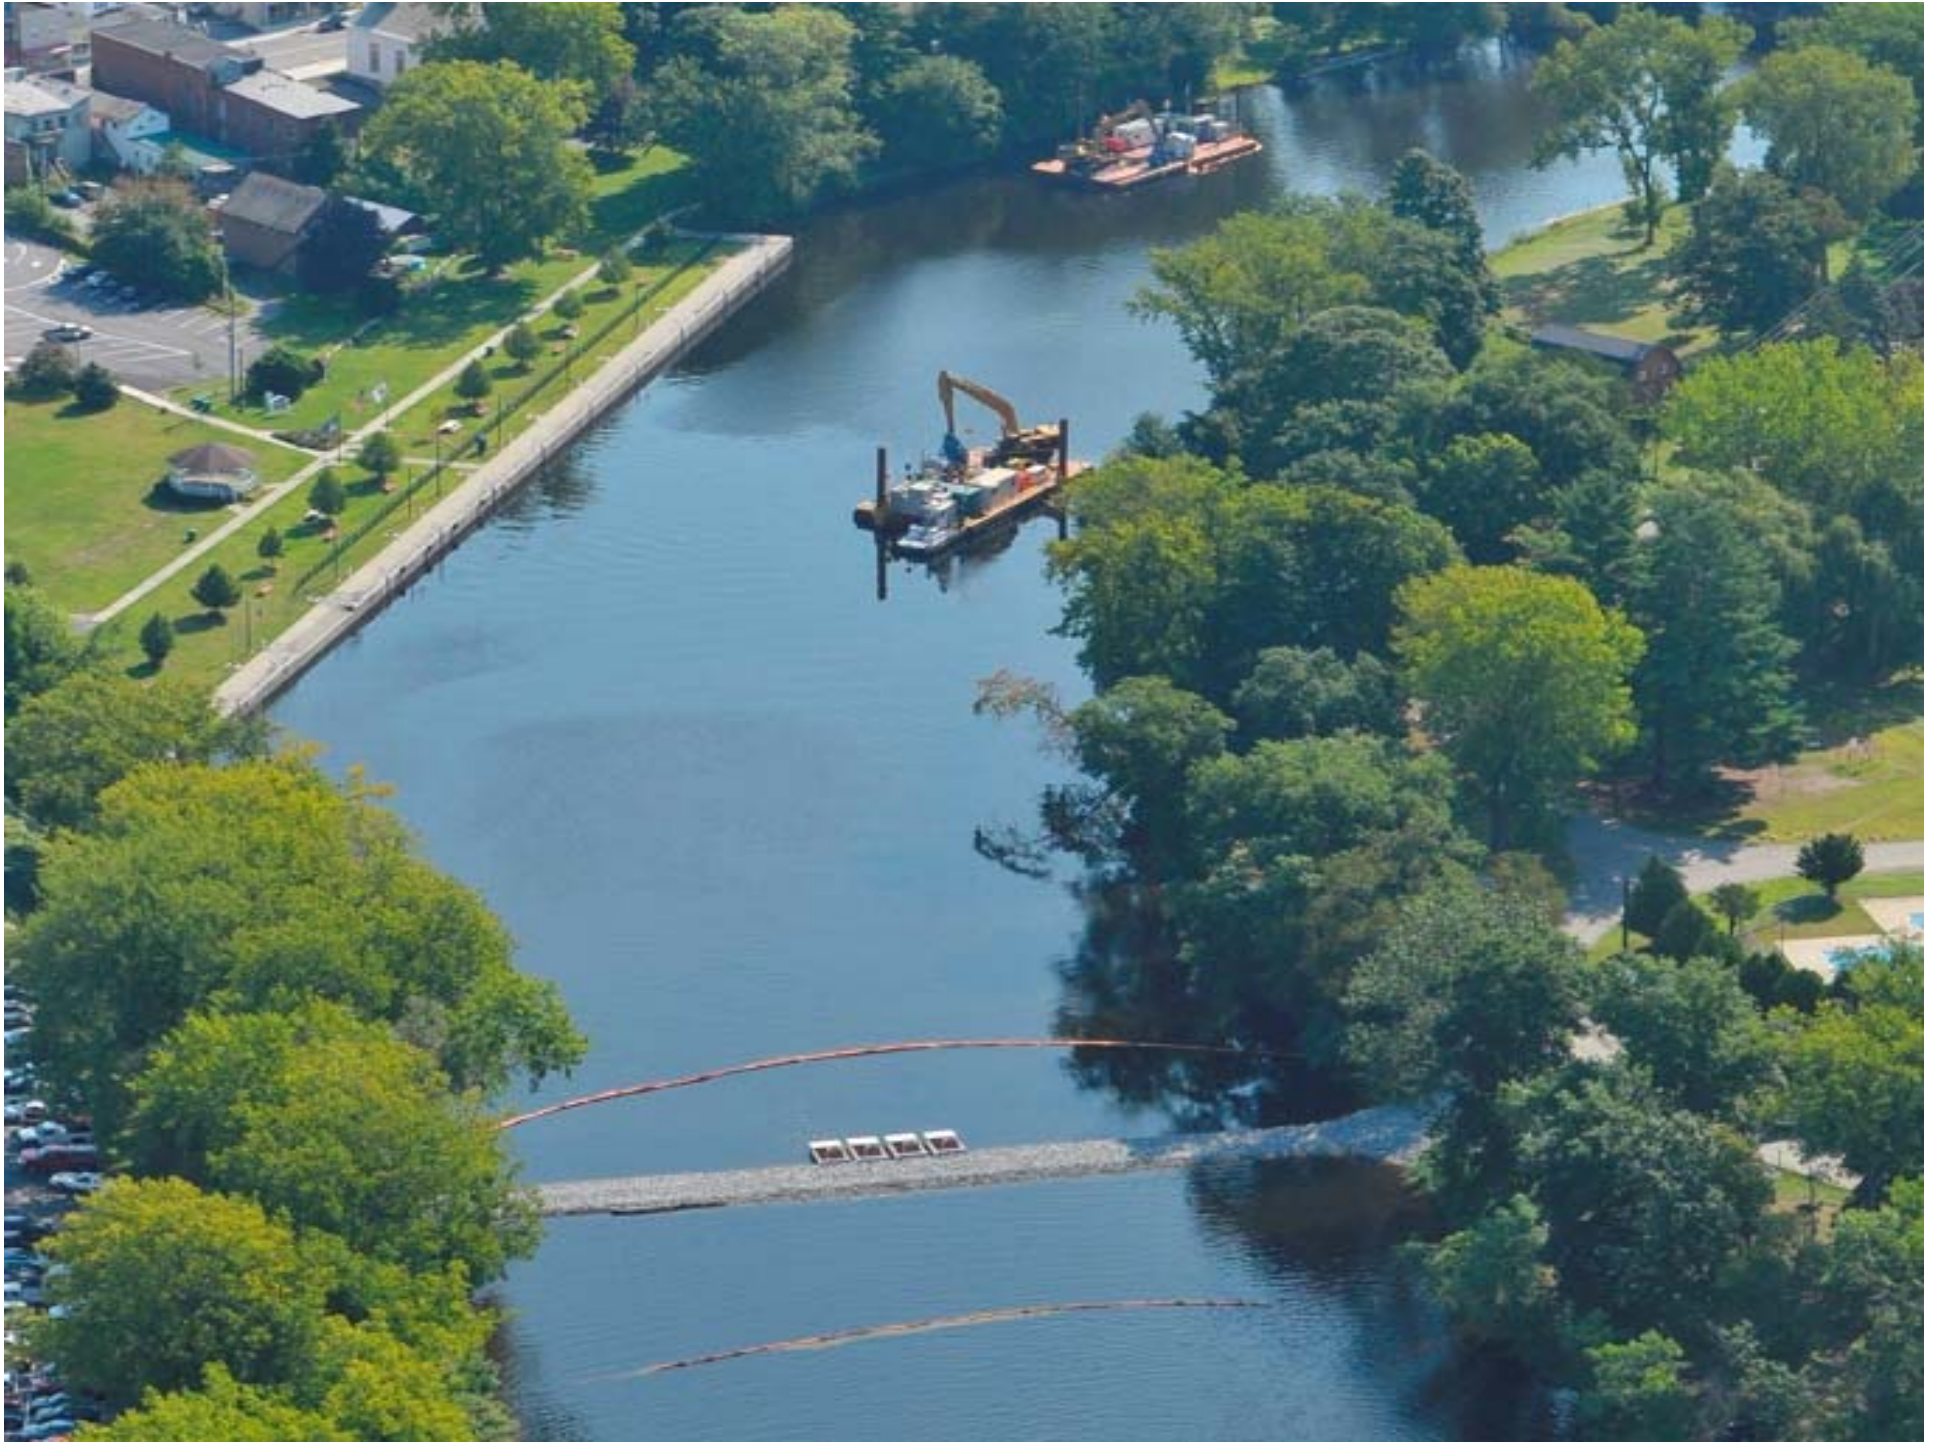
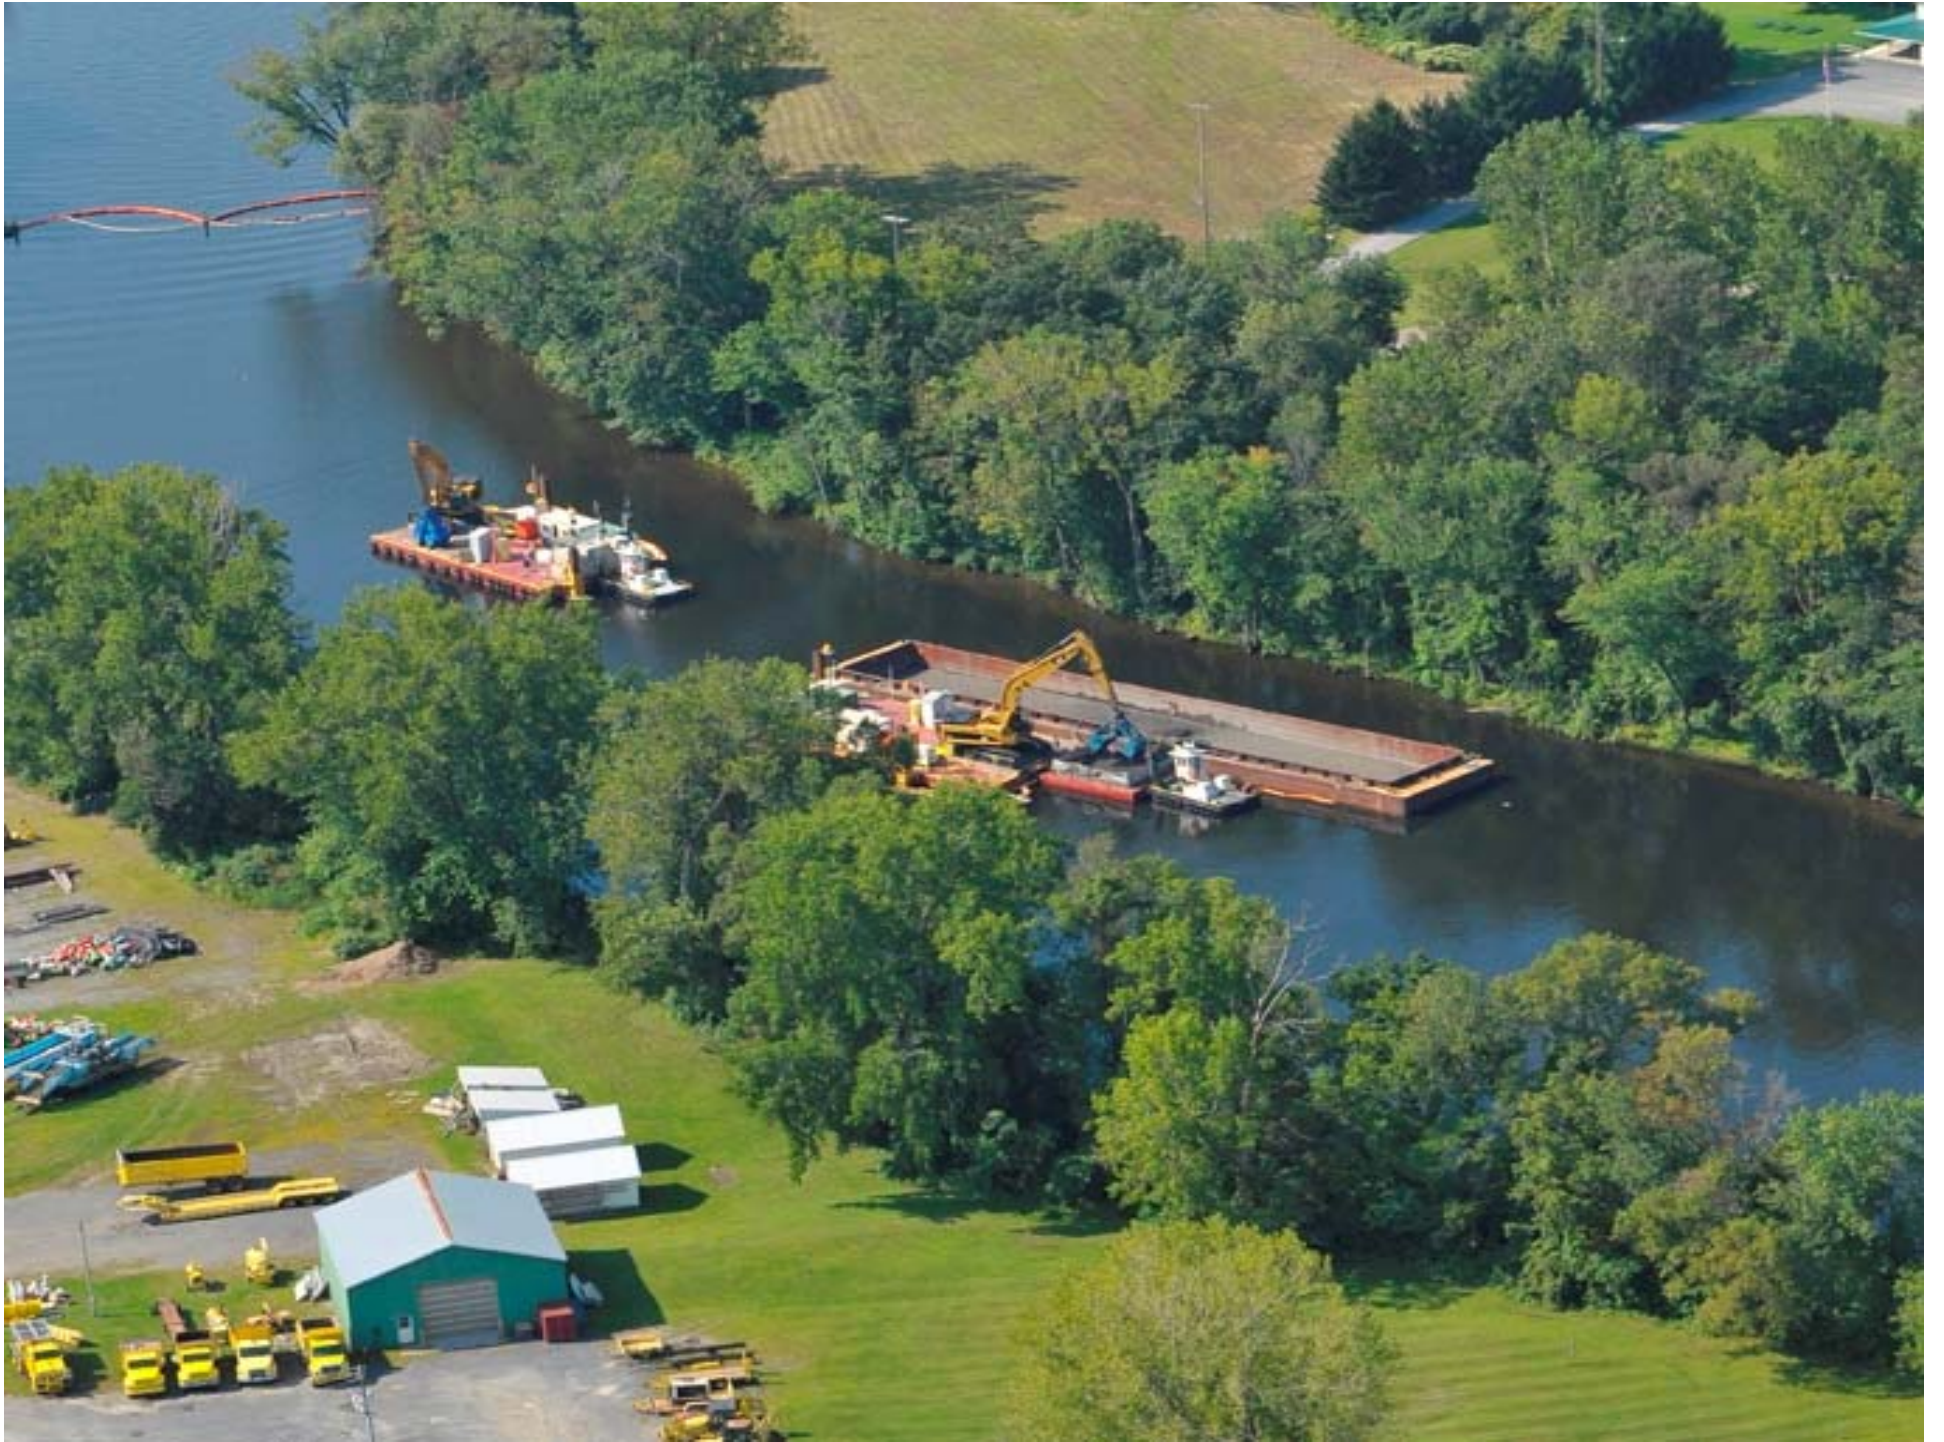
Progress by CU

Update on Phase 1: River Operations

Current River operations:

- **Dredging underway**
 - East and west channel at Rogers Island and CU-18
- **Backfilling underway**
 - CU- 5 and 17

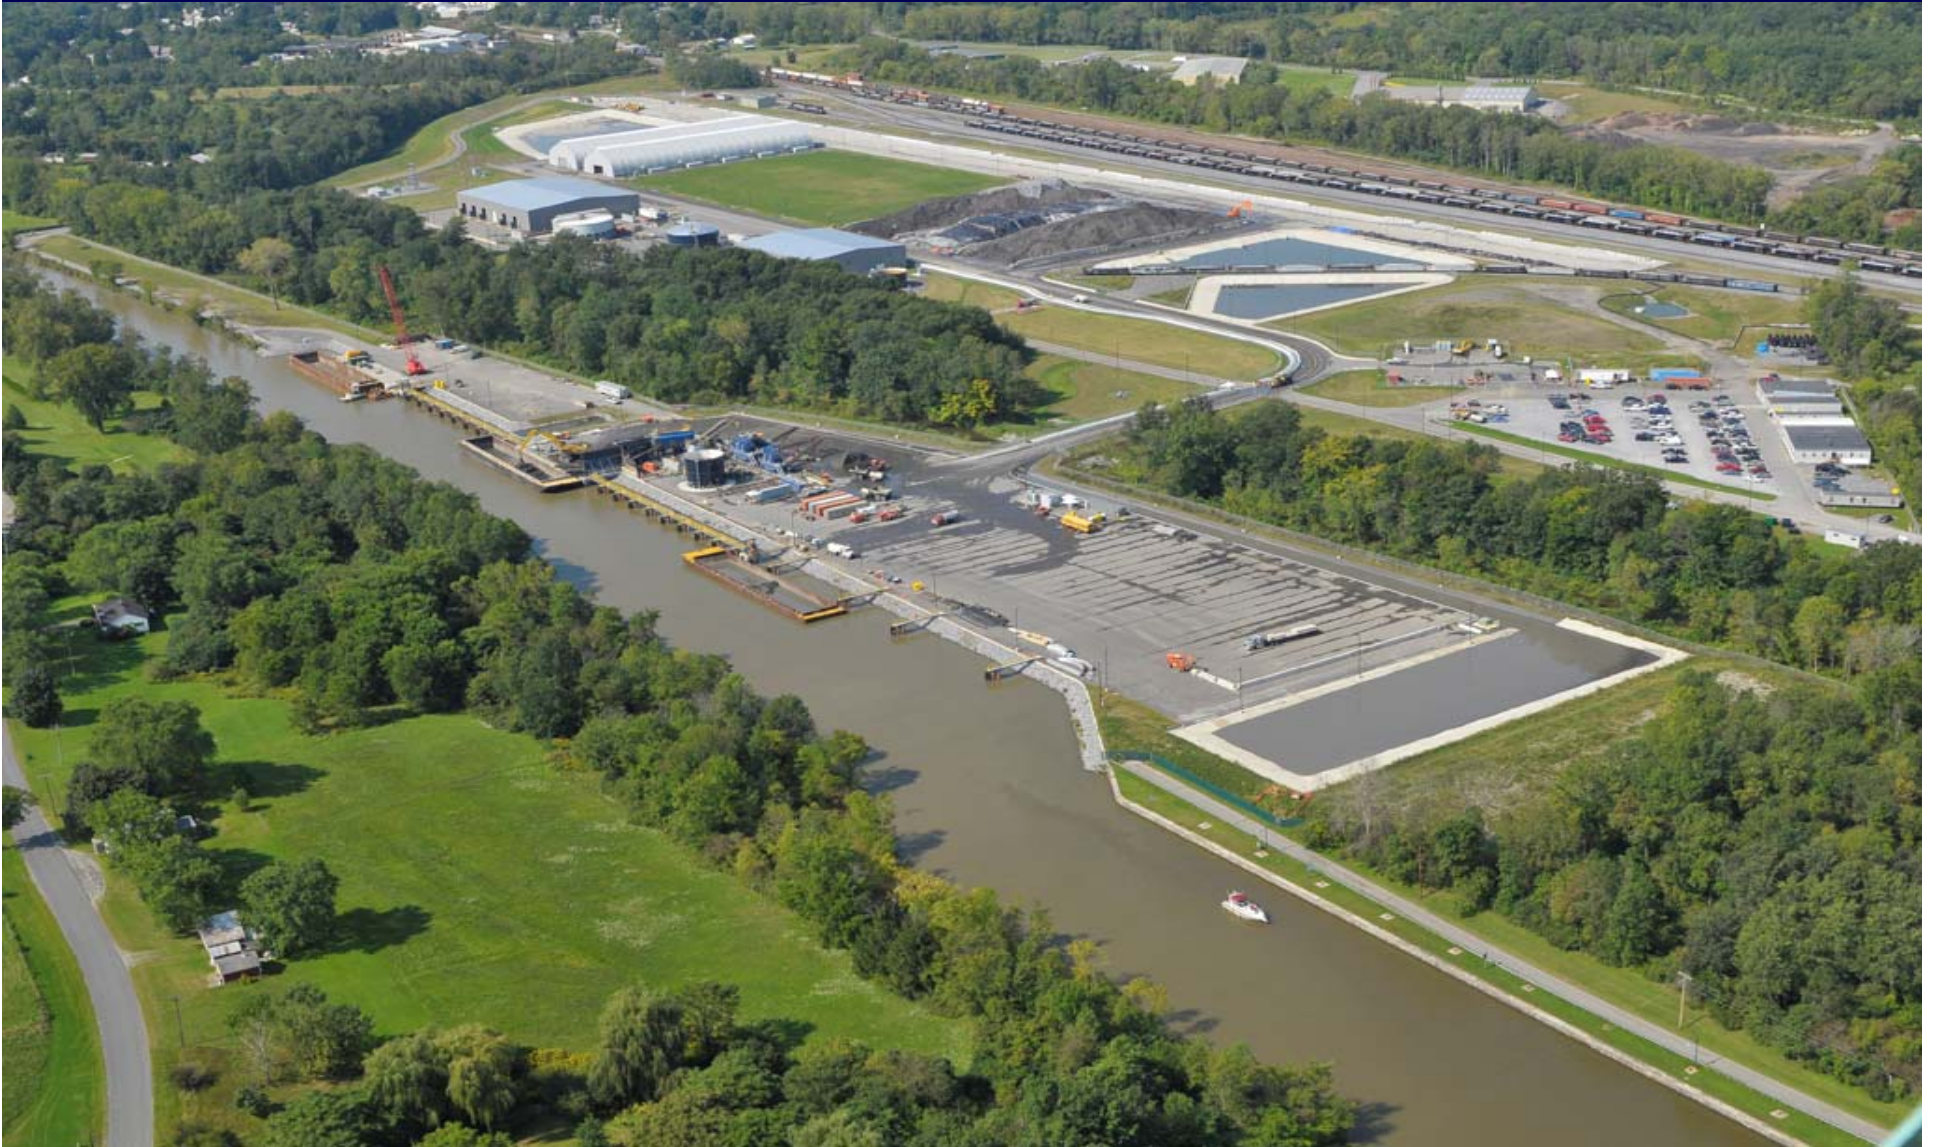
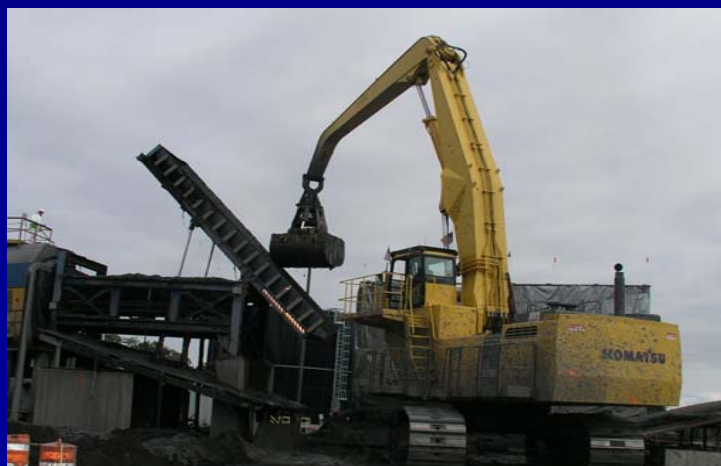
Facility Operations

Facility Operations:

- Up to 5 barges can be staged
- 24-hour operation started in June
- 5 unit trains have gone to Texas (81 cars in a unit)

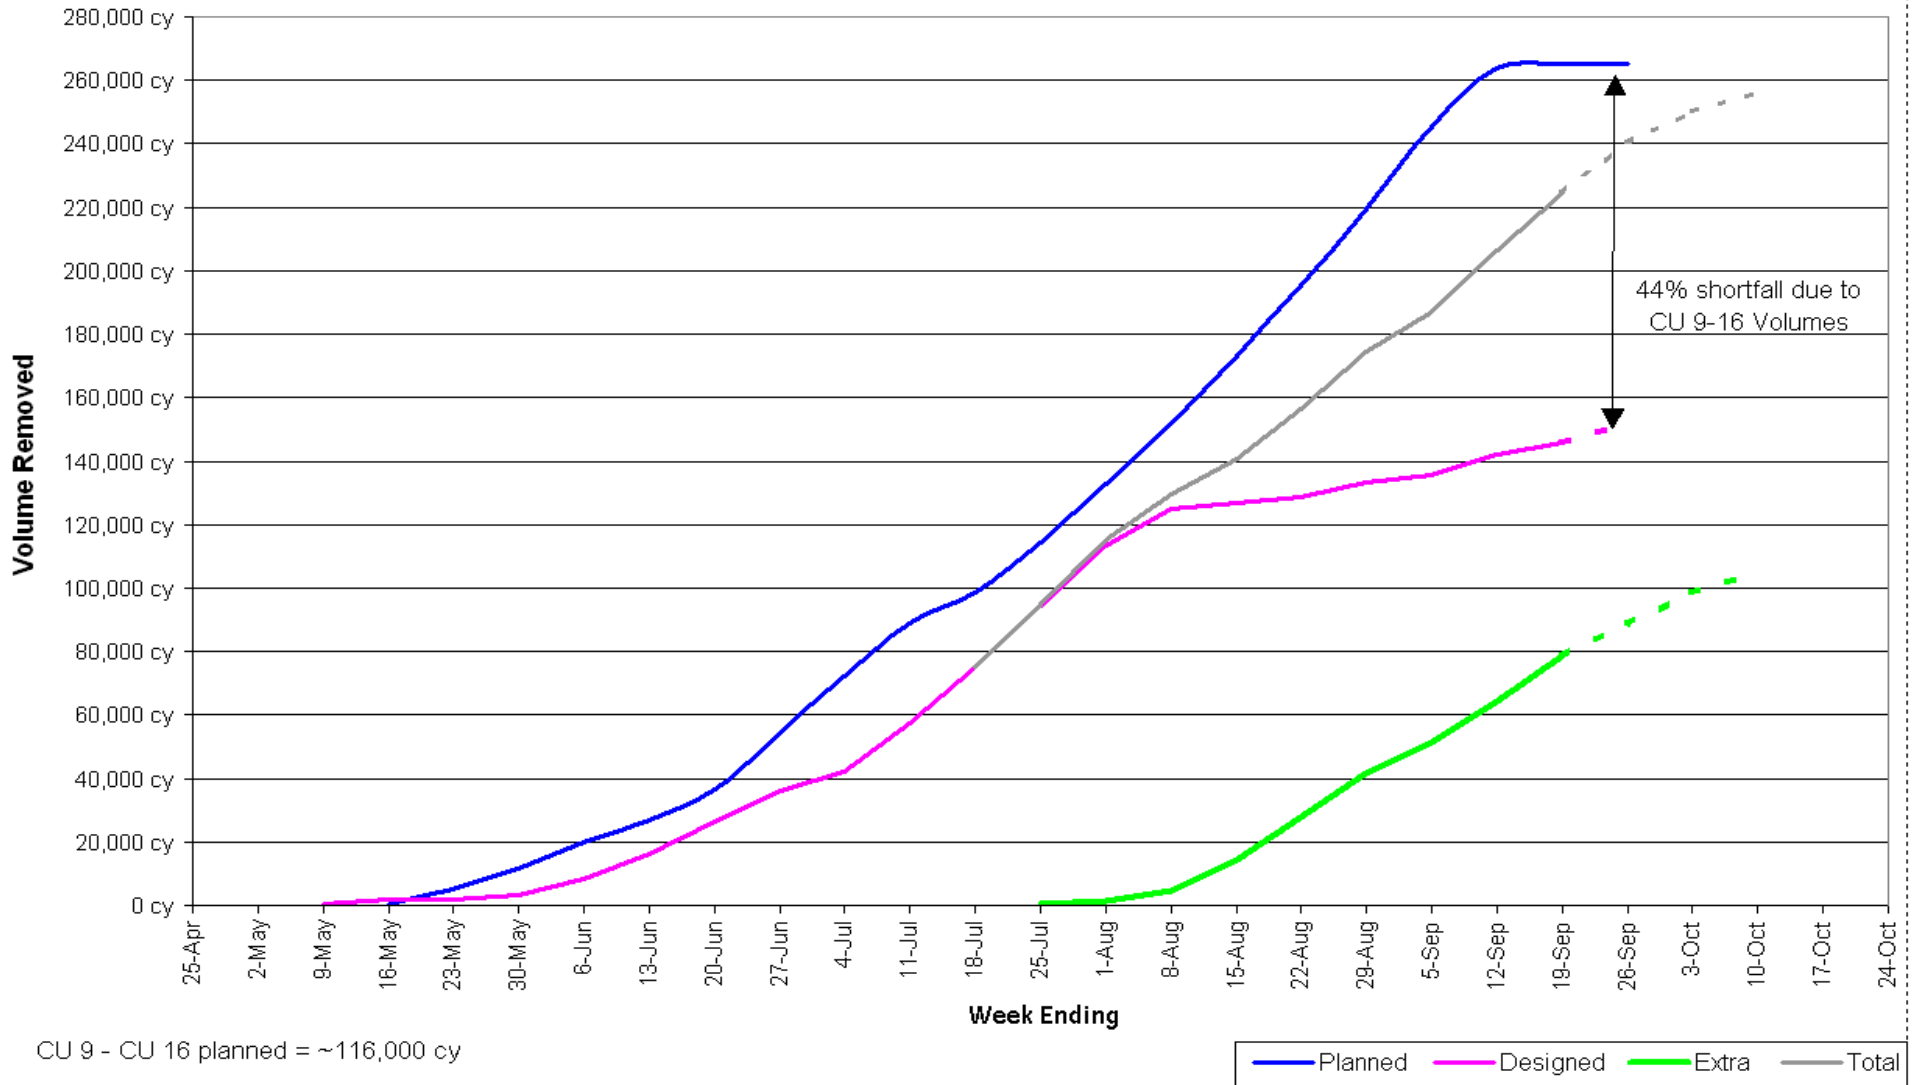
Volumes To Date

Planned vs Actual Volumes of Sediment Removal

- Approximately 224,500 cubic yards dredged as of September 23, 2009.

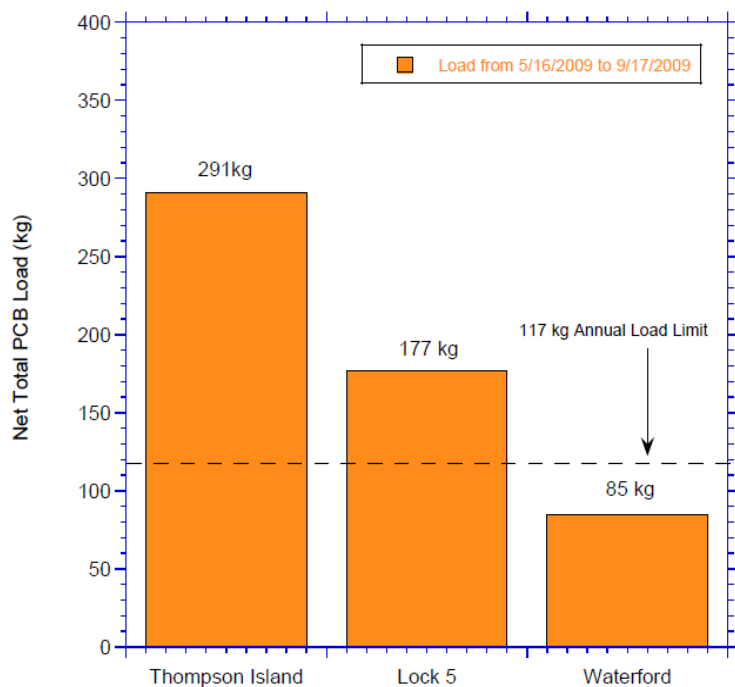
Figure B-1b. Cumulative Net Total PCB Load due to Remedial Activities From Inception of Dredging (May 16, 2009) to September 17, 2009

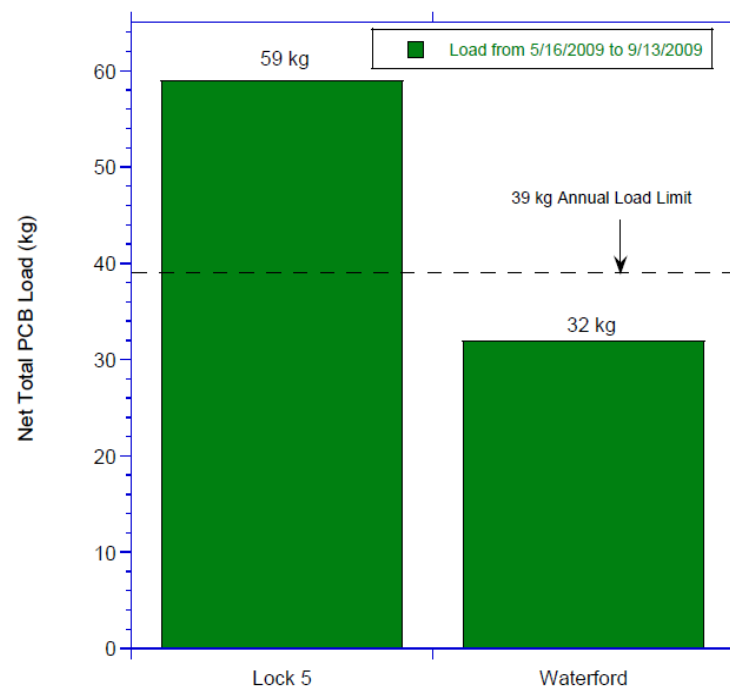
Figure B-2b. Cumulative Net Tri+ PCB Load due to Remedial Activities From Inception of Dredging (May 16, 2009) to September 13, 2009

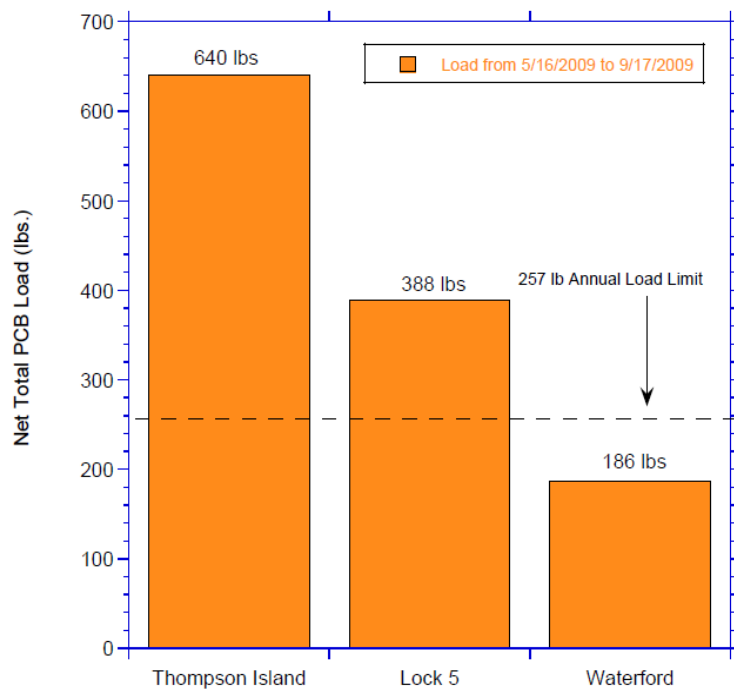
Figure B-1a. Cumulative Net Total PCB Load due to Remedial Activities From Inception of Dredging (May 16, 2009) to September 17, 2009

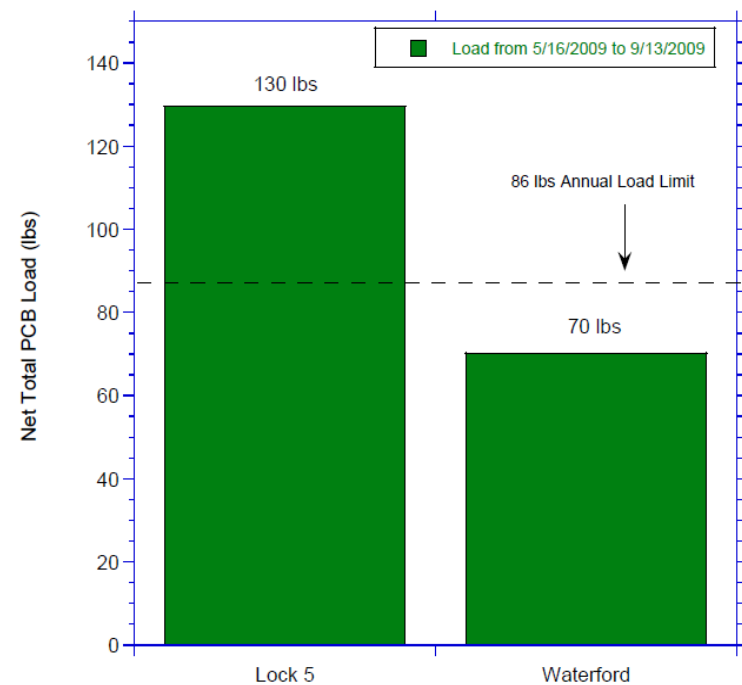
Figure B-2a. Cumulative Net Tri+ PCB Load due to Remedial Activities From Inception of Dredging (May 16, 2009) to September 13, 2009

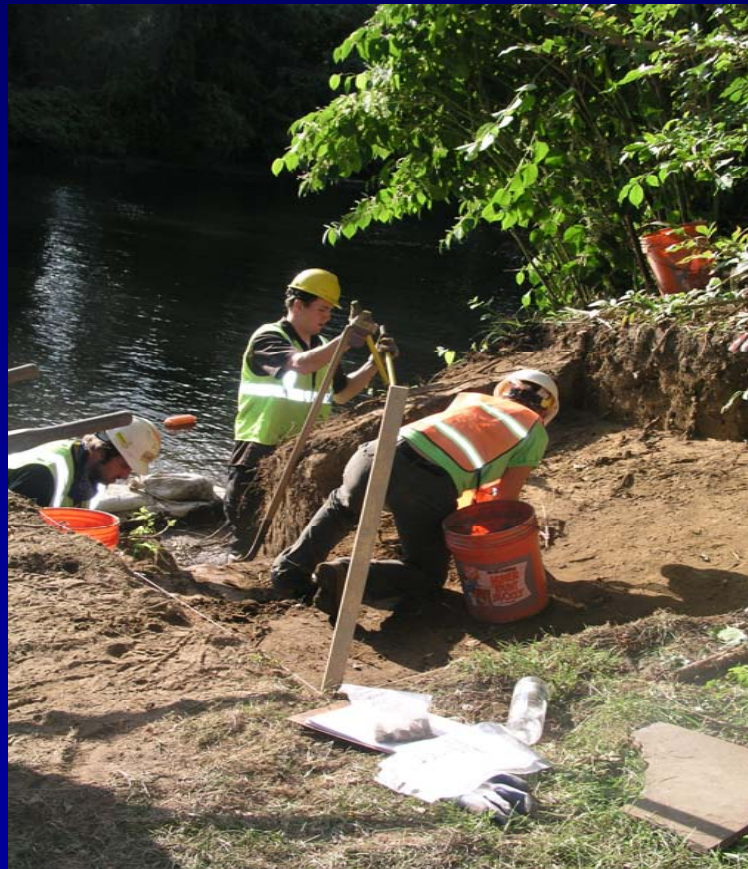
Archeological Investigation

- Archeological work is underway at the site of historic Fort Edward.
- Archeologists have
 - completed underwater studies
 - removed the upper soil layers (recent material) to expose older strata dating from the time of the occupation of the Fort.

- **Completion of exposure of timbers**
- **Analysis of configuration of timbers (above and below water)**
- **Results of PCB testing of timbers**
- **Preparation of detailed reports**

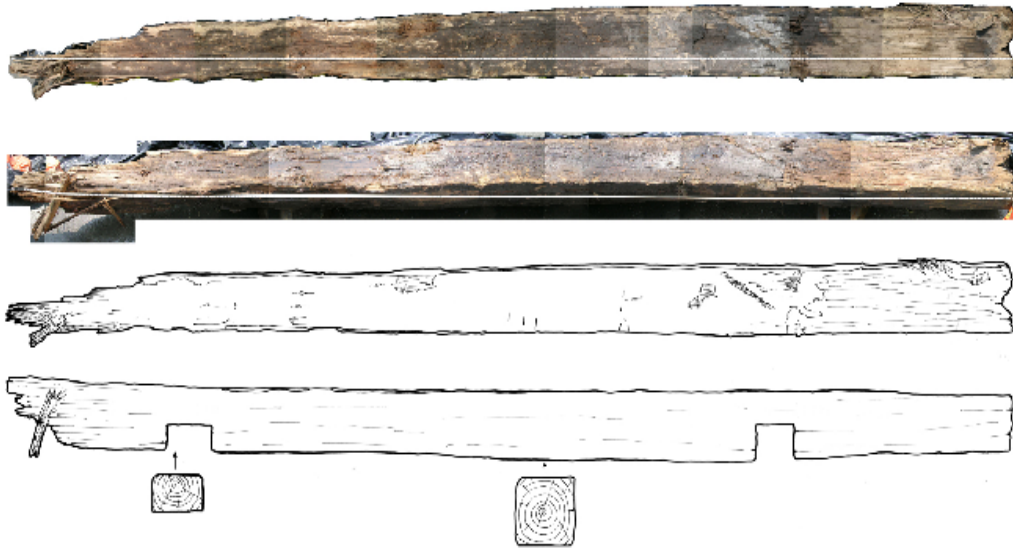
Timber 1

Drawings and Photo-Mosaics of Timbers Removed from the Hudson River at the Site of Fort Edward

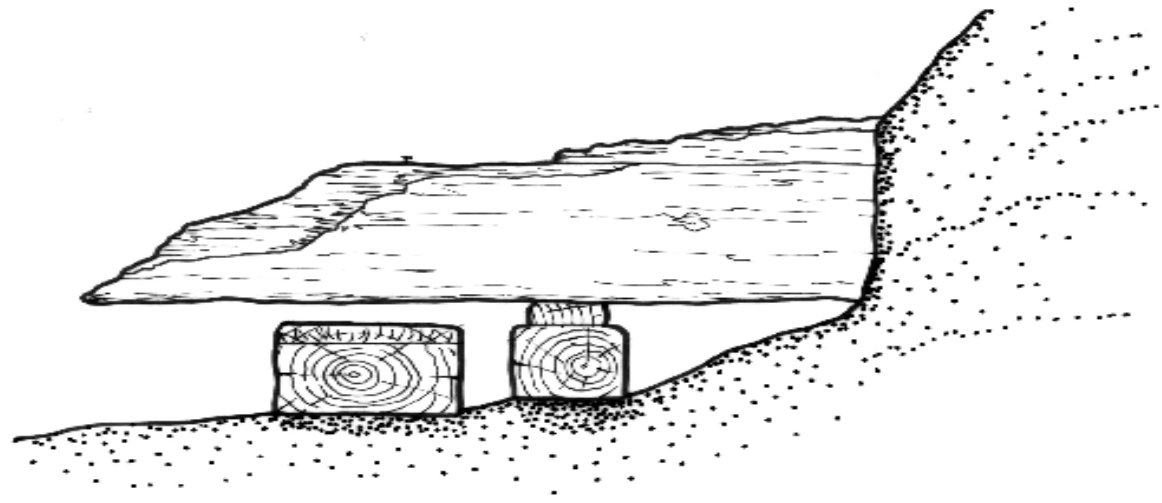
Profile
Facing Northeast

Fort Edward Archaeological Study
Hudson River PCBs Superfund Site
Lake Champlain Maritime Museum
Drawn: Chris Sabick
Inked: Adam Kane
September 2009
In-River Fort Remains
Scale 1"=1'

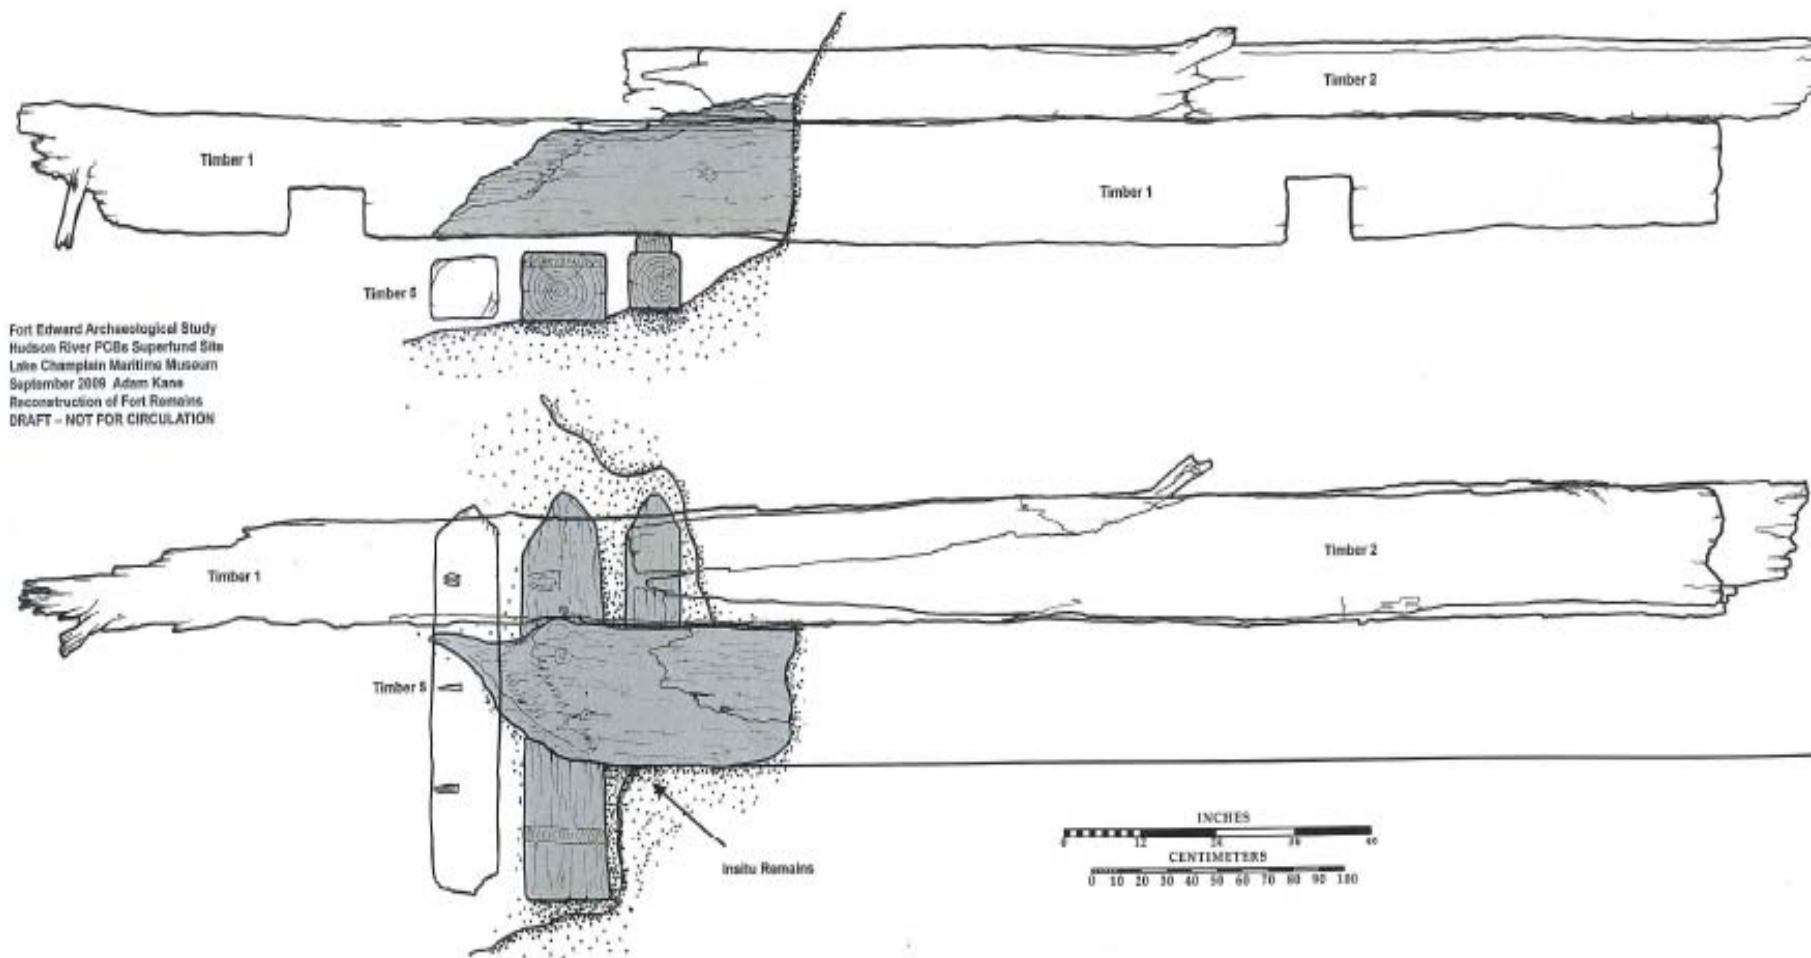
Fort Edward Archaeological Study
Hudson River PCBs Superfund Site
Lake Champlain Maritime Museum
September 2009 Adam Kane
Reconstruction of Fort Remains
DRAFT - NOT FOR CIRCULATION
