Upper Hudson River

Habitat Reconstruction and Restoration

2023 Habitat Reconstruction Monitoring

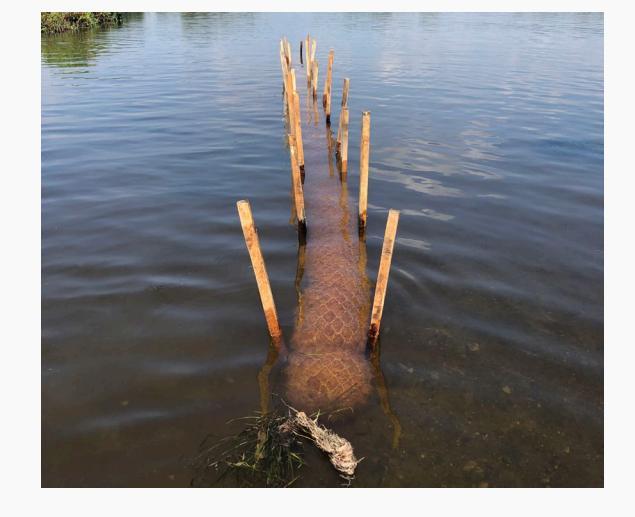
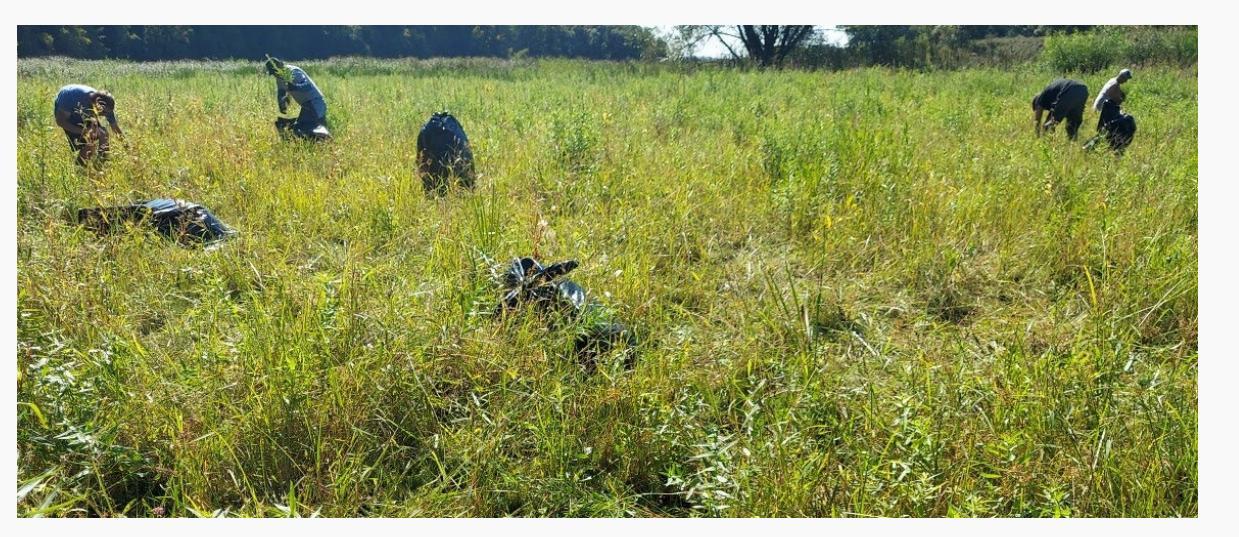
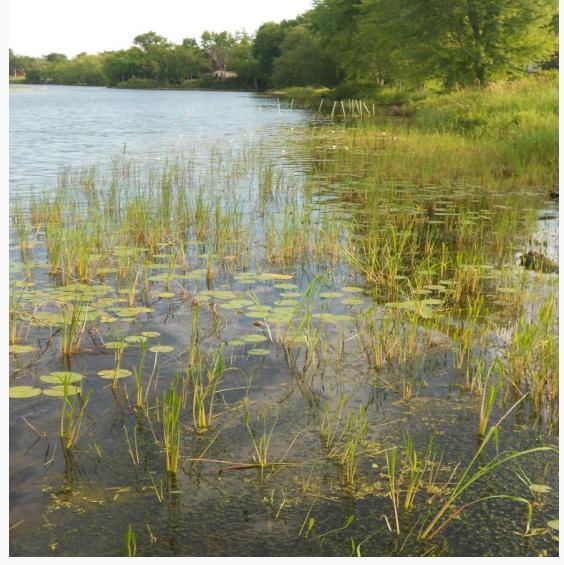
- Certification Unit (CU) 68-70:
 - 4,600 plants (primarily water lily)
 - 12 coir logs installed to absorb wave energy
- CU64:
 - 1,600 plants (pickerelweed, bur-reed, bulrush, water lily)
 - 8 coir logs to slow down flows and prevent sedimentation
- Invasive species management (multiple areas)

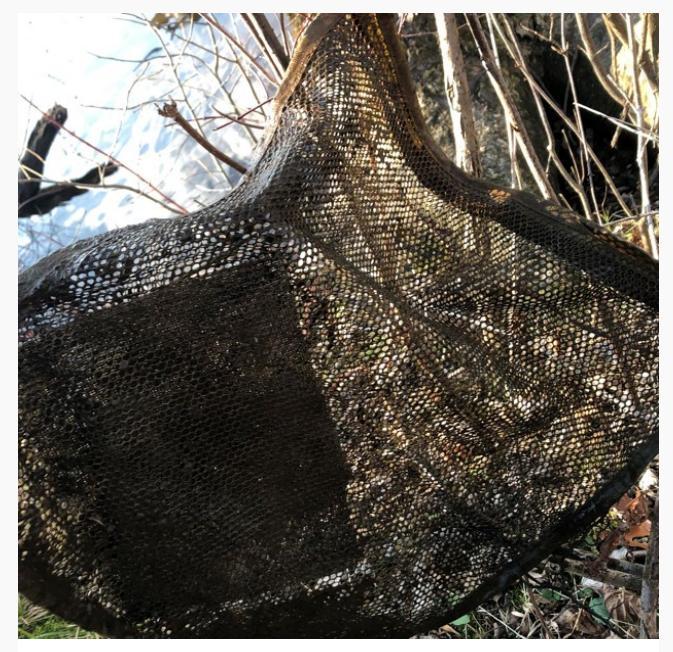
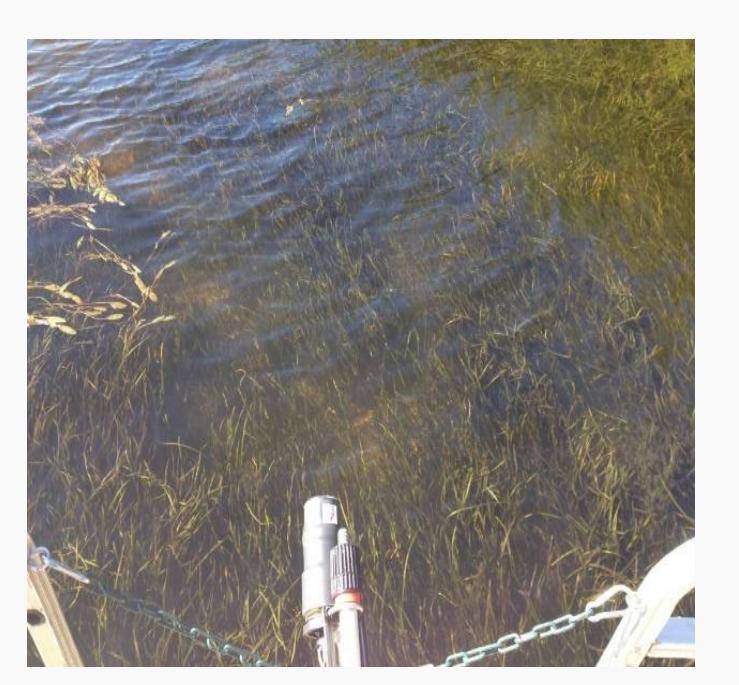
Seed Buoy Mesh Bag

- More about wild celery seed pods
 - Seed pods are harvested from relatively dense SAV beds, placed into mesh bags, and attached to buoys to encourage re-vegetation seeds fall in area around seed buoy

- Response actions implemented annually based on previous years monitoring results and the results of planting pilot and other studies
- 2023 RFW response actions included:
 - Installation of wave-break measures (coir logs),
 - Plantings in select RFW areas, and
 - Invasive species management
- 2023 SAV response actions include using American wild celery (Vallisneria americana) seed buoys (scheduled for November)
