**Community Advisory Group Meeting
Fort Edward Fire House**

September 22, 2011

Floodplains Update
(last update February 17, 2011)

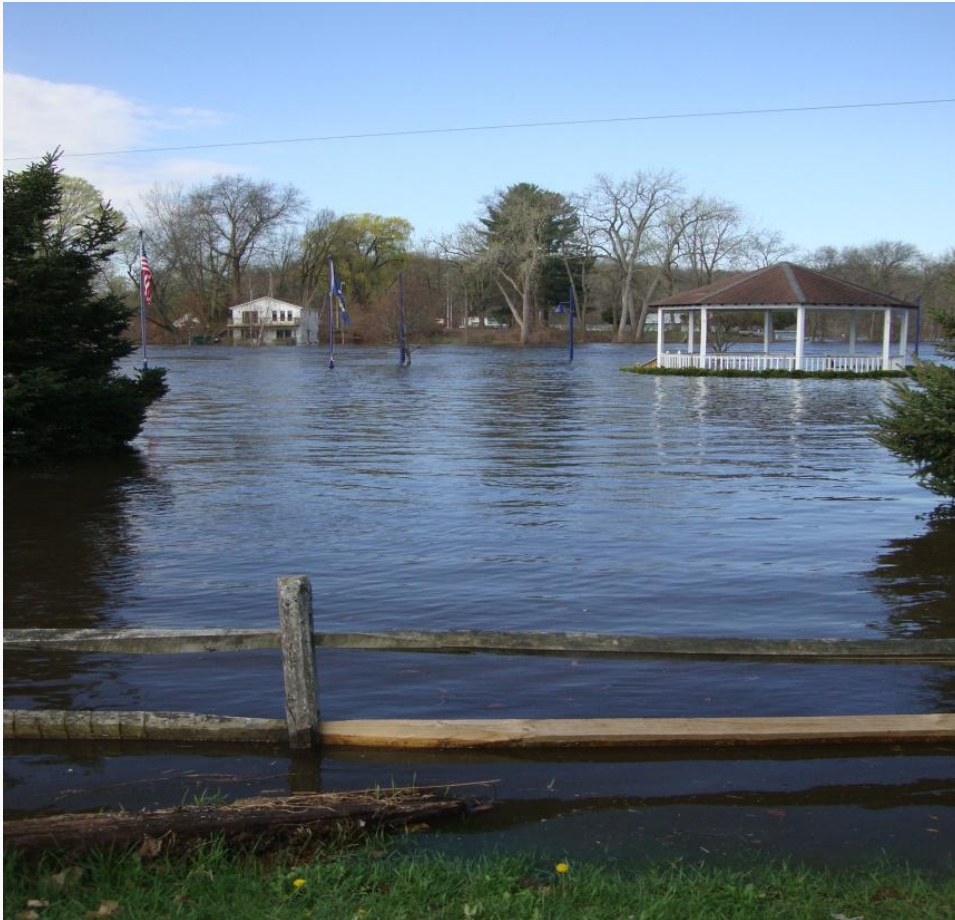
2008 - 2010 Sampling Results

Key Points (Where are the PCBs ?):

- Low-lying areas (flooded more frequently)
- Decrease as move away from River

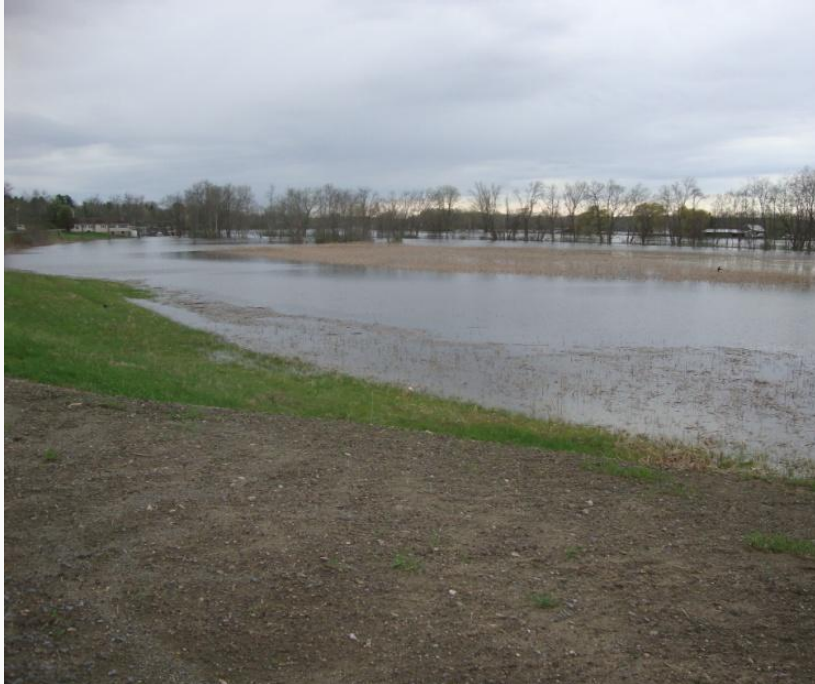
2008 - 2010 Sampling Results

Data Summary:

- Approximately 5,000 samples collected (400 properties)
- 80% of samples <1 ppm or non-detect
- 14% ranged from 1-10 ppm
- 6% samples >10 ppm
- 99% samples <1 ppm in agricultural fields

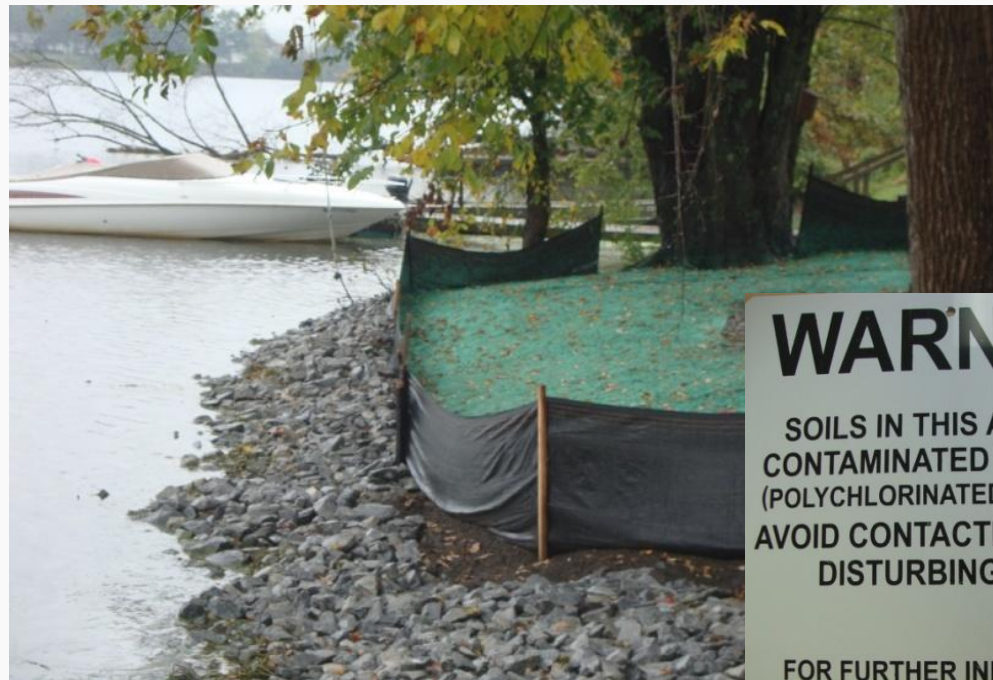
Soil Covers or Signage where PCB concentrations >10 ppm

- 35 Soil covers
- 15 Signs

- 7 Soil Covers
- 1 Sign

* *Seasonal inspections and repairs if needed*

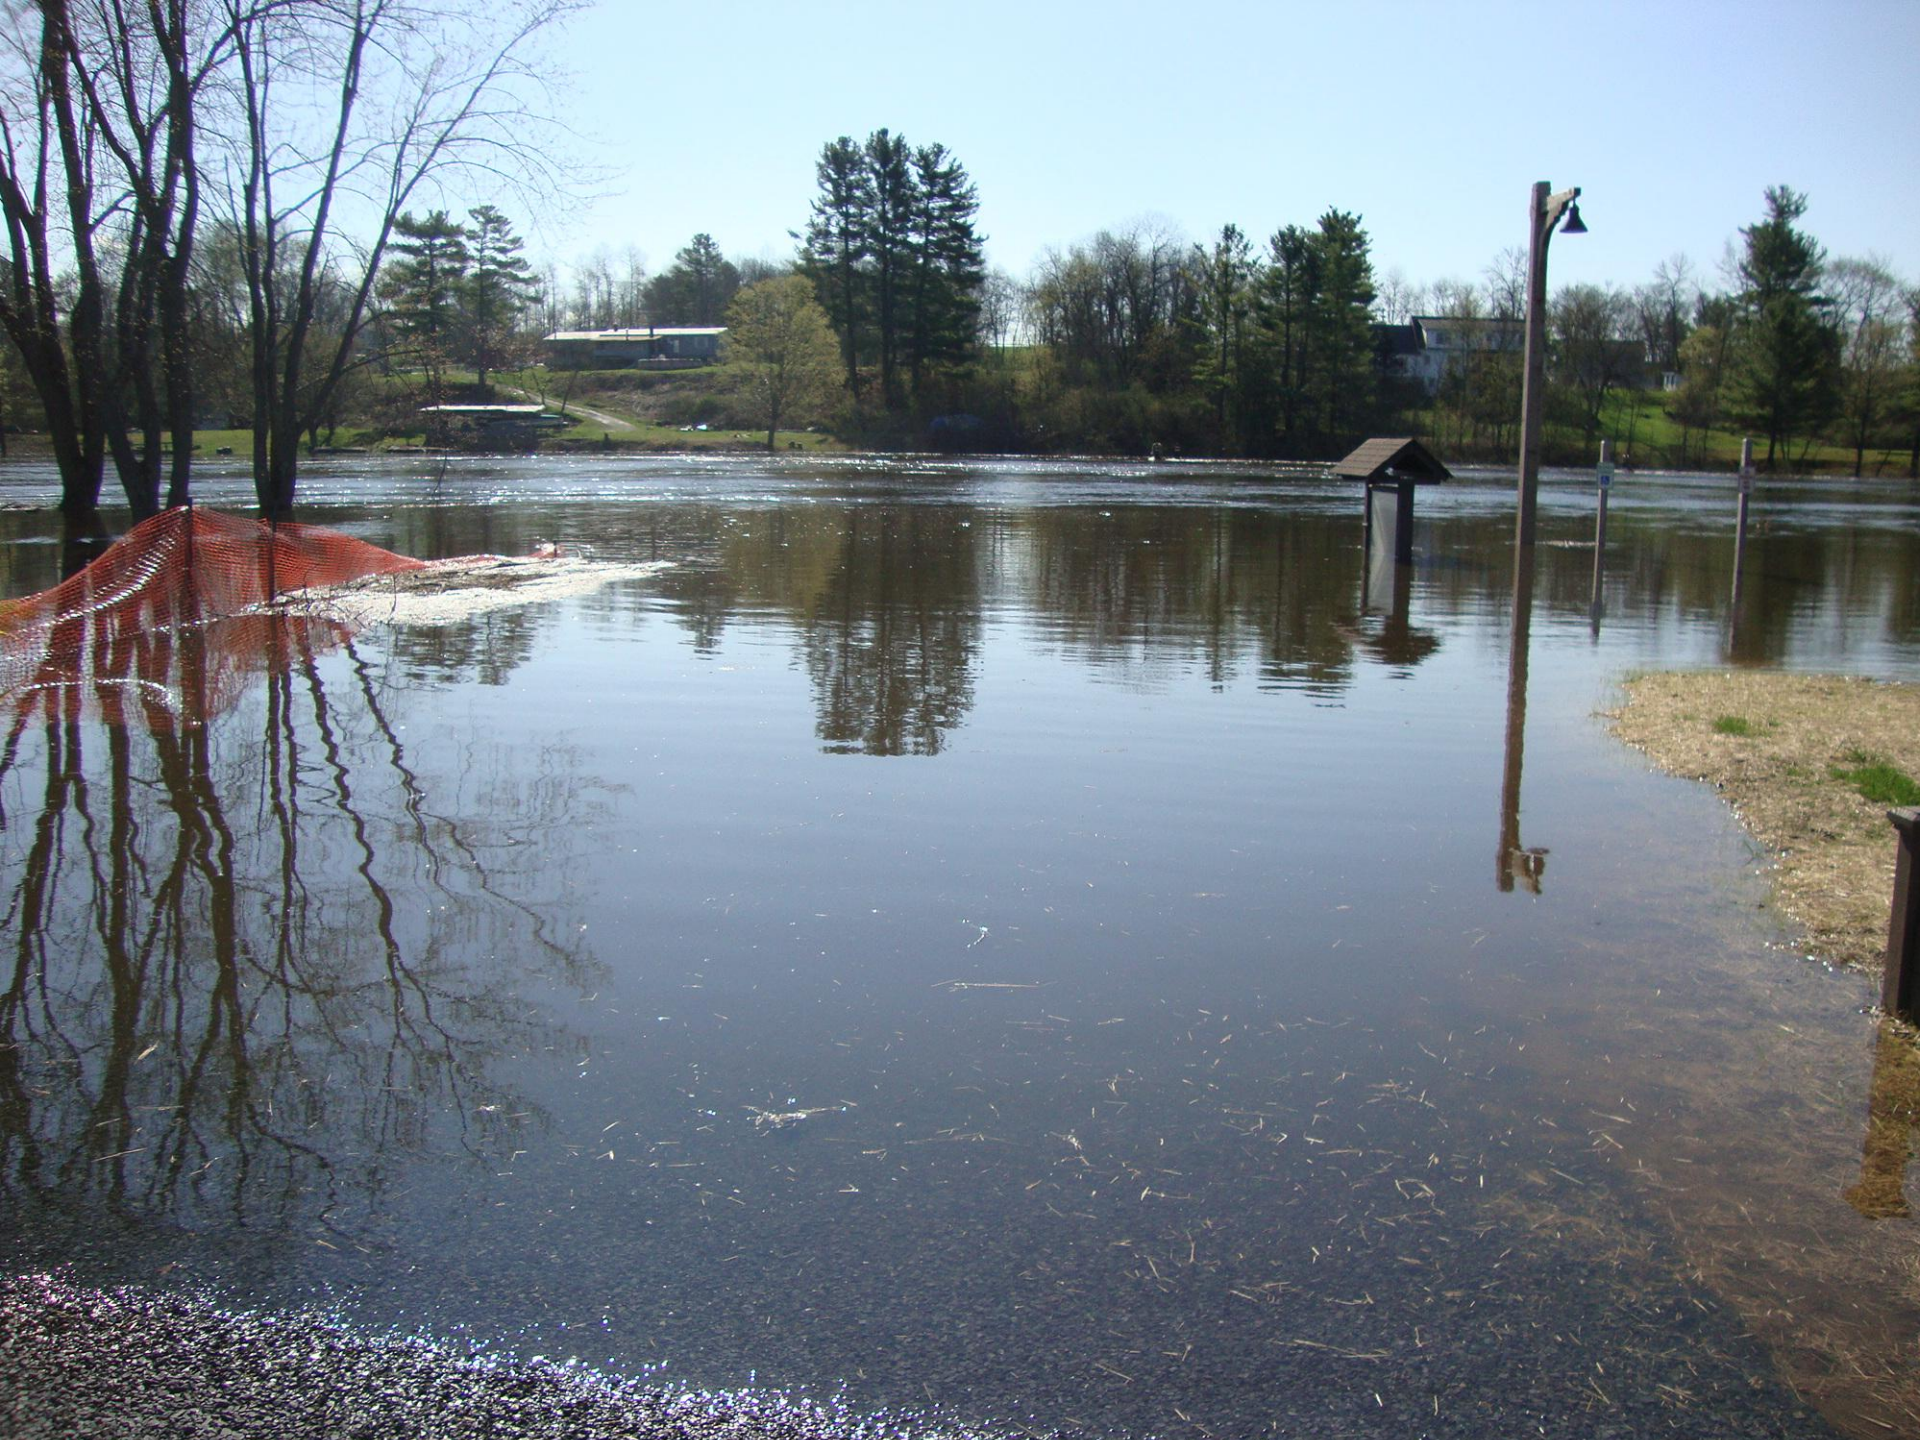
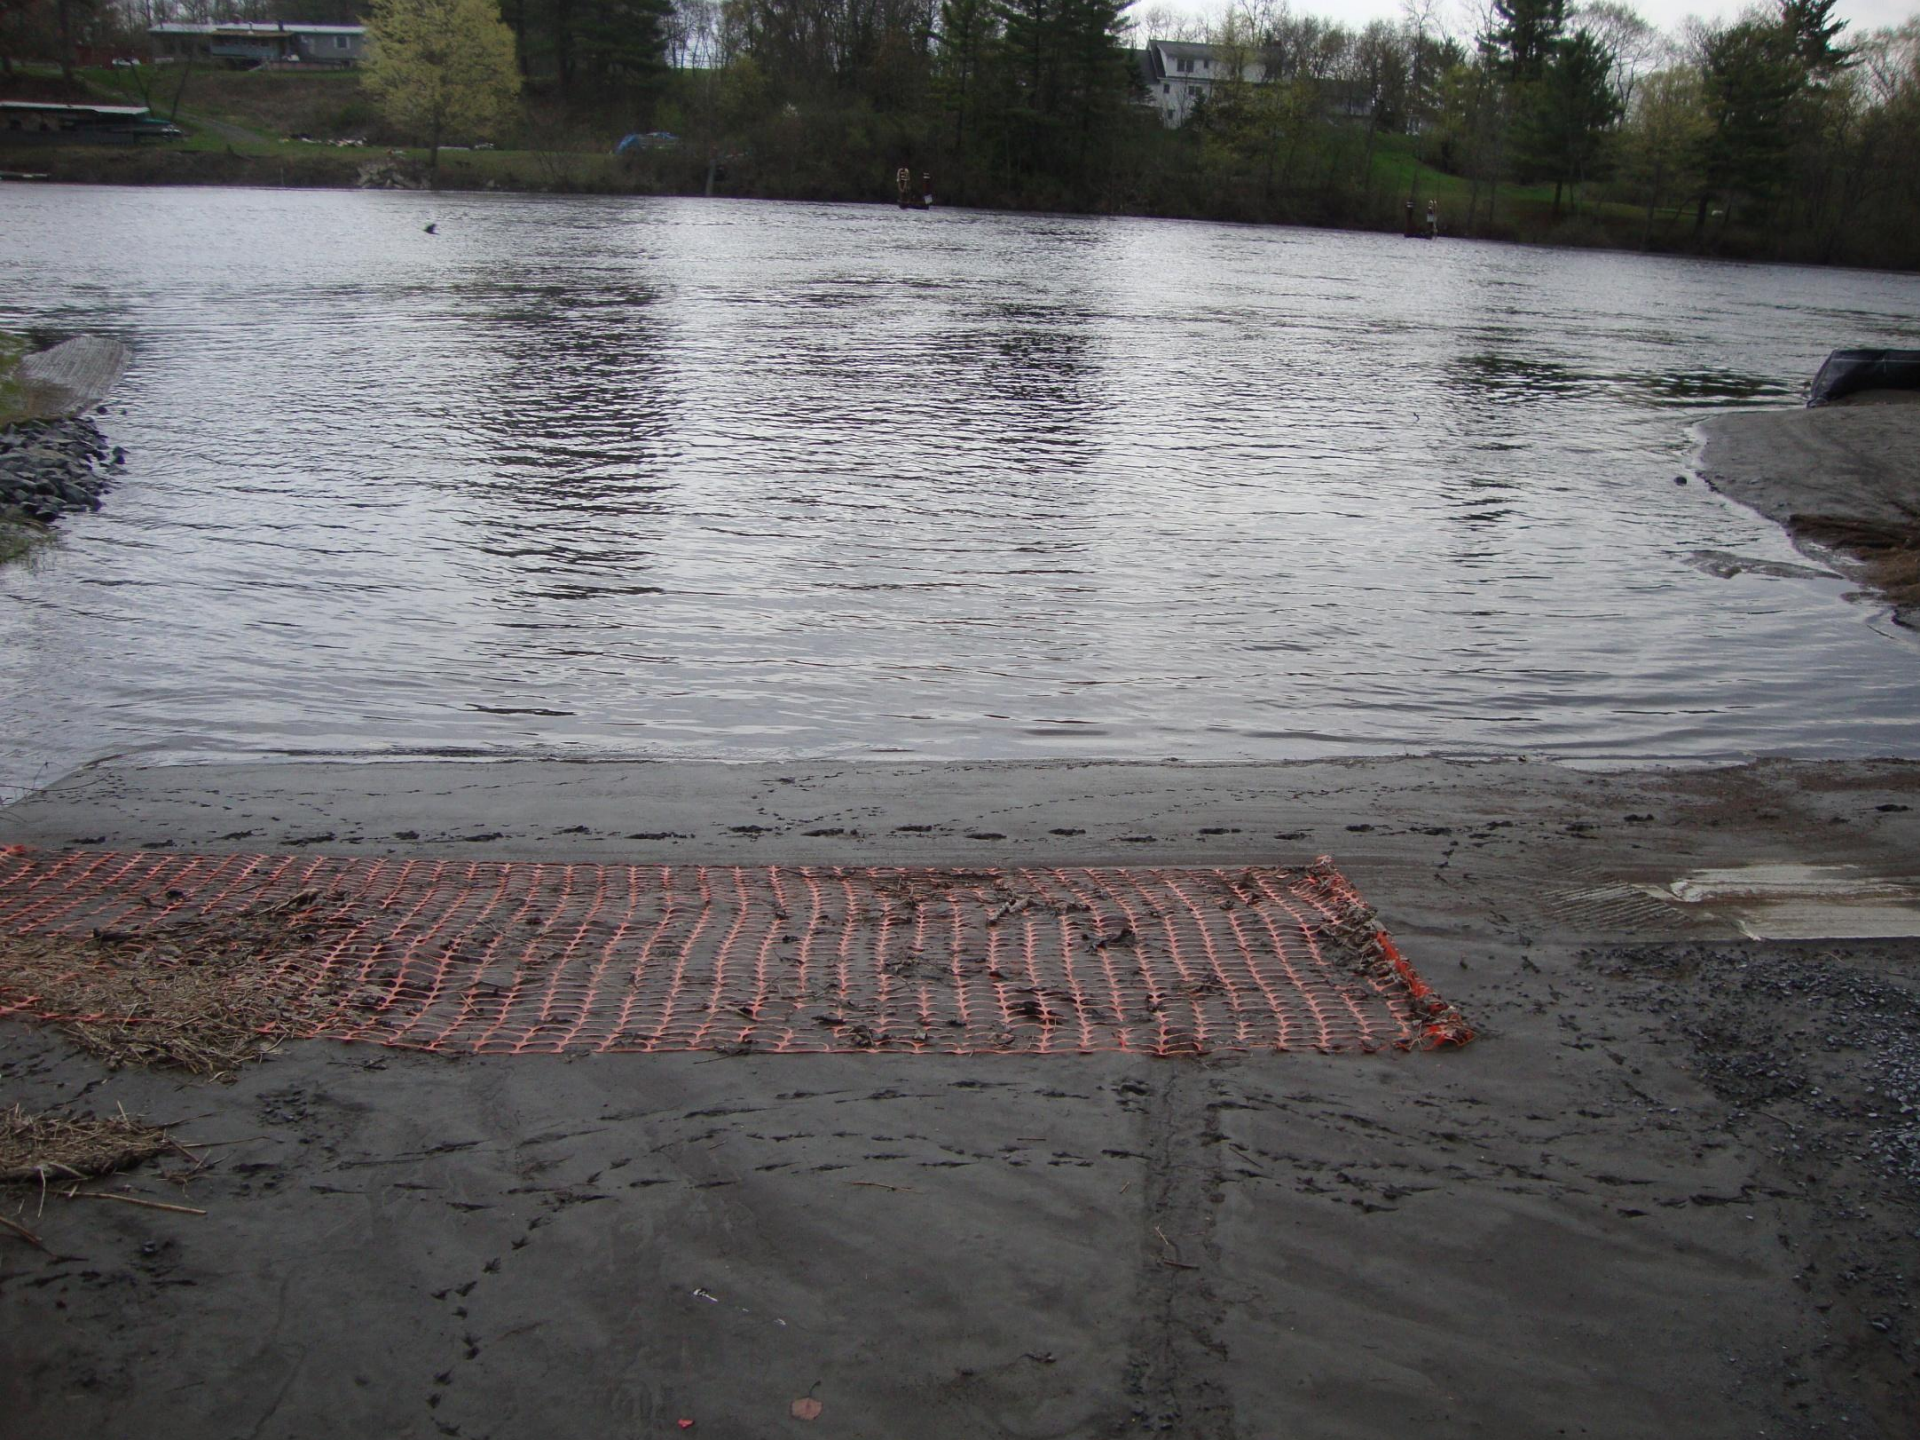
SOILS IN THIS AREA ARE CONTAMINATED WITH PCBs (POLYCHLORINATED BIPHENYLS) AVOID CONTACTING AND/OR DISTURBING SOILS

FOR FURTHER INFORMATION PLEASE CONTACT THE USEPA FIELD OFFICE AT (518) 747-4389 OR LOG ONTO THE USEPA HUDSON RIVER PCBs WEBSITE AT <http://www.epa.gov/udson>
